**July 2, 2026**

Version 3

**Safety Recall: 2025–26 CR-V e:FCEV, 2023–26 Accord Hybrid/CR-V Hybrid Tire Repair Kit****Supersedes version 2 to revise the information at:**

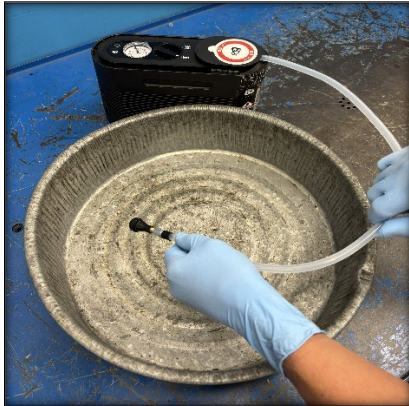
2. Position the sealant hose over a catch tray. Then, thread a used tire valve stem (A) into the sealant hose valve (B) to open the valve, allowing any pressure to be released and any remaining tire sealant to drain from the sealant bottle.

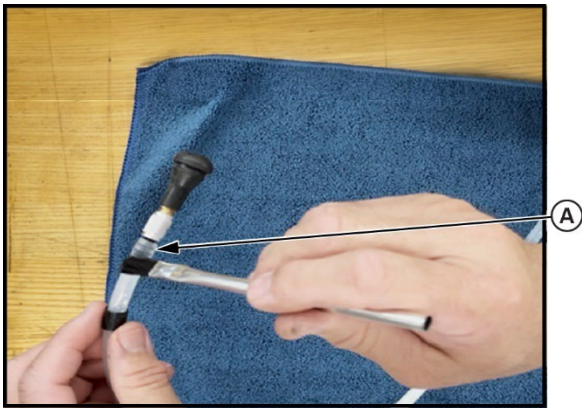
8. Apply a soap-and-water solution to the outside of the sealant hose and hose retainer area (A).
