**June 5, 2026**

Version 2

## Safety Recall: 2025–26 CR-V e:FCEV, 2023–26 Accord FHEV/CR-V FHEV Tire Repair Kit

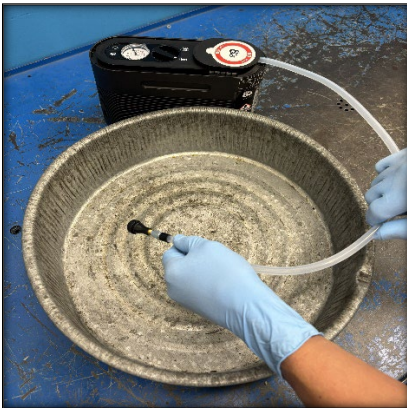
2. Position the sealant hose over a catch tray. Then, thread a used tire valve stem (A) into the sealant hose valve (B) to open the valve, allowing any pressure to be released and any remaining tire sealant to drain from the sealant bottle.

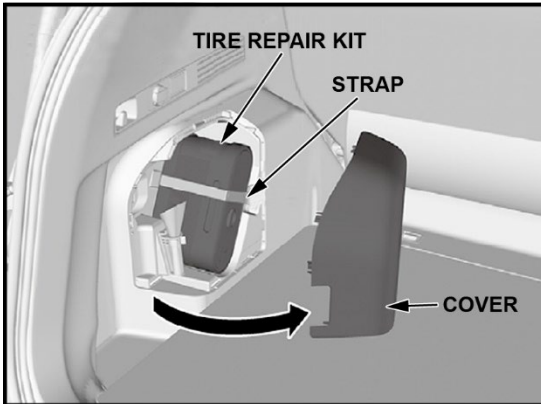
**CR-V Hybrid (left side cargo area)**

7. Reinstall the tire repair kit, including the user guide, back into the vehicle.

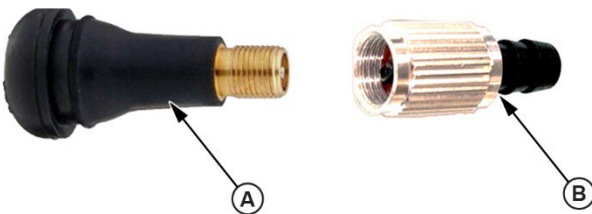
6. For better leverage during repair, thread a used tire valve stem (A) into the **new** sealant hose valve (B).

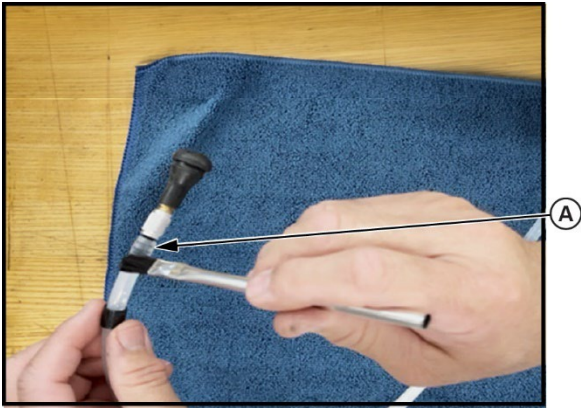
8. Apply a soap-and-water solution to the outside of the sealant hose and hose retainer area (A).

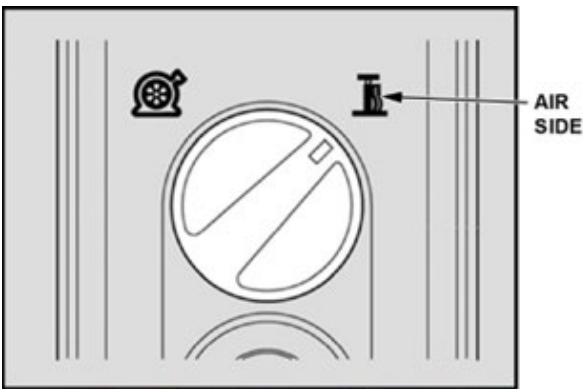
13. Reinstall the sealant hose back into the tire repair kit.  
14. Make sure the air pump selector knob is pointing to the **Air Side** and **not** the **Repair Side**.
