**July 2, 2026**

**Safety Recall: 2018–20 Odyssey Rearview Camera****APPLIES TO**

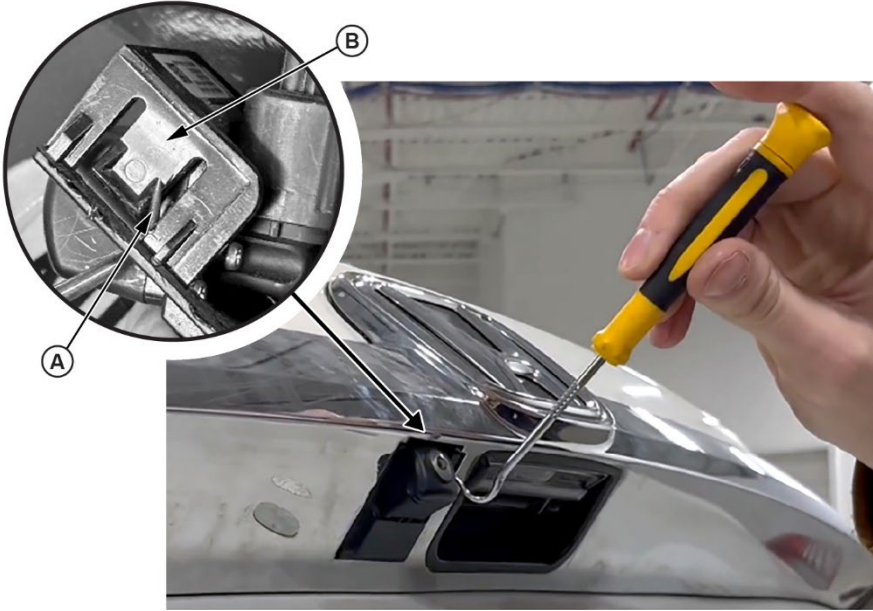
2. Using a suitable pick tool, carefully slide the pick (A) behind the retention tab (B). Push the tab inward toward the camera lens while gently pulling the camera downward to disengage and release the tab.

NOTE: Use a 3.1 mm, 6-inch pick tool with a 90° tip or an equivalent commercially available tool.

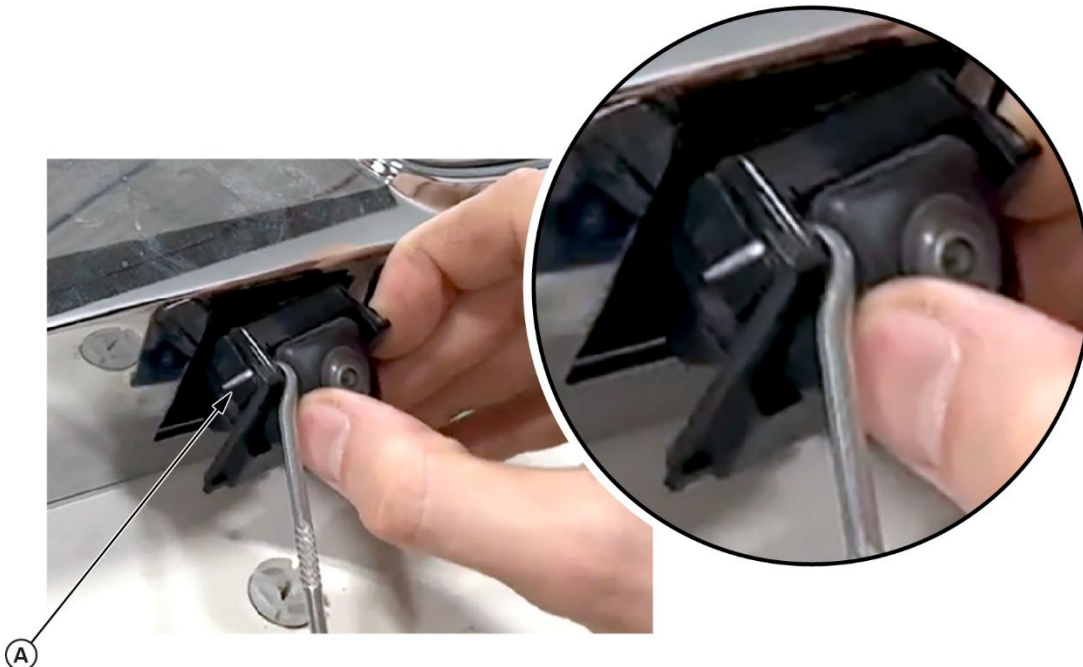
3. Repeat the procedure to release the retention tab (A) on the opposite side, then remove the rearview camera.

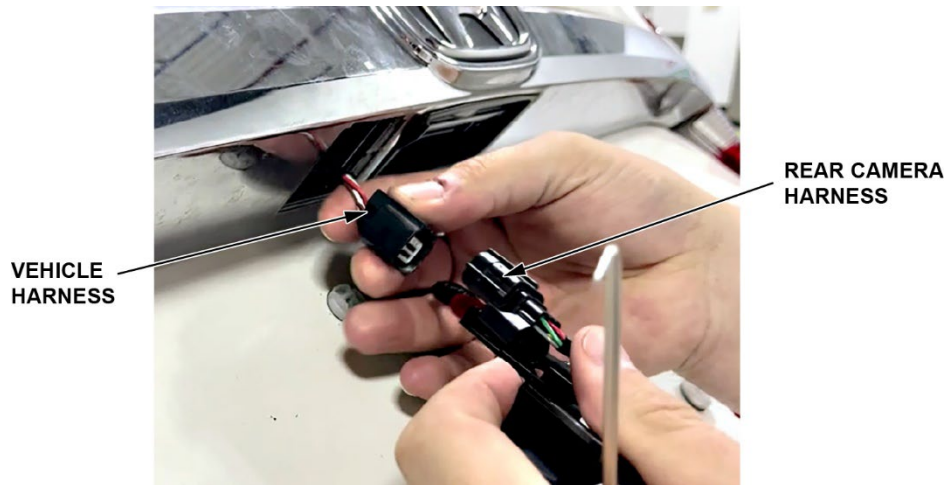
4. Disconnect and remove the defective rearview camera assembly.

5. Connect the **new** rearview camera harness to the vehicle harness.

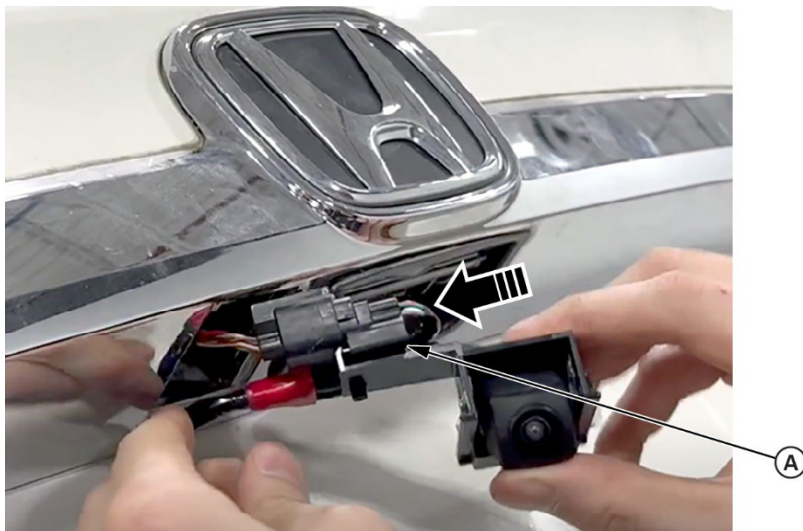
6. Insert the harness and camera bracket (A) into the trim. Push the rearview camera assembly into place until the retention tabs lock.

NOTE: Make sure the rearview camera is securely installed.
