**Subject:** Tail Pipe Replacement

**Bulletin:** R0007

**Campaign #:** A4250

**Affected Models:** 2005 – NA6J, NB6J, NC6J

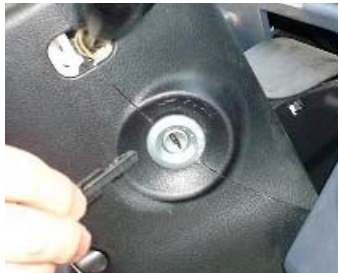
Turn the starter key while pushing to set it at “LOCK” position. Then Pull out the key.

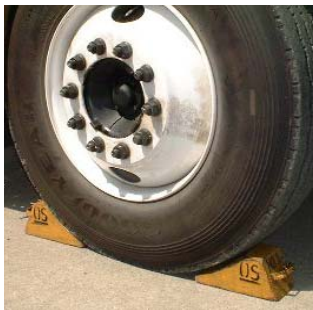
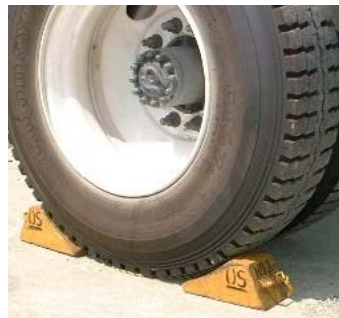
Apply the parking brake firmly and block the wheels.

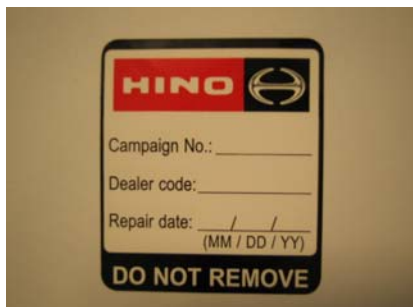
Fill out the Campaign Completion sticker in the picture to the left once the Recall repair is completed. This sticker should be attached to the passenger side door jam above the V.I.N. Plate.

- Be sure to confirm that the bolts and nuts are tightened properly and verify that there are no abnormalities
- Turn on the key switch to start engine, and confirm there is no abnormal noise and gas leak.
- Remove the wheel chocks
- Install the Campaign Completion Label on the Passenger Side door pillar once the repair is complete.

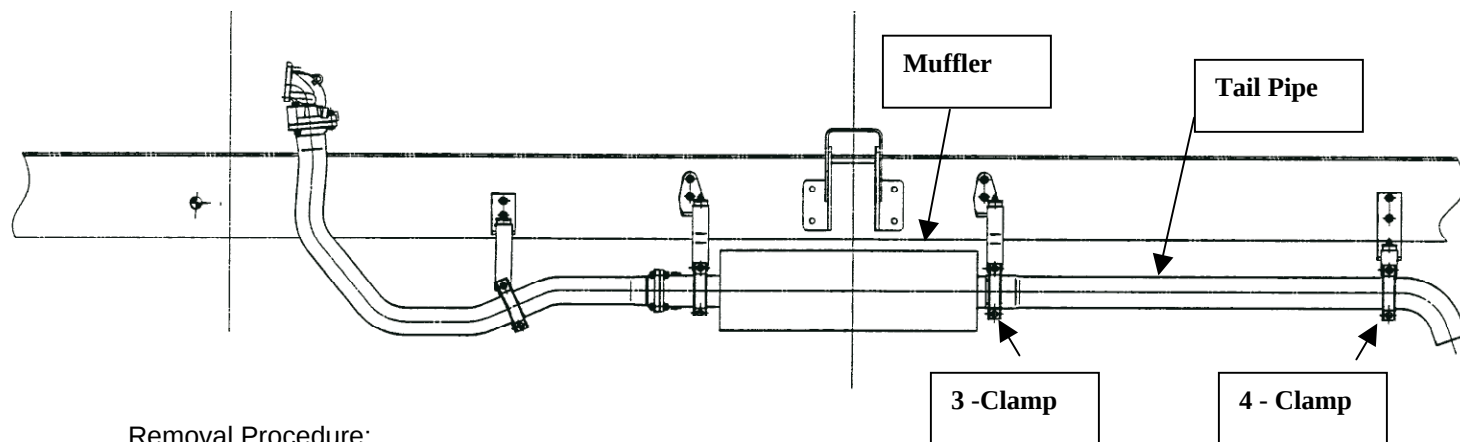
1. Loosen the bolts and Nuts on clamp #3 in the illustration above.
2. Remove Clamp #4 in the illustration above.
3. Remove the Tail Pipe

- In accordance with the following torque, tighten the bolts/nuts in the order of 1,2,3 and 4 as described in the illustration on the prior page. (When tightening the clamps 2,3 and 4, tighten those of lower side after tightening the bolts of upper side.)

| Torque Value: | Upper Part of Clamp | 34-42 ft. lbs. |
| | Lower Part of Clamp | 20-24 ft. lbs. |

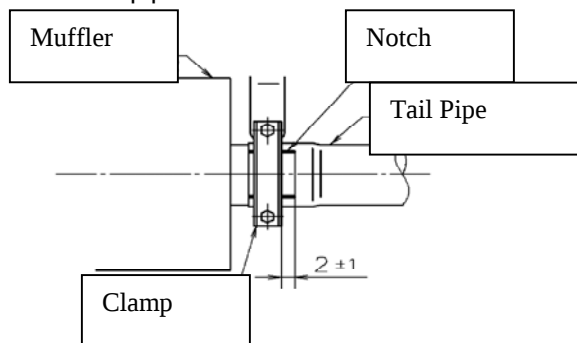
- Slide the new tailpipe over the muffler until the tailpipe bottoms out.
