**Subject:** Catalytic Converter and Tail Pipe Replacement

**Bulletin:** R0006

**Campaign #:** A3821

**Affected Models:** 2005 – NA6J, NB6J, NC6J

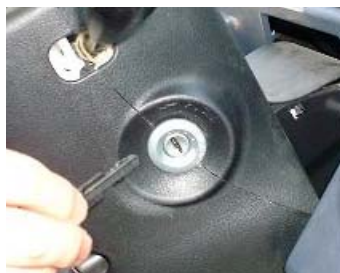
Turn the starter key while pushing to set it at “LOCK” position. Then Pull out the key.

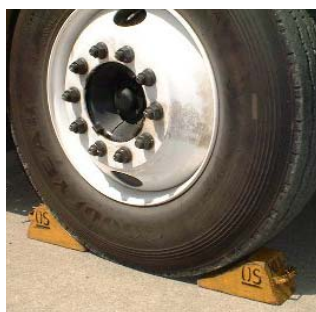
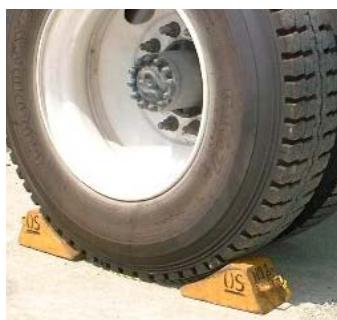
Apply the parking brake firmly and block the wheels.

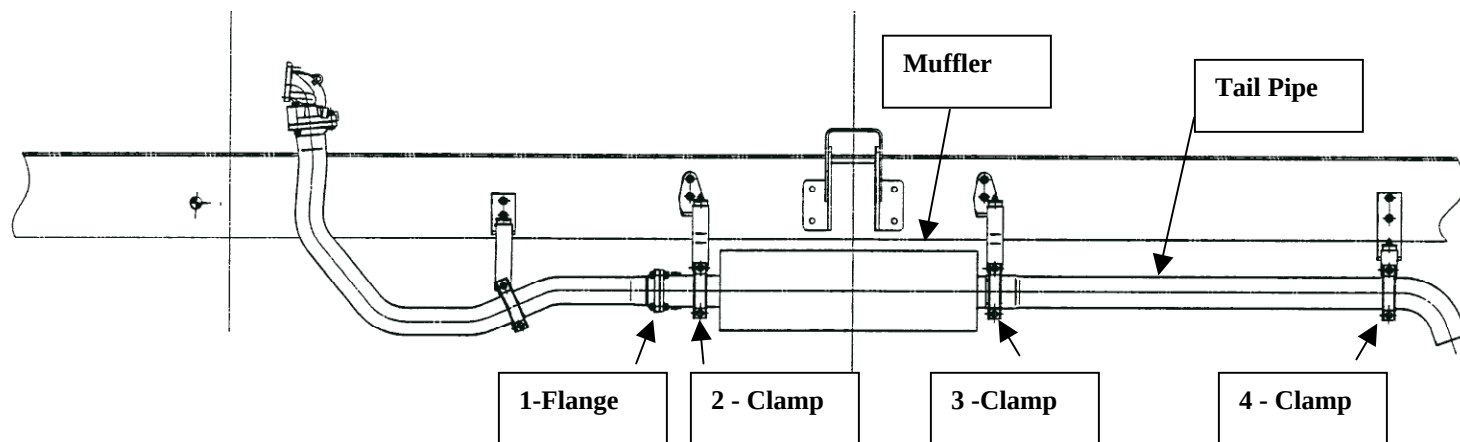
## Removal Procedure:

1. Loosen the bolts and Nuts on clamp #3 in the illustration above.
2. Remove Clamp #4 in the illustration above.
3. Remove the Tail Pipe
4. Remove bolts and nuts of the flange 1 and the clamps 2 and 3 from the illustration above to remove the muffler.

- Place the new muffler as shown above and install the bolts and nuts in flange 1 and clamps 2 and 3 temporarily as shown in the illustration above. **(Be careful not to forget to install the new gasket between the flanges. Also when installing the clamps be sure the clamps are installed with the arrows pointed upward and that the weld seam is turned toward the inside of the vehicle as shown in the illustration below).**

- In accordance with the following torque, tighten the bolts/nuts at each part in the order of 1,2,3 and 4 as described in the illustration on the prior page. (When tightening the clamps 2,3 and 4, tighten those of lower side after tightening the bolts of upper side.)

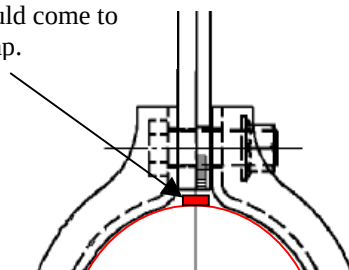
- Slide the new tailpipe over the muffler until the tailpipe bottoms out.
- Adjust the stopper (tab) position of the tail pipe as shown in the illustration below.

Stopper of tail pipe should come to upper center of the clamp.

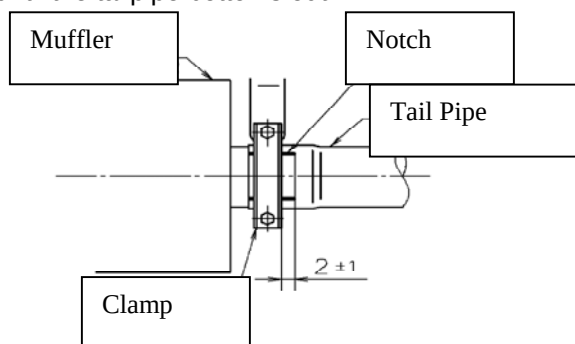
- Slide the new tailpipe over the muffler until the tailpipe bottoms out.
