You will find enclosed a copy of Service Bulletin S07MU regarding the power steering reservoir cap on your 2008 model year Blue Bird "Vision" buses.

Power Steering Reservoir Cap

MODELS AFFECTED: 2008 BBCV Vision

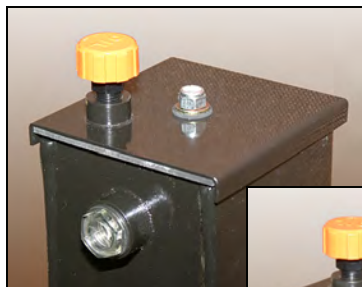
Old Design

Power Steering Reservoir Cap allows fluid leak.

Replace the existing reservoir cap with the newly designed reservoir cap.
