# BBCV Left Wiper Sweep

# BULLETIN

MODELS AFFECTED: 2008 BBCV

Due to noncompliance with design specification of a bicycle crank, the sweep of the driver's-side windshield wiper may be reduced.

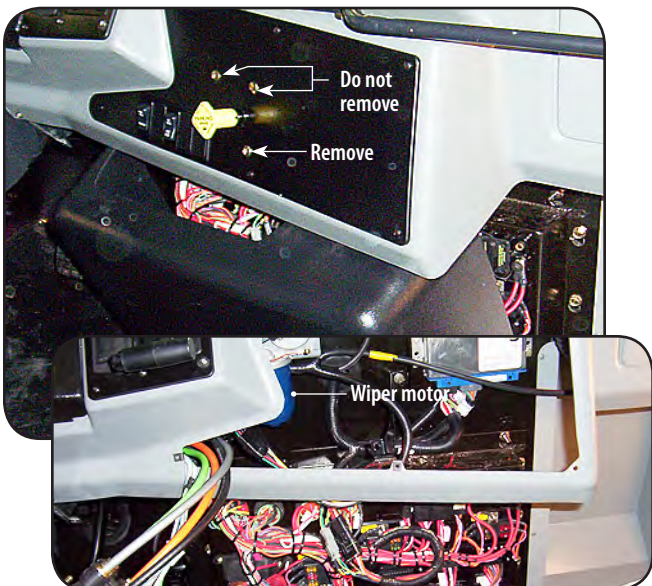
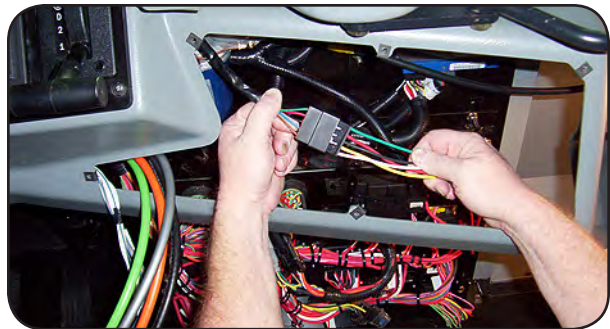
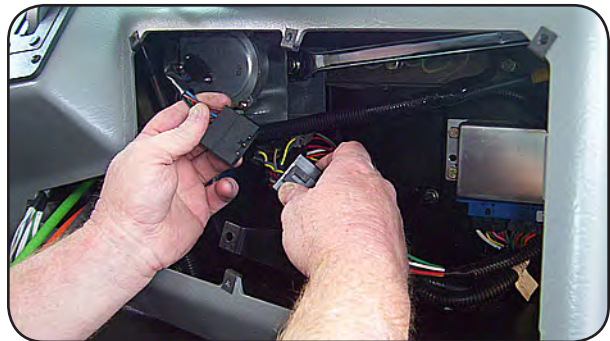
**2** Remove the PDU cover and the driver's center switch panel:

2.1 Remove the thumbscrews which secure the PDU cover, and set the cover aside.

2.2 Remove the screws around the perimeter of the driver's center switch panel. On buses equipped with air brakes, the bottom parking brake release valve mounting screw threads into a support bracket, and must also be removed to remove the panel. Do not remove the other two park brake valve screws. Carefully move the panel assembly toward the driver's seat sufficiently to gain access to the wiper motor.

**3** Locate and disconnect the windshield wiper motor harness connector and disconnect the wiper motor harness from the vehicle harness.

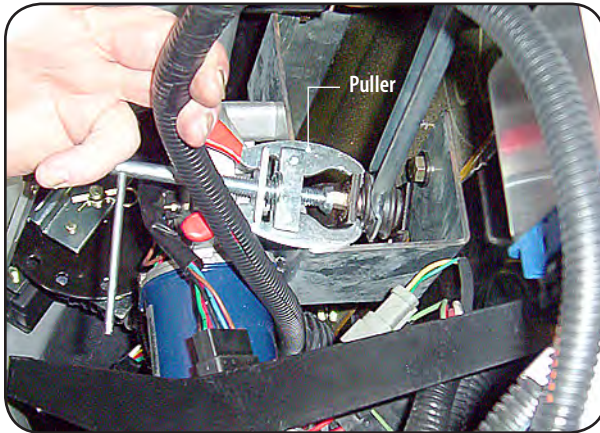
**5** Remove the original lower short crank plate:

- 5.1 Using a  $\frac{5}{16}$ " socket or wrench, loosen the attaching nut. There is no bolt head on the front of the assembly; a 1" open end wrench may be used to hold the bicycle crank while loosening the nut.
- 5.2 Using a small battery terminal puller, remove the lower, short crank plate from the bicycle crank. To start the removal, do not completely remove the nut—the puller should press against the hex nut, not the threaded stud. When the lower crank plate pops loose, remove the nut and lower plate. Discard the plate.

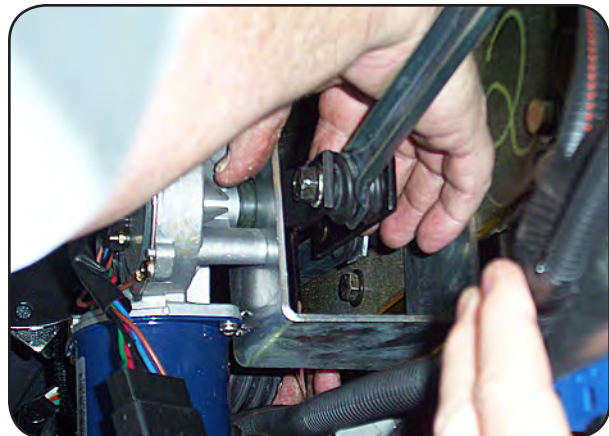
- 7.2 Rotate the bicycle crank by hand so that the wiper arms and blades are all the way down and parked parallel to the bottom edge of the windshield. *The long lever of the bicycle crank must be positioned exactly horizontally.*
- 7.3 Slide the bicycle crank onto the motor output shaft and install the M8 nut snugly by hand. Recheck that the long lever on the bicycle crank is still horizontal. Rotate to correct if necessary.

- 7.4 Using the 1" open end wrench to prevent the long lever from turning, tighten the M8 nut on the motor shaft with the 13mm wrench. Make sure the M8 nut is tight.
- 7.5 Check the entire wiper linkage area to ensure that all wires, hoses, and other objects are clear of the wiper linkage path.

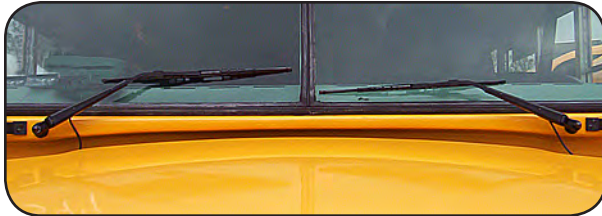
*Wipers not properly aligned*

8.2 Insert the ignition key and turn it to the Accessories position. Operate the wipers for several cycles, turn off the wiper switch and allow the wipers to park. Check the alignment of the wiper blades, as was done in step 2. If the wipers are not aligned to each other, and parallel to the bottom of the windshield, it will be necessary to reposition one or both wiper arms on the pivot shafts.

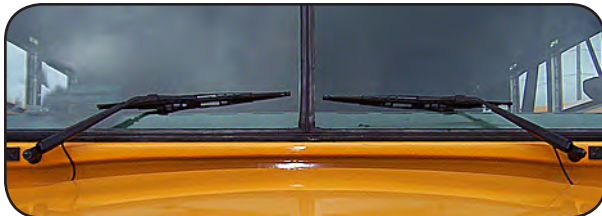
*Wipers properly aligned*

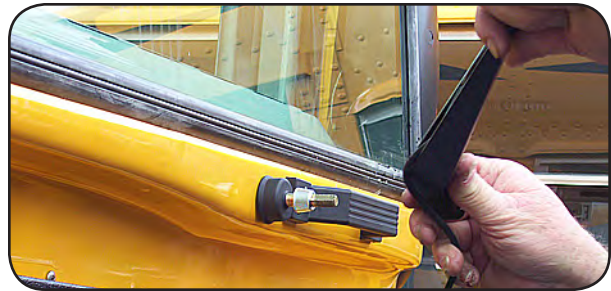
9.2 Remove the wiper arm(s) and separate the knurled driver from the wiper arm.

9.3 Reinstall the knurled driver onto the pivot shaft, install the wiper arm in the proper position, and then reinstall the lock washer and domed nut. The wiper system should now be correctly timed and parked.
