# Service Campaign

**Subject:** Incorrect Shock Absorbers on Rear Air Suspensions

**Bulletin:** C0005

**Affected Models:** Select 2008-2009 268A (NJ8J), 338 (NV8J)

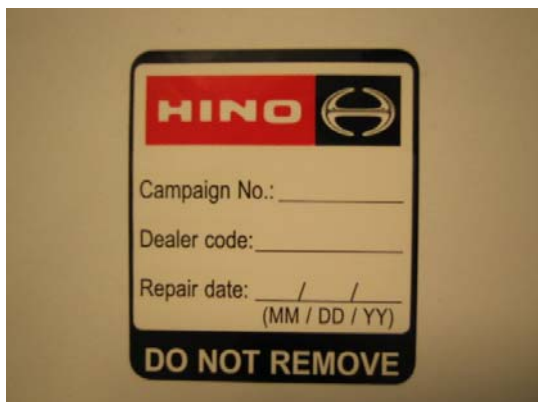
Fill out the Campaign Completion sticker as shown in the picture to the left. This sticker should be attached to the door jam above the V.I.N. Plate.

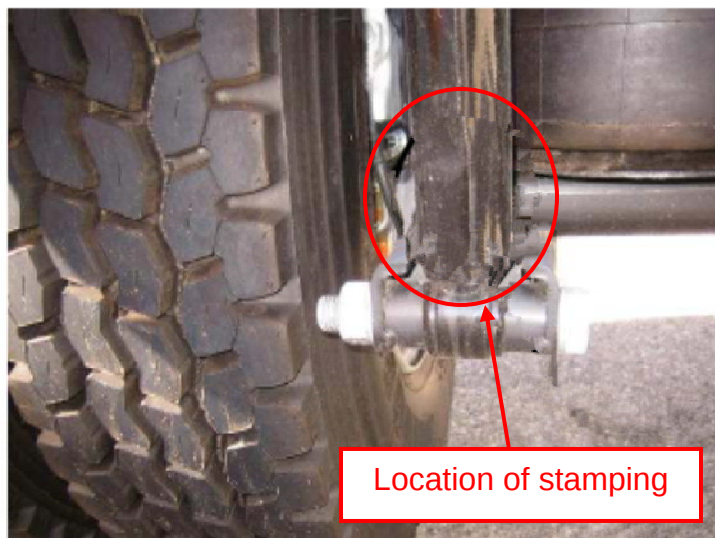
Inspect the part number stamped on both right and left shocks lower shock bodies to determine if replacement is needed.

**If the Number is 60670-14, no Replacement is needed.**

Location of stamping

If the number on either shock absorber is found to be incorrect, refer to the chart on Page 2 for the parts that must be replaced.

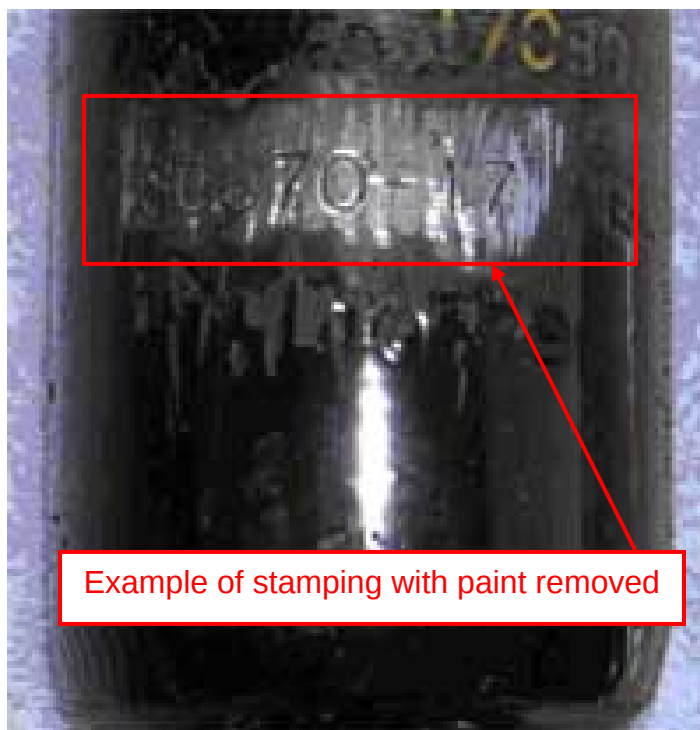
Example of stamping with paint removed

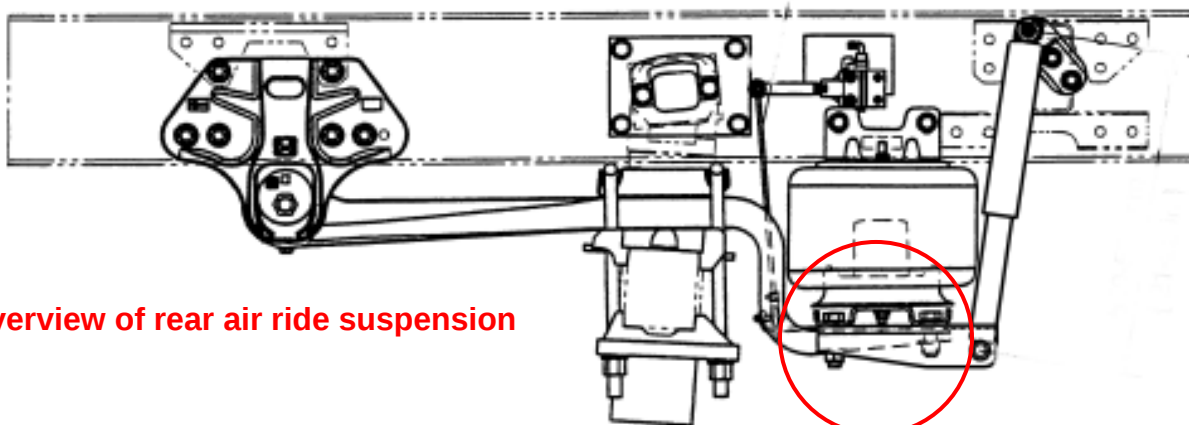
#### Overview of rear air ride suspension

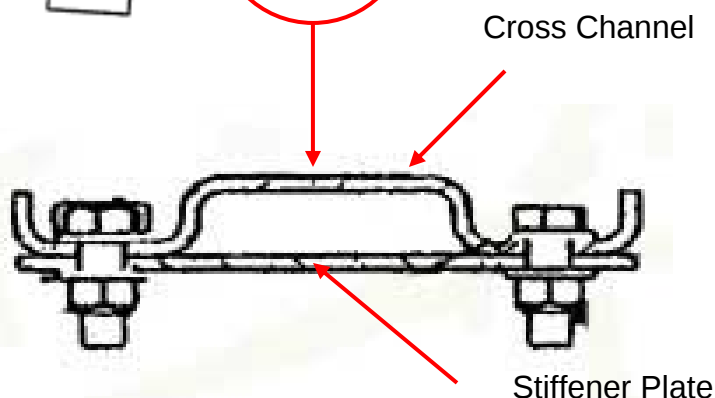
Inspect the part number stamped on both the right and left shock assemblies to determine if replacement is needed.

**If the vehicle is equipped with a stiffener plate, the correct part number is 60670-19**

**If the vehicle is not equipped with a stiffener plate, the correct part number is 60670-14.**

If either shock absorber is found to be incorrect, refer to the chart on page 2 for the parts that must be replaced.

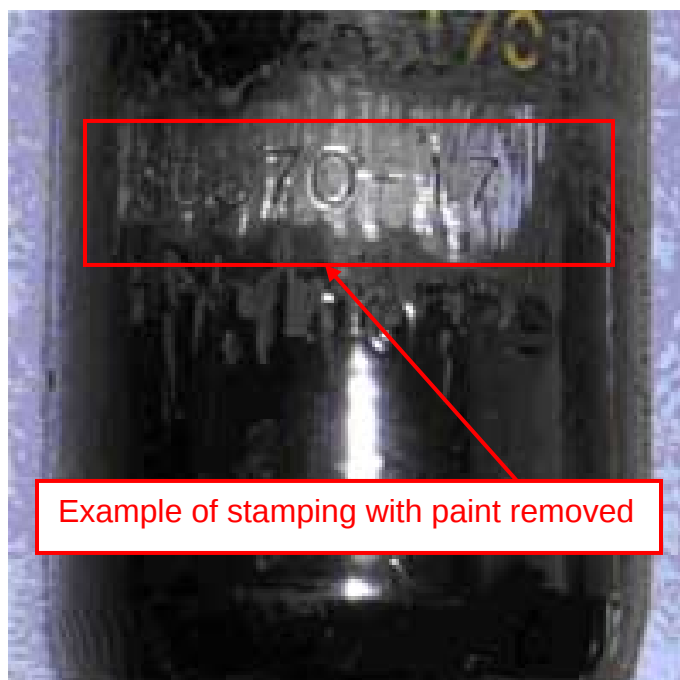
Example of stamping with paint removed

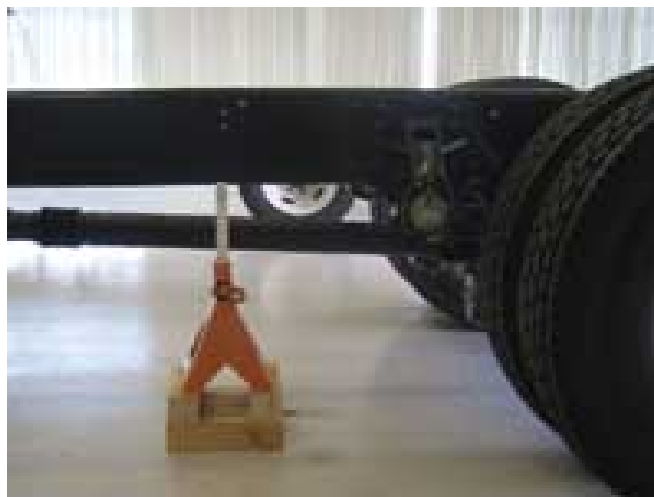
1. Support **both** sides of the frame at the ride height.

**NOTE:** The picture shows only the left side of the vehicle.

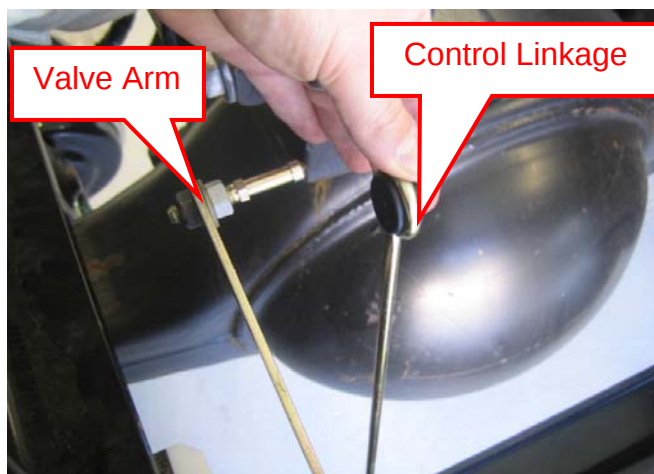
2. Disconnect the height control linkage from the height control valve arm by sliding the rubber grommet from the stud.

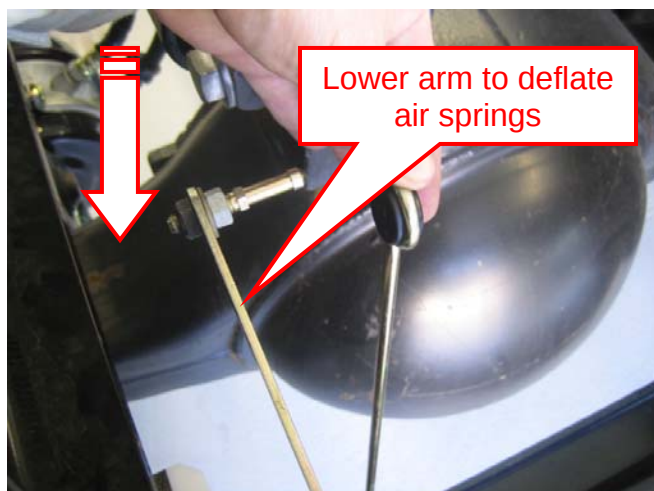
3. Lower the leveling arm to exhaust the air inside the air springs and deflate the rear springs.

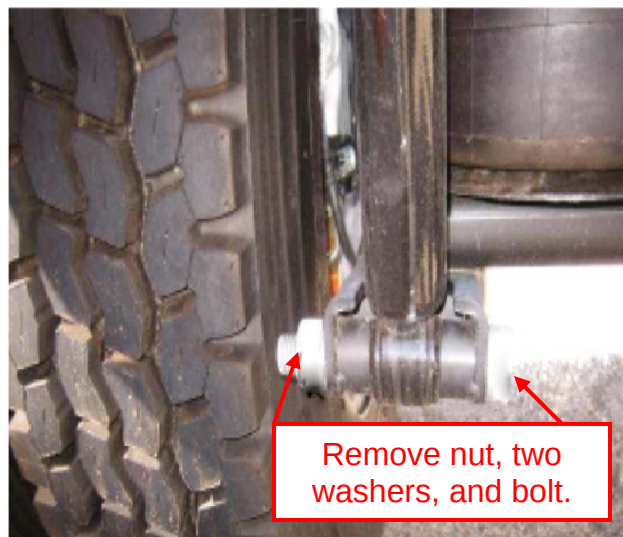
4. Remove and discard the through bolt and locknut from the lower shock absorber mounting bracket.

*Save the washers for reuse later.*

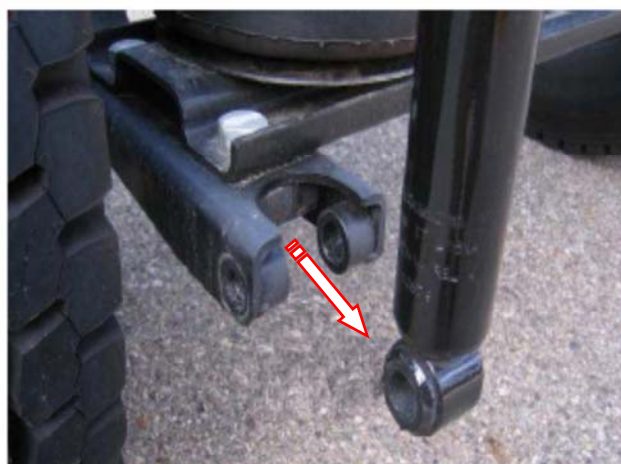
5. Slide the shock absorber out of the lower mounting bracket.

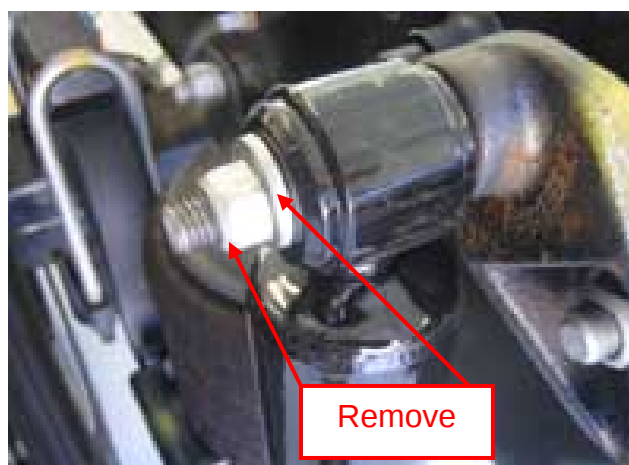
6. Remove and discard the locknut. Remove washer from the upper shock absorber mounting stud.

*Save the washer for reuse later.*

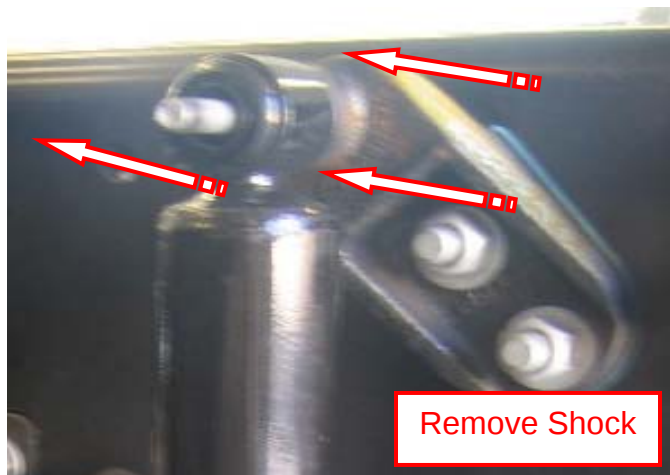
7. Remove the shock absorber from the upper mounting stud.

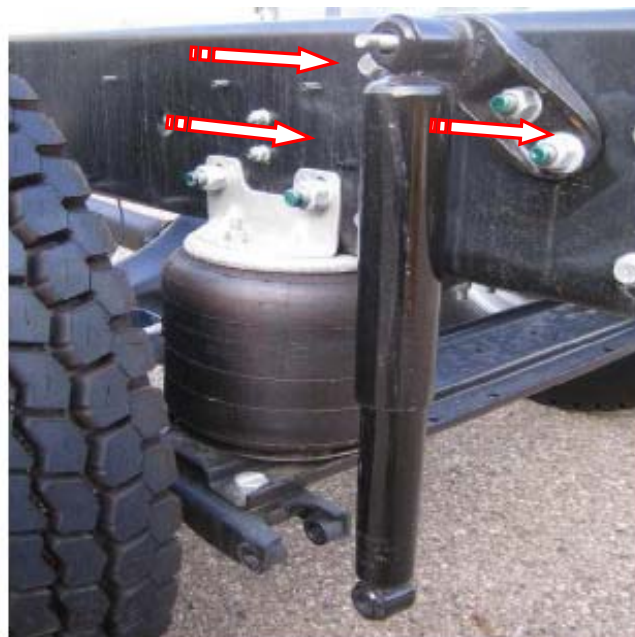
1. Install the shock absorber onto the upper mounting stud.

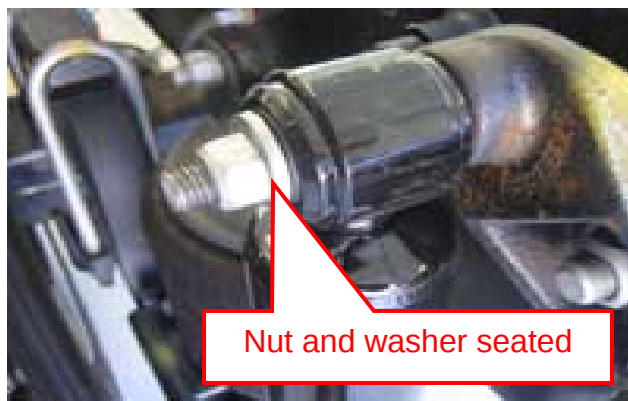
2. Install the washer and **new** locknut on the upper shock absorber mounting stud until the nut and washer are seated against the shock absorber.

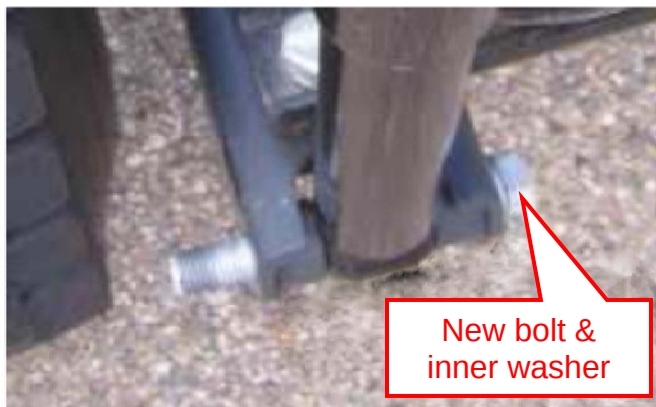
3. Install the **new** hex bolt and inner washer through the lower shock mount and the lower shock bracket.

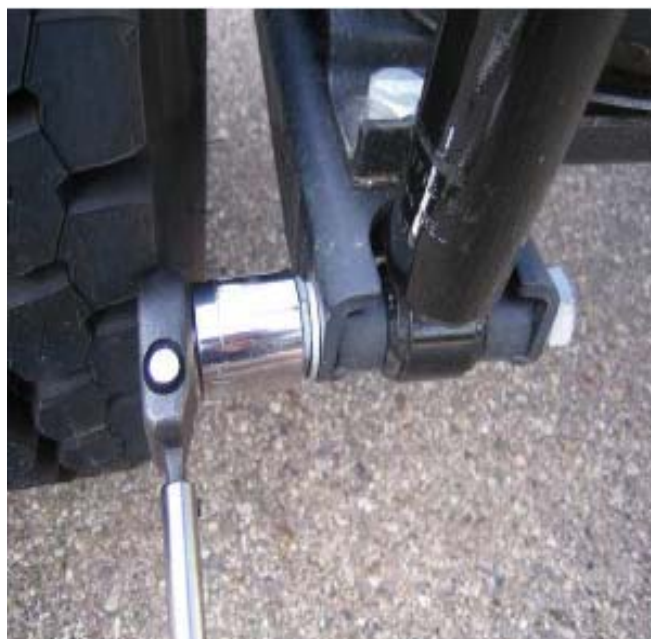
4. Install the outer washer and **new** locknut.

Torque the locknut.

**Torque Specification:**  
**160-180 ft. lbs. (217-245 Nm)**

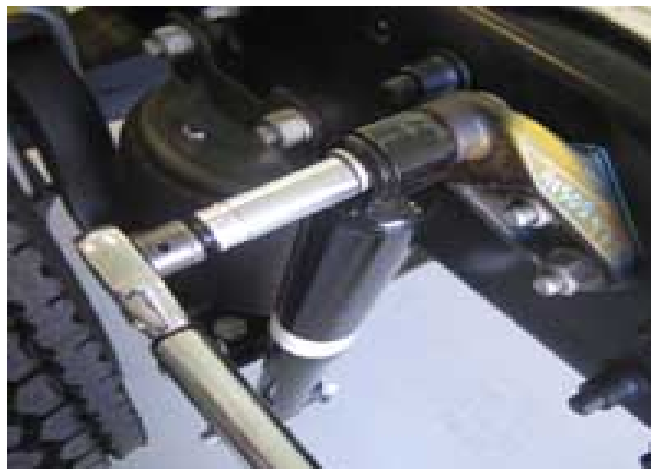
5. Torque the upper shock absorber locknut.

**Torque Specification:**  
**50-70 ft. lbs. (68-95 Nm)**

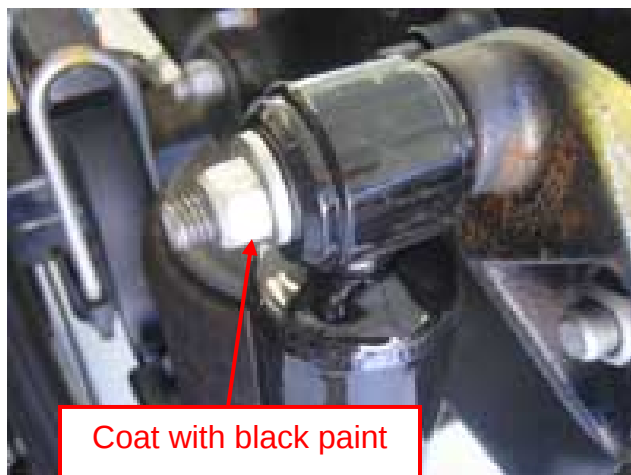
6. Paint the upper locknut with black paint.

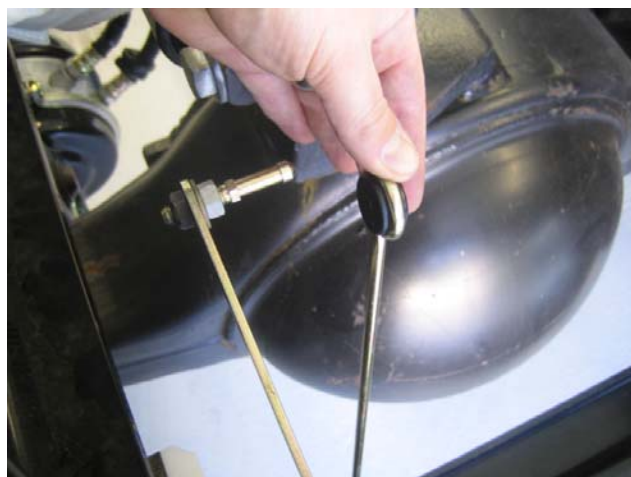
7. Reconnect the height control linkage to the height control valve arm.

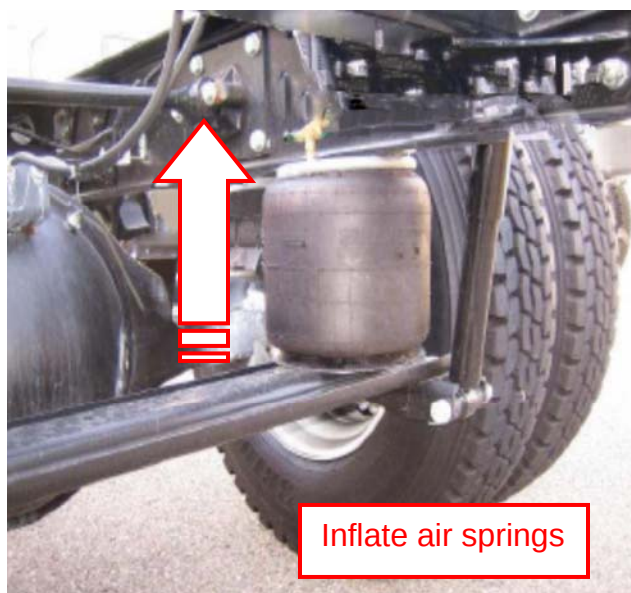
8. Start the engine and confirm the air springs re-inflate.

***Remove the supports and wheel chocks.***
