SERVICE NOTIFICATION

Models Affected: 2008 SunTracker "HP" (High Performance) Pontoon Boats equipped with Trailstar trailers.

Condition: In some cases the upright w/roller design has caused significant damage to the high performance strakes.

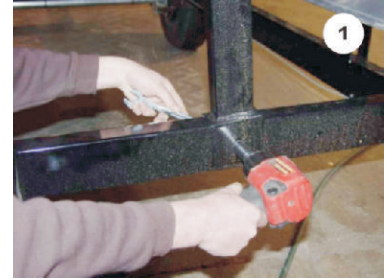
Step 1: Using a 3/4" open ended wrench and a 3/4" ratchet wrench or similar tool, loosen the bolts that attach the port side upright to crossmember #1 (tongue brace). **(YOU WILL REUSE THE BOLT AND THE WASHERS.)**

DO NOT REUSE THE ORIGINAL NYLOCK NUTS. THE UPRIGHT KIT CONTAINS REPLACEMENT NYLOCK NUTS.

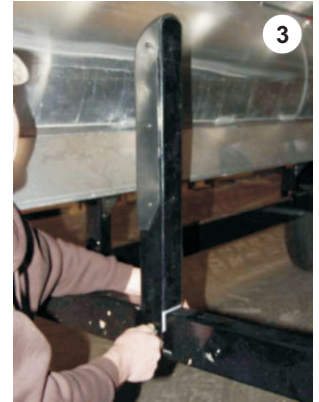
Step 2: Position the plastic isolator into the new upright tube mount.

Step 3: Place the upright onto crossmember #1, ensuring that the bolt holes are properly aligned.

Step 4: Insert the bolt through the upright and the crossmember. (Ensure that a washer is installed on both sides of the upright.)

Step 5: Using a 3/4" open ended wrench and a 3/4" ratchet wrench or similar tool, tighten the nut onto the bolt.
