Emissions Recall

Subject: Fuel System Hose Replacement LDT

Bulletin: R0032

Affected Models: 2008-2009 NA6J (145), NB6J (165), NC6J (185)

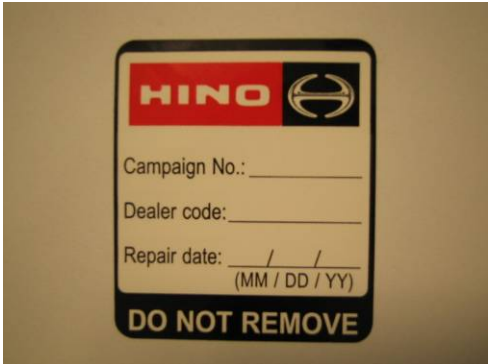
Fill out the Recall Completion sticker as shown in the picture to the left. This sticker should be attached to the left door jam above the V.I.N. decal.

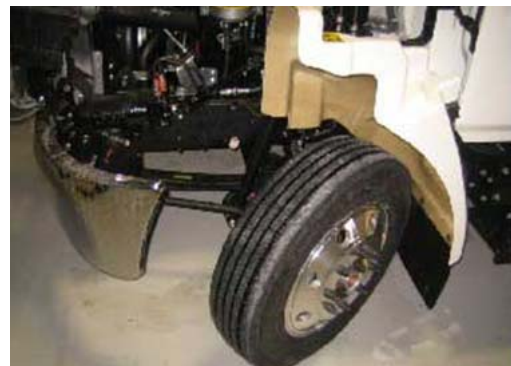
1. Turn the front wheels completely to the left.

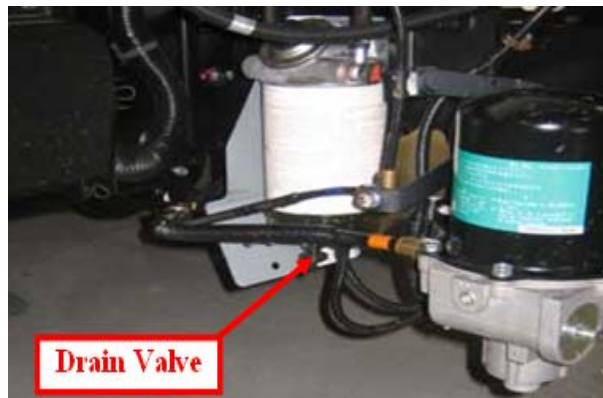
2. Drain the fuel from the filter assembly into a suitable container.

Close the drain valve once the filter assembly is empty.

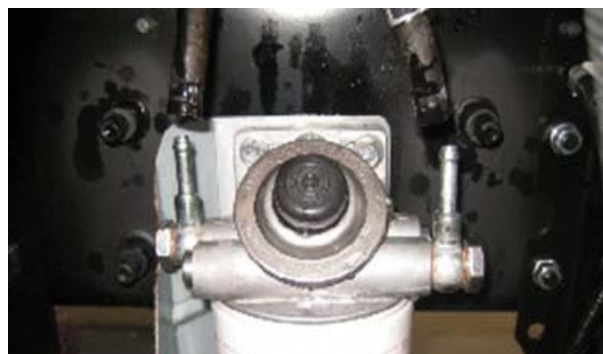
3. Disconnect the inlet and outlet hoses from the filter assembly.

Allow hoses to drain into a suitable container.

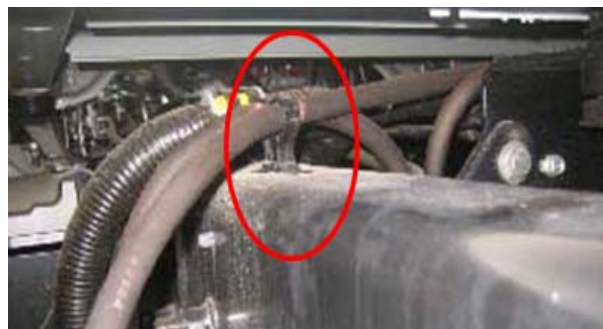
4. Remove and discard the clamp located on the top of the left side-rail.

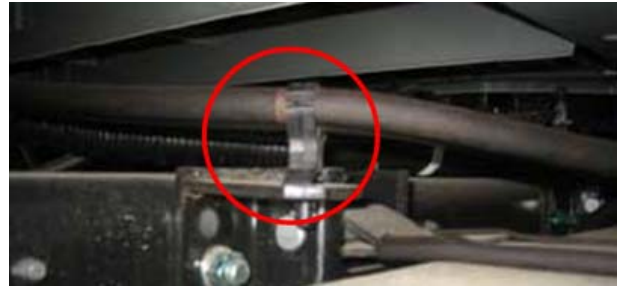
6. Remove and discard the clamp securing the fuel hoses to the top of the right side-rail.

Remove and discard both hoses.

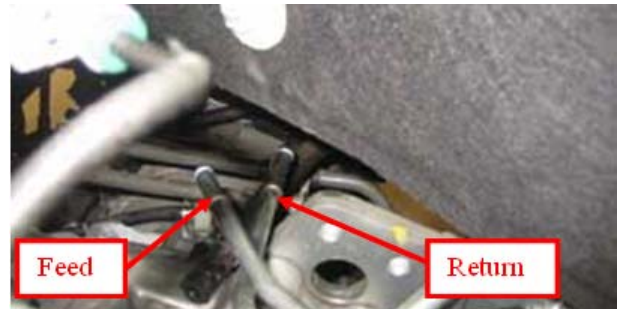
7. Disconnect the feed and return hoses from the pipes located at the rear of the engine.

NOTE: Access these hoses from the engine bay.

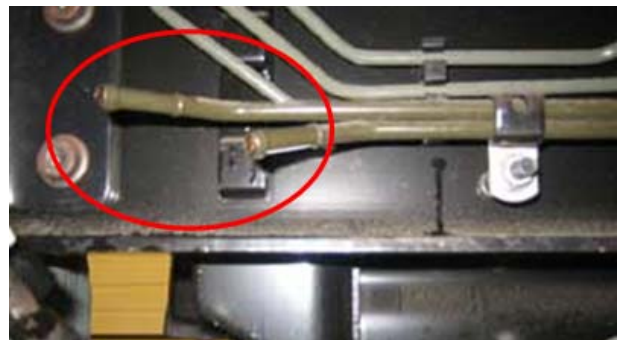
9. Disconnect the feed and return hoses at the rear of the steel fuel pipes located on the left side-rail.

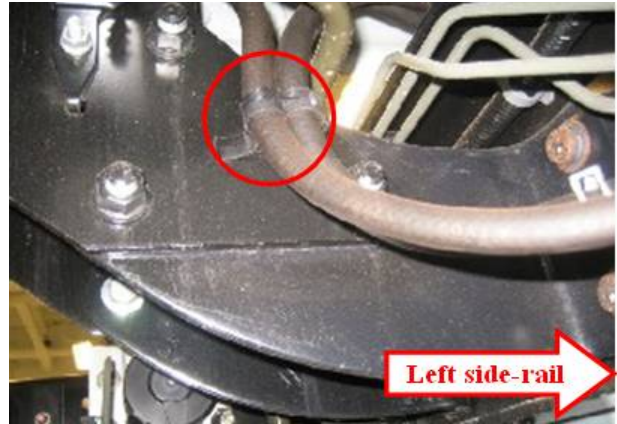
- Remove the clamp that secures the fuel hoses to the front left side of the #3 crossmember.

NOTE: The #3 crossmember is located under the rear of the cab.

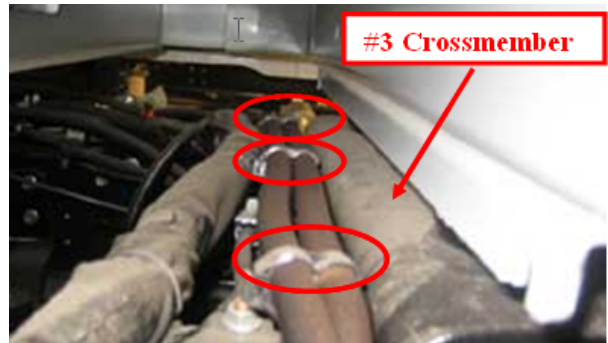
- Remove and discard the three clamps securing the fuel hoses to the #3 crossmember brackets.

Discard hoses.

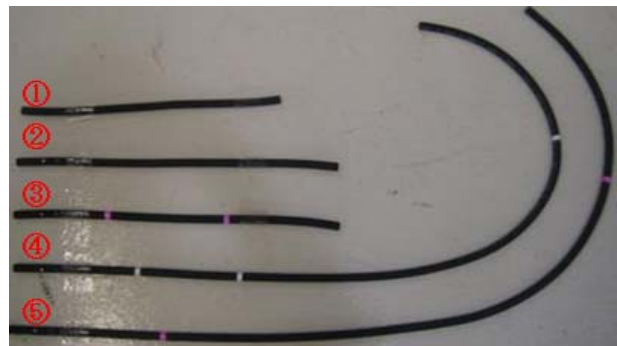
The hoses have brightly colored paint stripes and paint dots that indicate the hose's function.

- Blue dot = Hose installation starting point
- Pink dot = Feed hose
- White dot = Return hose

- Pink stripe = Feed hose clamp location
- White stripe = Return hose clamp location.

Note: Once connected, the end of the hose must be 30 mm past the end of the pipe. The clip must be 15 mm from the end of the hose.

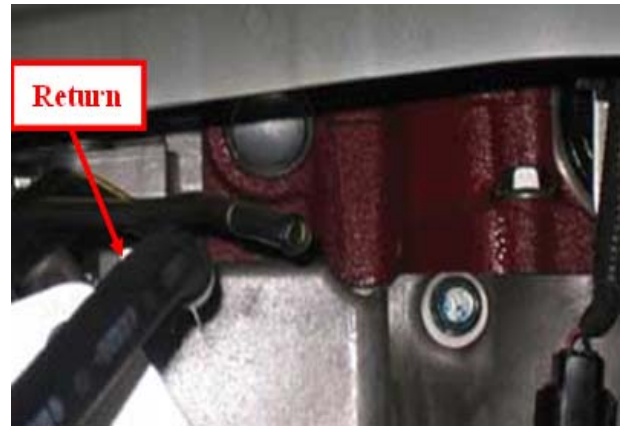
12. Connect the blue dot end of the return hose ① with a clip onto the engine return pipe.

NOTE: The blue dot end of this hose must be installed to the engine return pipe to ensure proper hose clamp location. The correct location of all clamps will be confirmed at the end of this procedure.

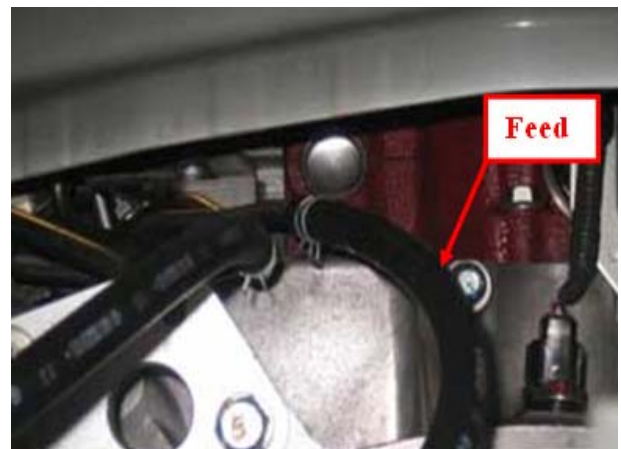
13. Connect the blue dot end of the feed hose ② with a hose clip onto the engine feed pipe.

NOTE: The blue dot end of this hose must be installed to the engine feed pipe to ensure proper hose clamp location. The correct location of all clamps will be confirmed at the end of this procedure.

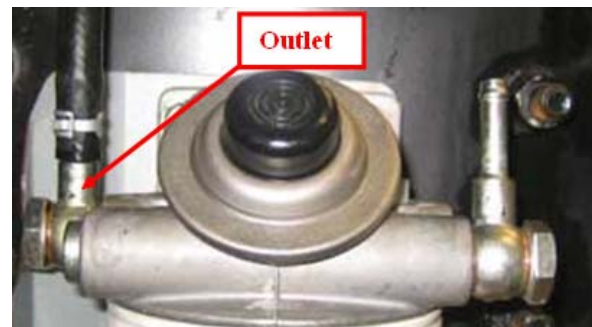
17. Connect the other end of the feed hose ③ with a clip to the outlet of the filter assembly.

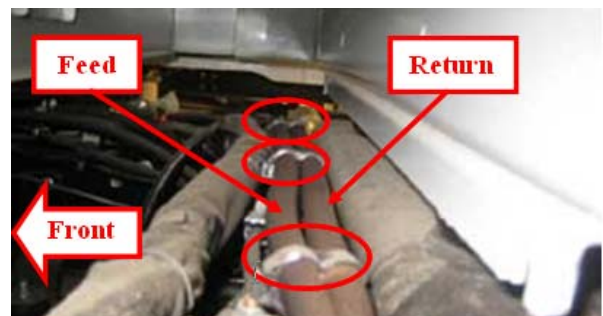
21. Secure the feed and return hoses to the top of the #3 crossmember using three clamps ⑦.

NOTE: Position the hoses as shown in picture.

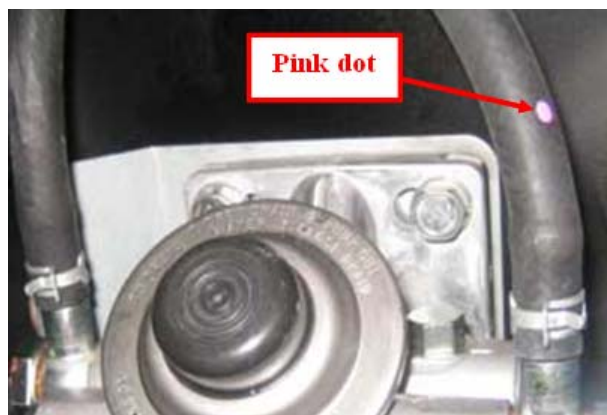
28. Inspect the feed hose ③ at the inlet of the filter assembly for correct installation.

- A) The pink dot end must connect to the inlet of the filter assembly.
