# SERVICE INFORMATION BULLETIN

**Subject:**  
**Supply Pump Suction Control Valve Design Change – J05D Engines**  
*Supersedes SB-07-006 dated 04-07-2008*  
*(Revised 2-24-2009 to include 2010 model year vehicles)*

This bulletin provides diagnostic information for monitoring the engine running data to determine if the Suction Control Valve is defective, and a service procedure for replacing the Suction Control Valve when necessary. The SCV should be tested and replaced when necessary before replacing the supply pump assembly for a fuel pressure related concern.

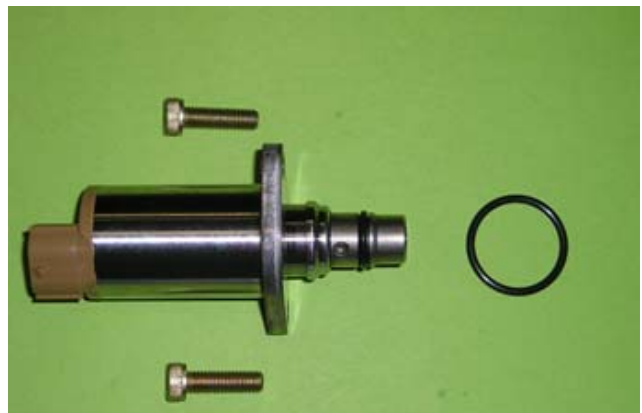
- SCV
- 2 Bolts
- Large O-ring
- Small O-ring

- 6) Confirm that the SCV replacement kit contains all the parts shown in the picture.

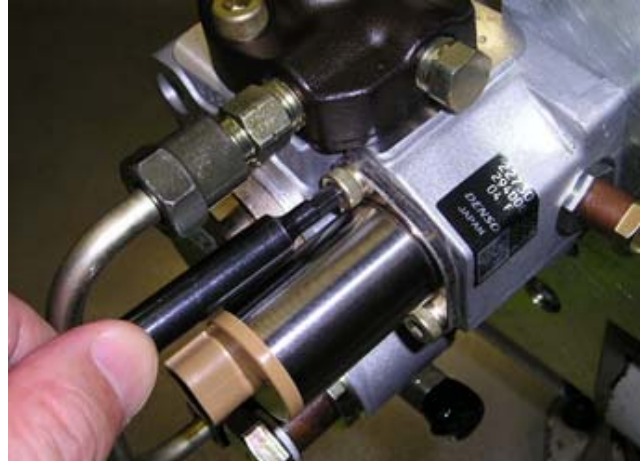
**NOTE:**  
Make sure the connector faces the correct direction. Direction will vary with part number.

- 10) Hand tighten the SCV mounting bolts making sure the bolts are equally tightened to prevent binding.
