| <b>Reference</b> | SSM41158 |
| <b>Models</b> | XF / X250 |
| <b>Title</b> | Rust Spots on Rear Bumper Upper Surface |

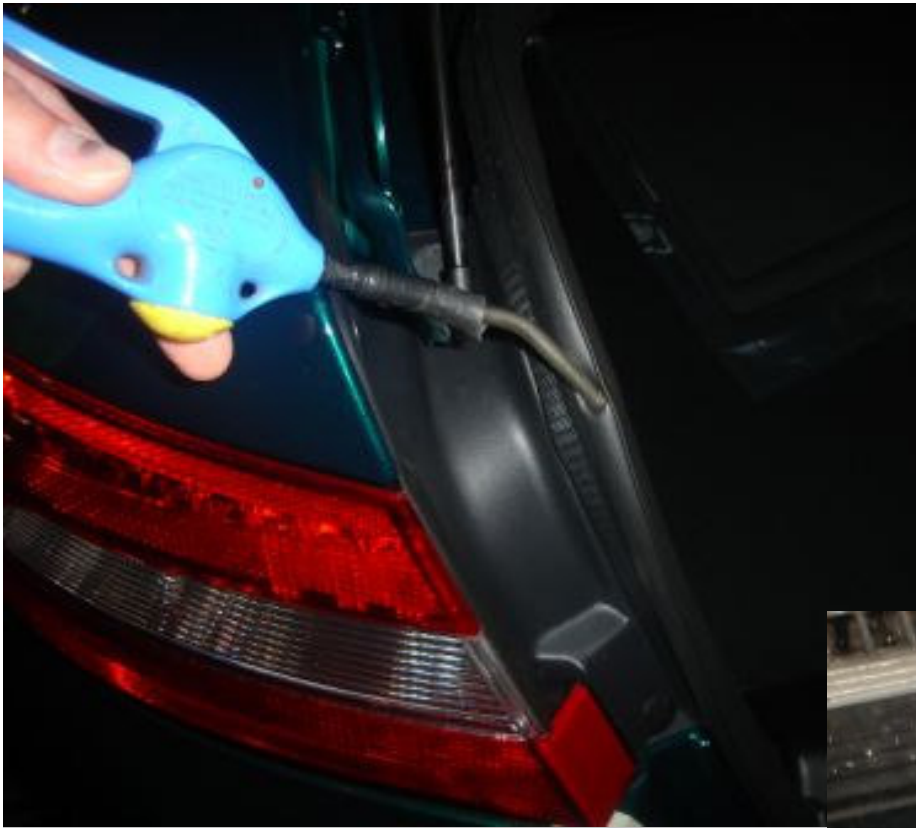
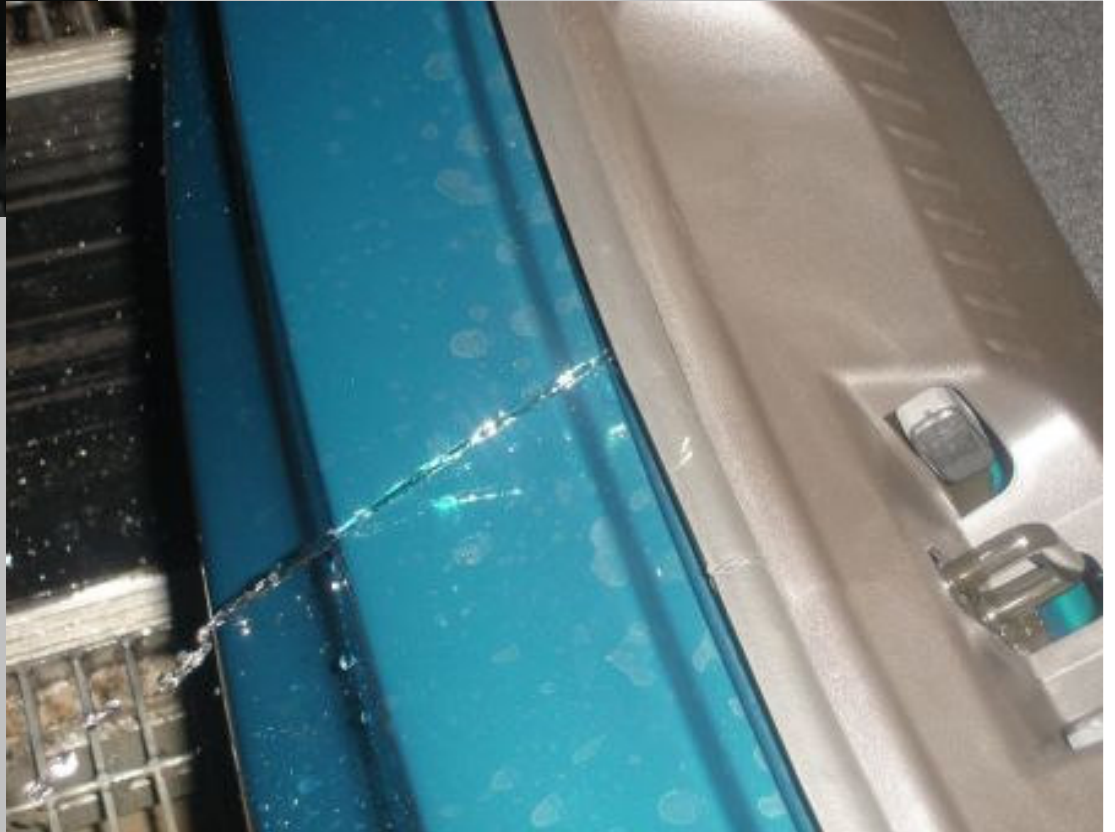
| <b>Content</b> | <p><u>Issue:</u><br/>Rust spots may be noticed on the rear bumper.</p> <p><u>Cause:</u><br/>Particles of metal remaining from boot seal manufacturing process, exiting the boot aperture seal.</p> <p><u>Action:</u><br/>Clean bumper with spirit based wipe suitable for painted surfaces.<br/>Find hole on vertical section of seal.<br/>Insert suitable water hose nozzle.<br/>Flush seal with water.<br/>Squeeze seal to remove all water.<br/>Repeat for other side of vehicle.</p> <p>Refer to .ppt file for pictorial guidance.</p> |
