| Reference | SSM41158 |
| Models | XF / X250 |
| Title | Rust Spots on Rear Bumper Upper Surface |

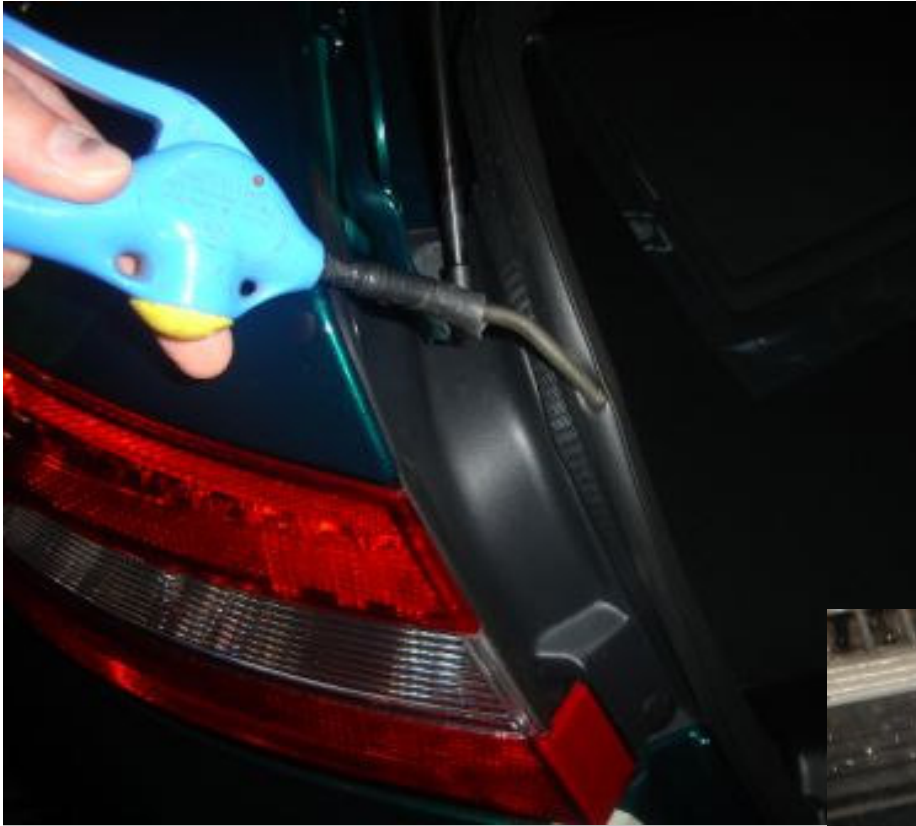
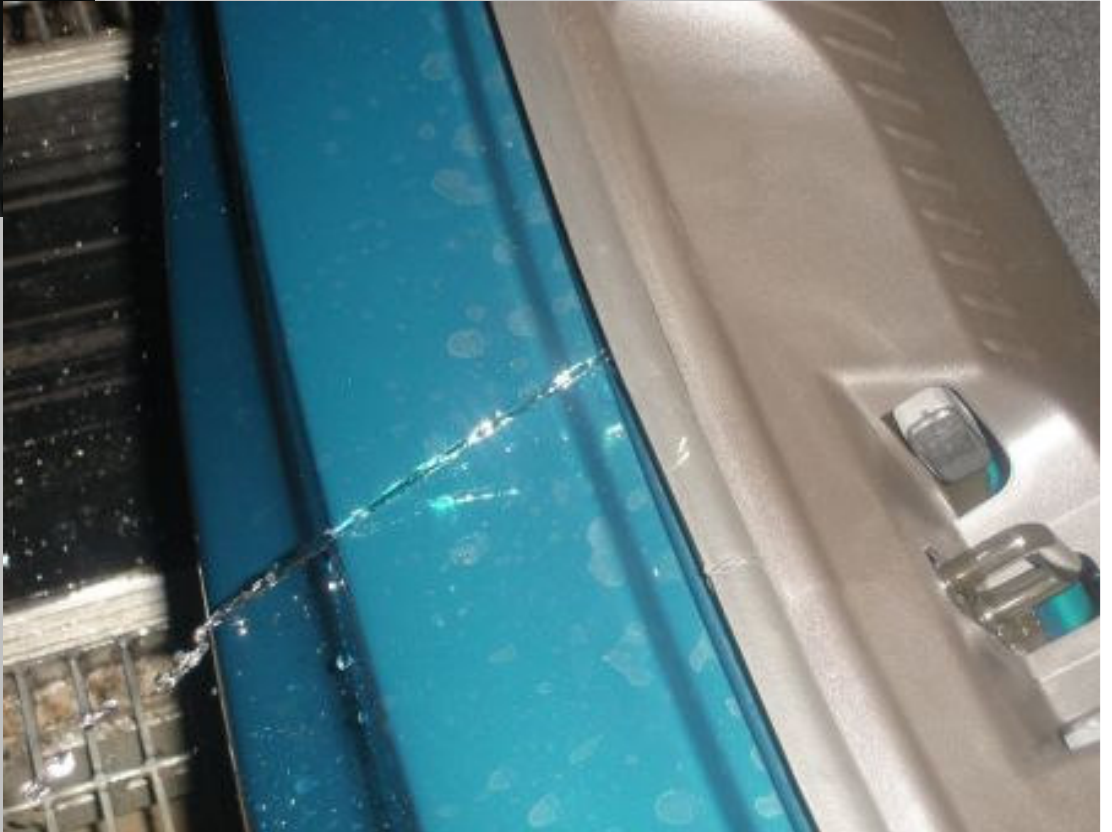
| Content | <p><u>Issue:</u> Rust spots may be noticed on the rear bumper.</p> <p><u>Cause:</u> Particles of metal remaining from boot seal manufacturing process, exiting the boot aperture seal.</p> <p><u>Action:</u> Clean bumper with spirit based wipe suitable for painted surfaces. Find hole on vertical section of seal. Insert suitable water hose nozzle. Flush seal with water. Squeeze seal to remove all water. Repeat for other side of vehicle.</p> <p>Refer to .ppt file for pictorial guidance.</p> |
