**AUTHORIZED FIELD CHANGE G-10921**

Navistar has decided to perform an authorized field change campaign on certain 5900, 7600, 8600, and ProStar model trucks built 5/27/10 thru 9/15/10 with a MaxxForce 13 engine equipped with a 4-tab style oil filter.

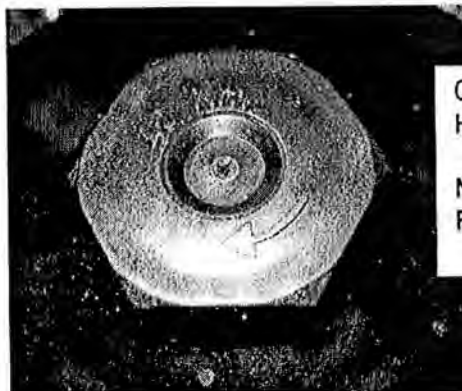
If you own this vehicle, inspect the engine oil filter housing cover. The picture below is of the correct cover. Notice the center circular section is indented.

**Correct Oil Filter  
Housing**

**No Repair  
Required**

If your vehicle is equipped with the correct housing, no repair is needed. Please call any INTERNATIONAL® dealer and ask them to submit an "Inspected - No Corrections Necessary" claim against your VIN for campaign 10921. This will update the records so that you will not be contacted again about this campaign. You can find your nearest dealer by calling 1-800-448-7825 or by using the dealer locator at <http://www.internationaltrucks.com>.

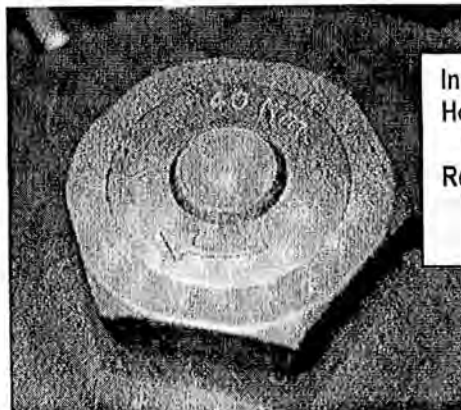
The suspect vehicles may have been built with an engine having a discontinued oil filter design. The replacement oil filter does not fit properly in the housing for the discontinued filter possibly allowing oil to by-pass the filter.

The picture below is of the incorrect oil filter housing cover. Notice that the center circular section protrudes outward.

**Incorrect Oil Filter  
Housing**

**Repair Required**

The repair will involve the customer inspecting the engine oil filter housing cover to determine if a repair is required. If a repair is necessary, a dealer will install a new engine filter housing and filter. Dealers have parts and instructions to repair your vehicle. The repair will be performed free of charge within the warranty period or one year from the date of this letter, whichever comes later and take approximately 60 minutes to complete.

If your vehicle is equipped with the incorrect housing, please schedule an appointment with any INTERNATIONAL® dealer to have your vehicle repaired. You can find your nearest dealer by calling 1-800-448-7825 or by using the dealer locator at <http://www.internationaltrucks.com>.
