All American Electric Entrance Door Modification

BULLETIN

Models Affected: 2010 All American models with feature 30978-06 DOOR CONTROL, ELECTRIC ROTARY delivered prior to November 6, 2009.

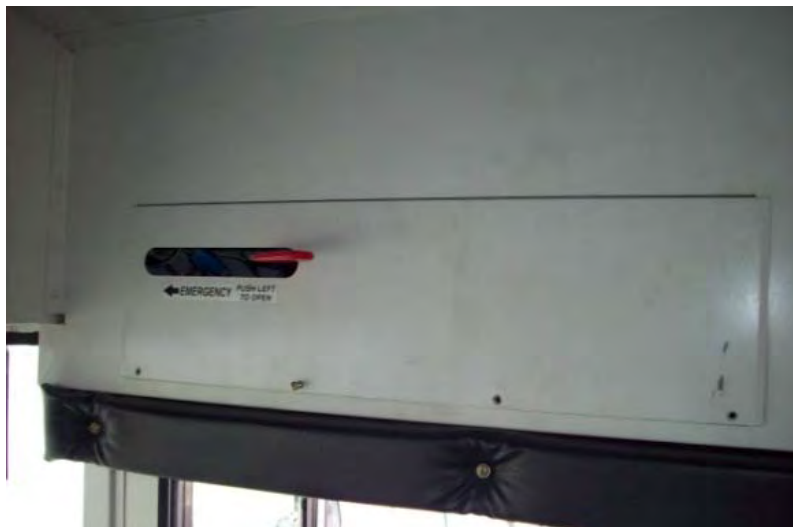
3. Remove interior access cover from entrance door header.

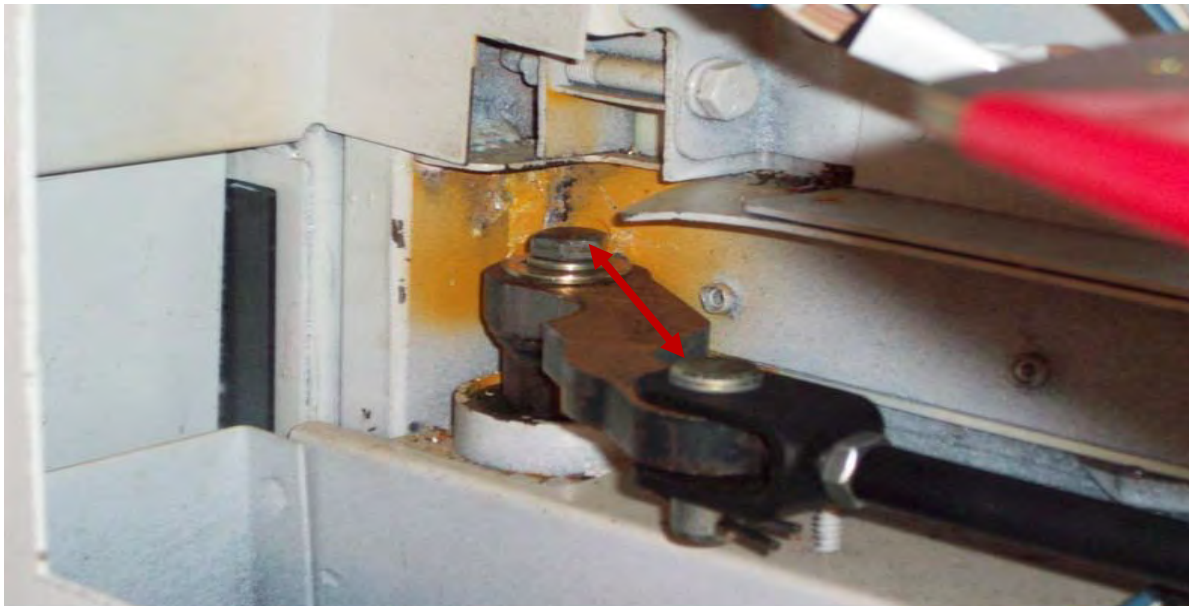
11. Measure the distance between pivot points on the front entrance door lever assembly. Correct dimension is 4" center to center.
12. Remove and replace the front entrance door lever assembly if the dimension between pivot points is not correct.
