BLUE BIRD

Vision Transmission Oil Cooler

MODELS AFFECTED: 2008 through 2010 Blue Bird Vision

On affected buses, high pressure cycling may cause the internal transmission oil cooler of radiator assembly 00115577 to fatigue, resulting in transmission oil / engine coolant contamination.

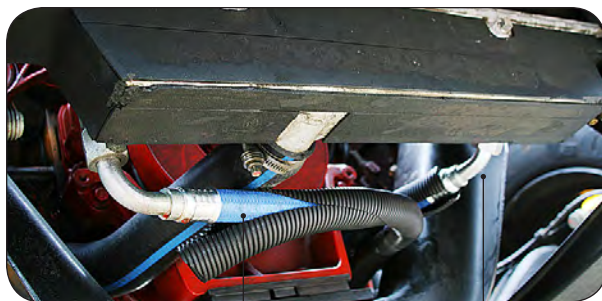
- 1.2 Remove the drain plug from the bottom of the transmission and drain the transmission oil into a suitable container.
- 1.3 Disconnect the two transmission cooler hoses at the bottom of the radiator. Be prepared to contain oil leakage from the transmission cooler and hoses. Cap the open ends of the transmission hoses to prevent contamination of the hoses. Support disconnected hoses out of the way. Remove the 45° and 90° elbows and retain for reinstallation.

Transmission oil hoses

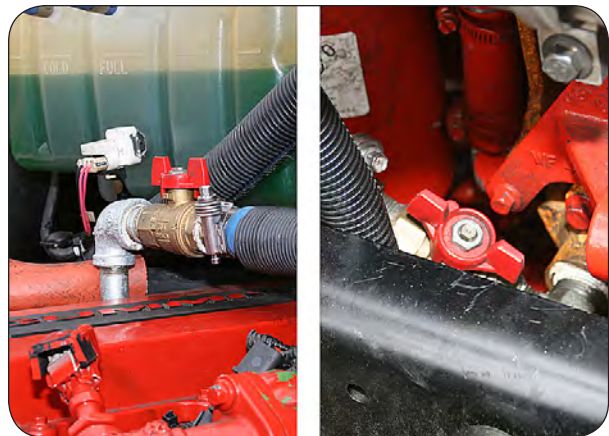
2 Open both heater circuit valves.

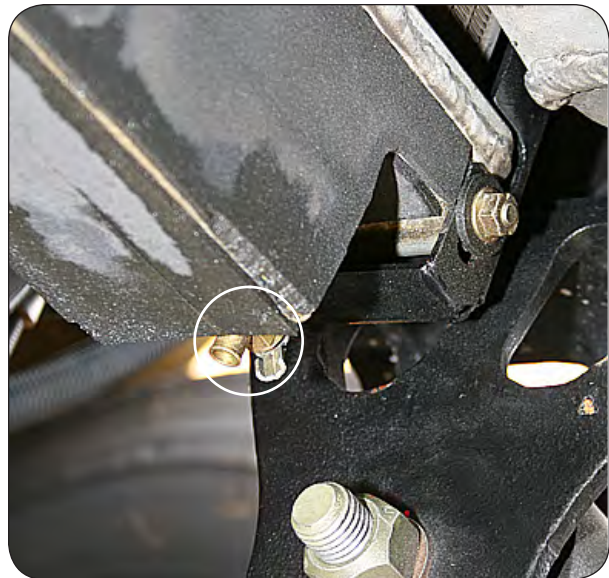
3 Drain the coolant from the petcock at the bottom of the radiator into an appropriate receptacle.

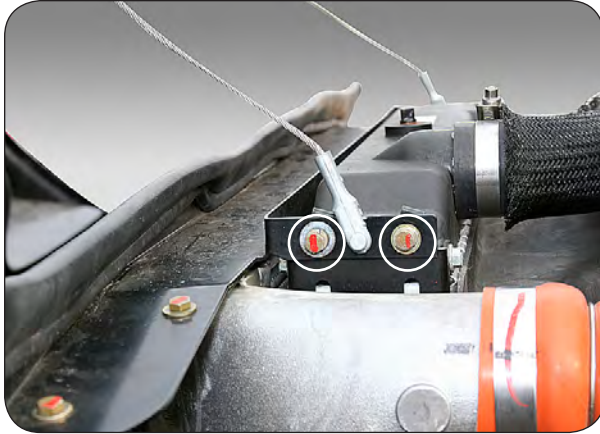
- 4.1 Open the engine hood to its fully upright position and support it securely so as to avoid damage to the shell when the stop cables are removed.
- 4.2 Remove the four bolts which mount the top radiator baffle to the top of the radiator.

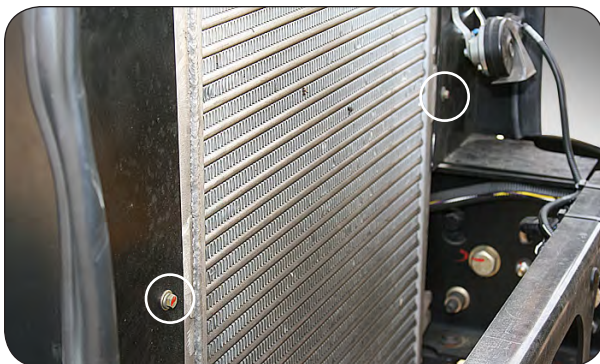
- 4.3 Remove the two bolts which mount the left and right radiator baffle panels to the front of the radiator.

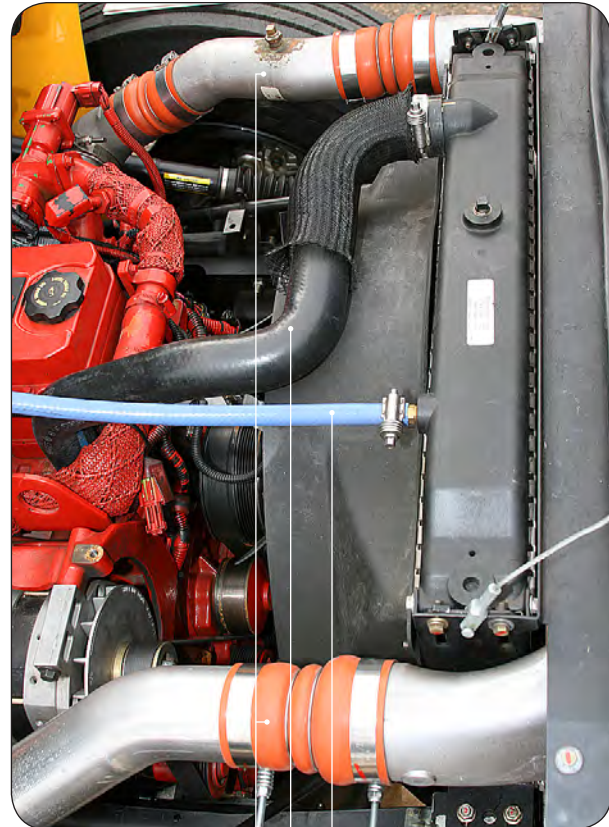
Charge air tubes
Top radiator hose
Vent hose

- 4.6 Disconnect the top radiator hose and the small vent hose from the top of the radiator. Secure the disconnected hoses out of the way.
- 4.7 If the vehicle is equipped with shutters, disconnect the shutter actuator air or oil line from the shutters actuator.

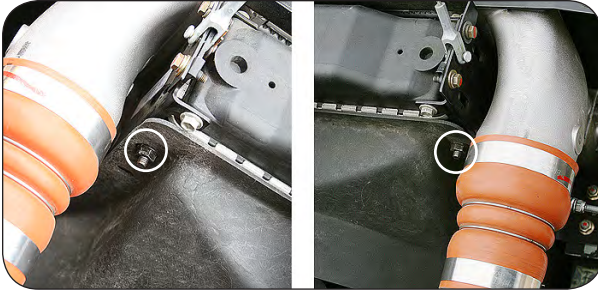
4.8 After removing all the hoses and piping, remove the four hex nuts at the corners of the fan shroud. Pull the shroud as far rearward (over the fan) as possible. Allow the shroud to hang over the fan blades.

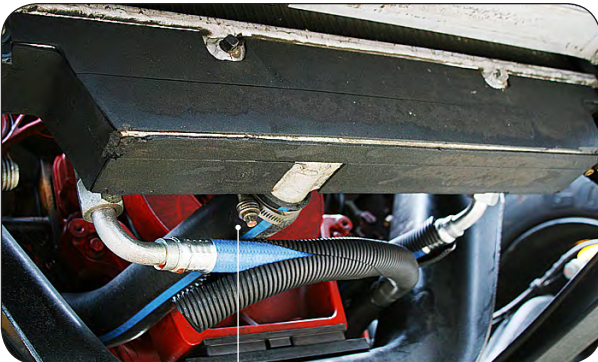
4.9 Remove the bottom radiator coolant hose.

Lower Coolant Hose

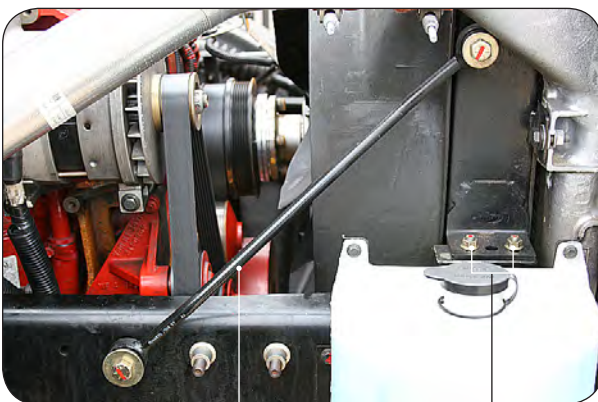
4.10 On each side of the radiator, remove the diagonal radiator support strut.

4.11 On each side of the radiator, remove the two nuts which secure the radiator to the rubber isolator blocks.

Diagonal Support Strut

Isolator Block Nuts

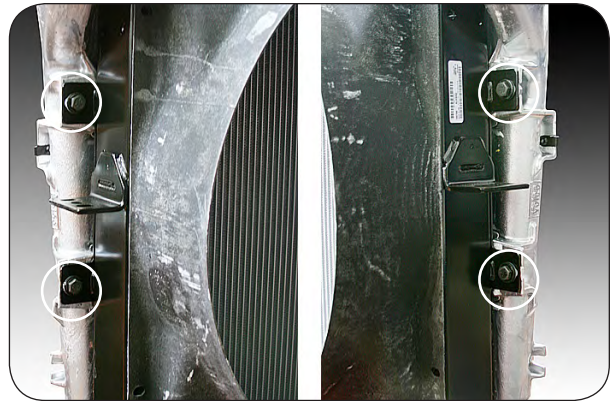
4.12 On each side of the radiator, remove the two bolts which fasten the charge air cooler to the radiator. Set the charge air cooler aside in a safe place.

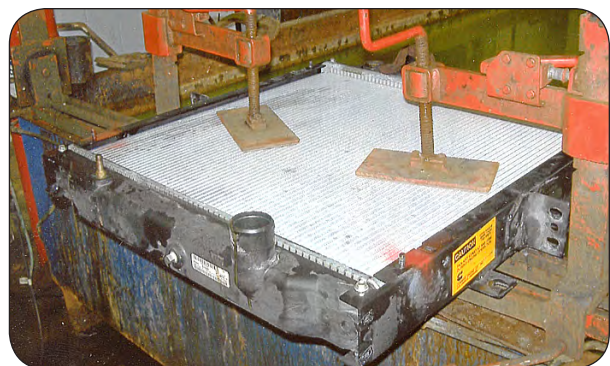
5.1 Mount the radiator core and tanks carefully in a radiator assembly fixture.

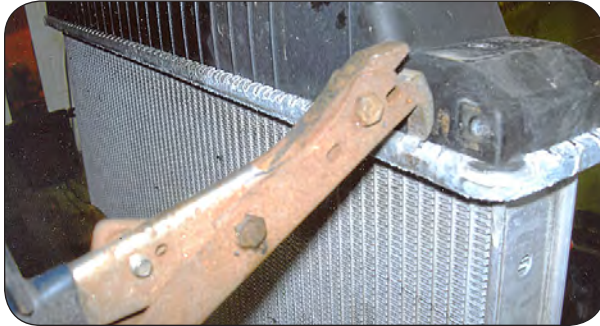
- 5.2 Position the radiator with the bottom tank upward. Starting near the middle of the radiator's width and working toward the ends, use Johnson Tab Tool 414-01W to bend the crimp strip tabs upward approximately 90°.

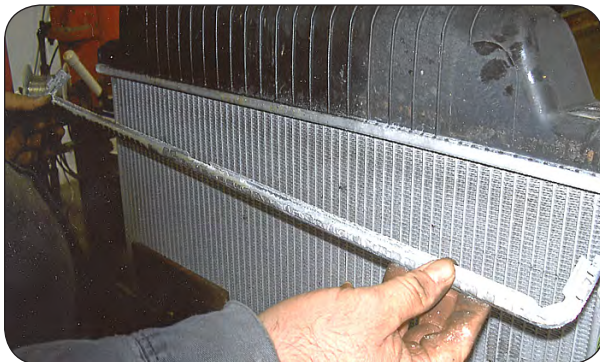
- 5.3 Remove the two crimp strips and dispose of them. New crimp strips will be used for reassembly.

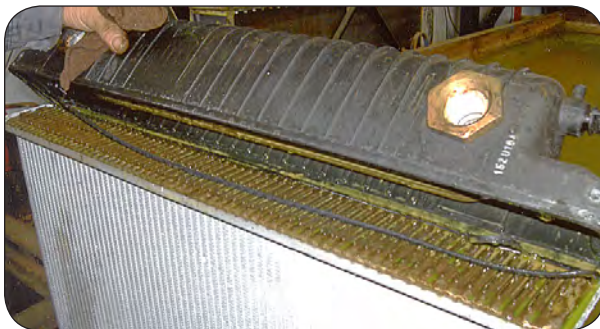
- 5.4 Carefully separate the plastic tank from the core. The fit is tight and may require some effort to remove. Avoid prying that may damage the sealing groove.

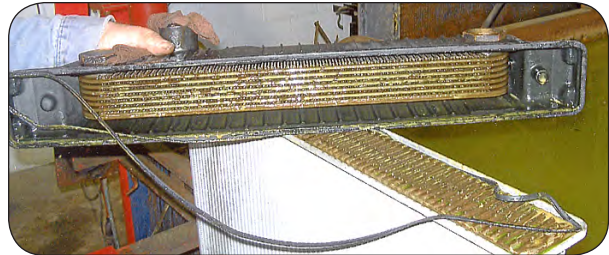
- 5.5 Remove and dispose of the sealing gasket.

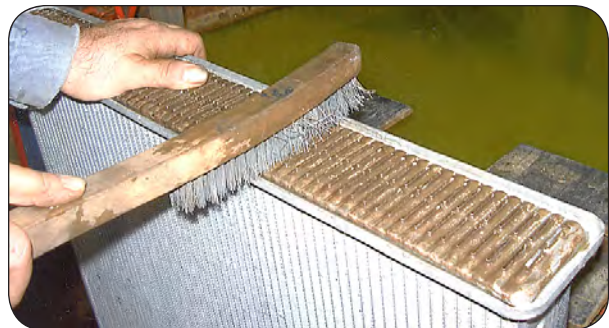
- 5.6 Using a wire brush, clean away accumulated debris from the sealing groove and cooling tube ends.

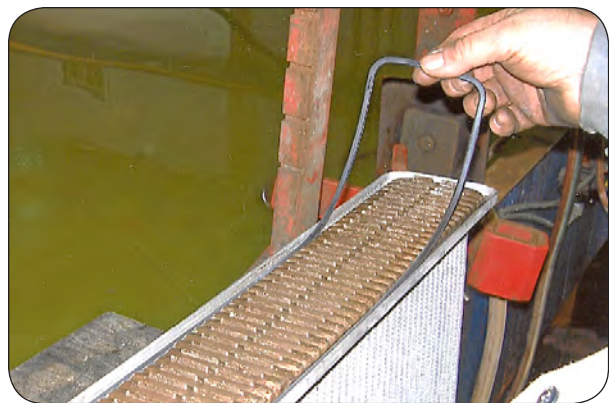
- 5.7 Lubricate the new gasket with ethylene glycol, and set it carefully in place. Be careful to avoid twisting, cutting or otherwise damaging the gasket.

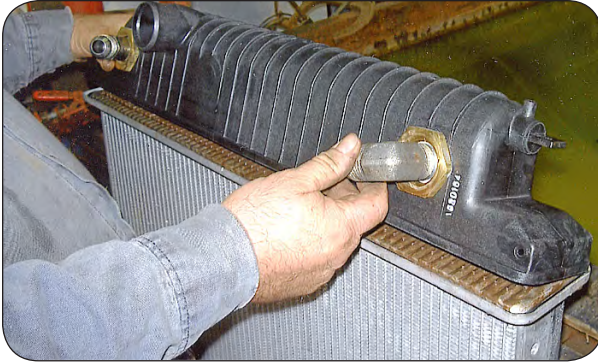
5.8 With the radiator core securely mounted in the assembly fixture, seat the new plastic tank against the gasket. The fit is tight. Use caution to avoid damage.

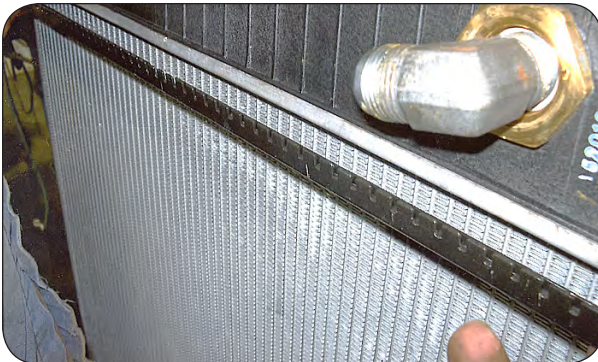
5.9 Install a new crimp strips to each side of the radiator sealing flange. Partially bending one or two tabs to help hold the strip in place is acceptable.

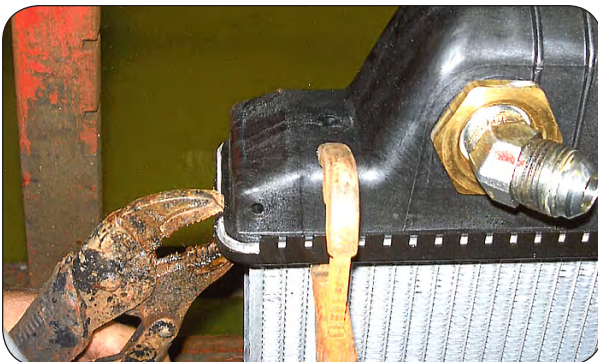
5.10 Using a plastic tank radiator repair fixture, apply uniform pressure to the tank to seat the tank and compress the gasket. Use extreme caution to distribute the clamping force evenly to avoid damage to the tank.

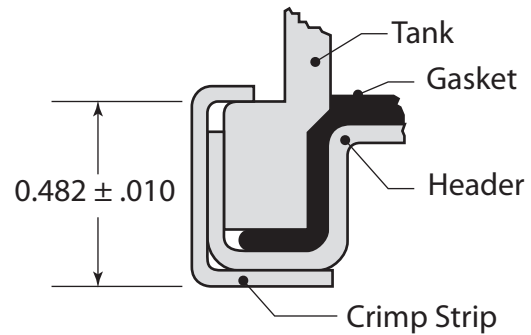
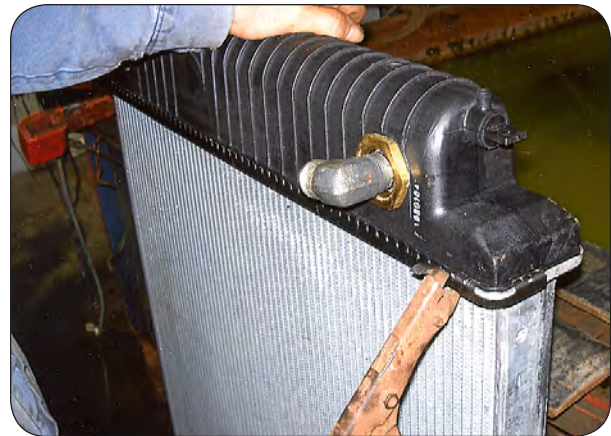
5.11 Starting at the center and progressing toward the ends, pre-crimp the tabs around the tank by partially bending each tab. This helps ensure uniform clamping while avoiding excessive localized stress.

5.12 Bend each tab firmly against the plastic sealing flange. While proceeding, take measurements to ensure the crimping strip's height is within the tolerance indicated in the drawing below. Do not attempt to compress the gasket further; doing so risks cracking of the tank.

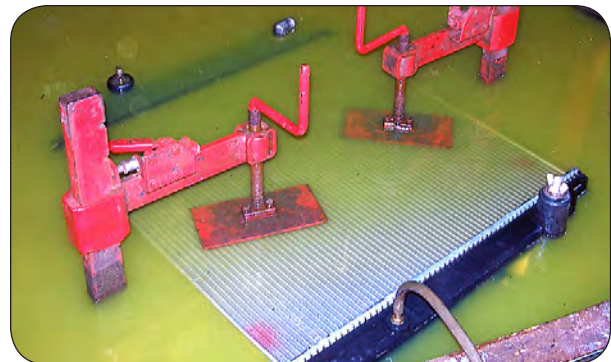
5.13 Test for leaks using air under water at 18 PSI.

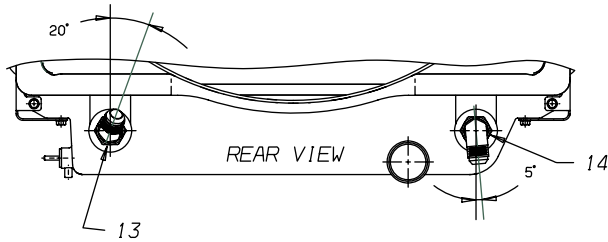
6 Reinstall the radiator by reversing the removal procedure described in step 4. When reinstalling the transmission hose elbow fittings, orient them as shown below:
