# Propane Vision Battery Drain

MODELS AFFECTED: 2009 & 2010 Propane Visions

S10RP

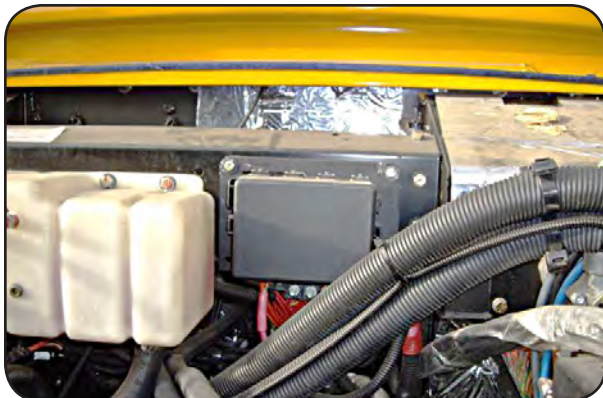
2.1 Locate GM fuse block and remove cover.

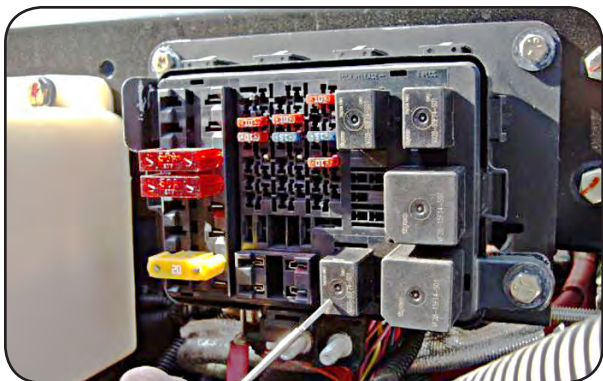
2.2 Identify and remove TAC Module brake relay.

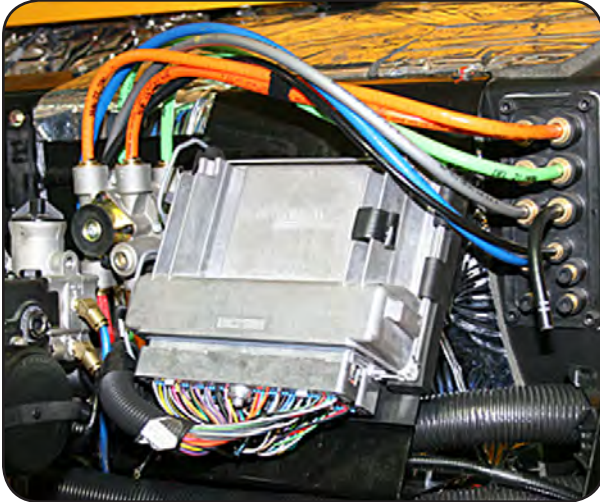
3.1 Locate the Powertrain Control Module.

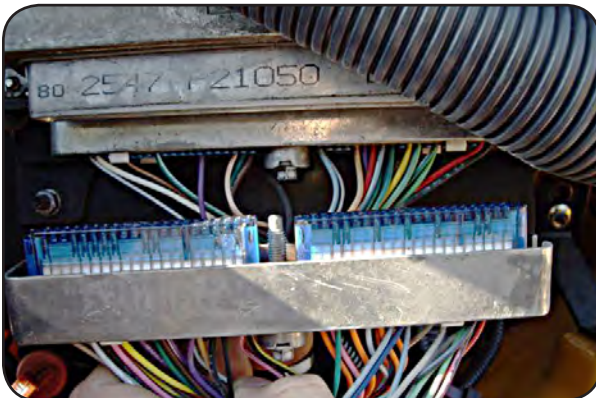
3.2 Locate and disconnect the Blue 80 way connector.

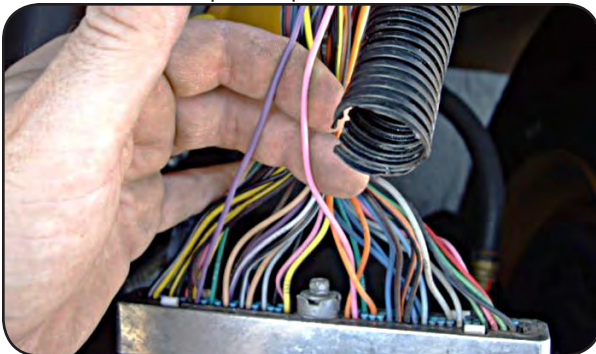
3.3 Locate purple wire #420B in cavity #33 and pink wire #439A in cavity #19. Remove tape and loom from wiring harness to allow space to splice these two circuits.

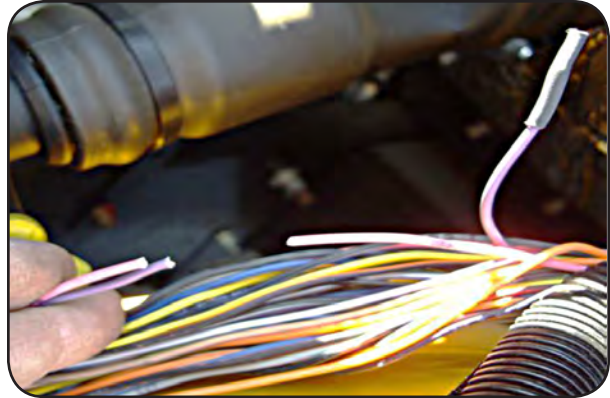
3.5 Fold back and tape to the harness the non-connector end of the purple #420B wire as it will no longer be used.

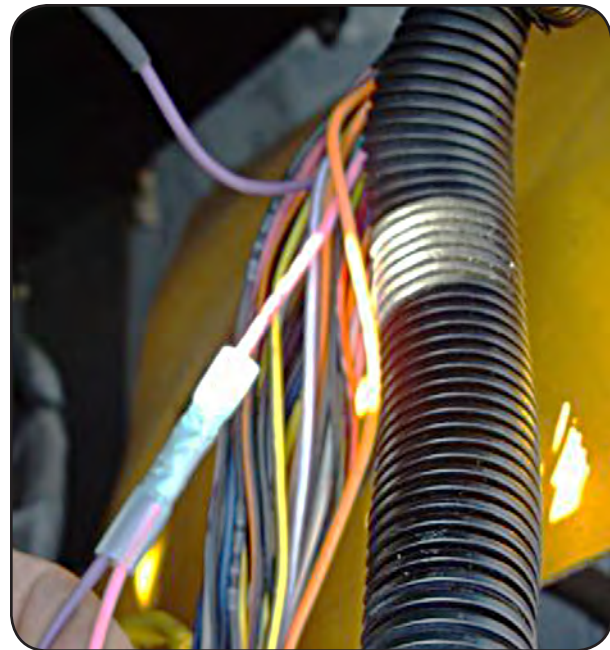
3.6 Strip ends and butt splice together the three remaining wires using a heat shrink butt connector.

3.7 Shrink heat shrink with heat gun, allow to cool.

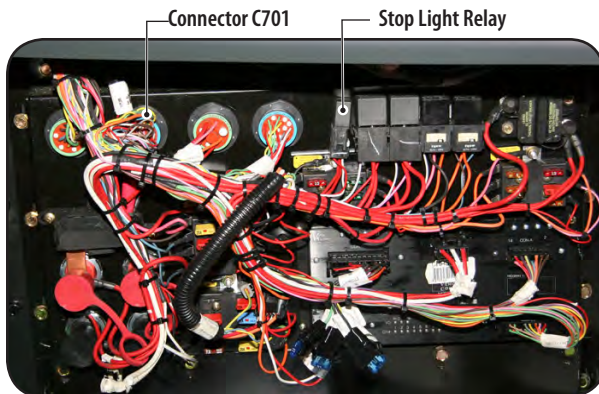
4.2 Locate connector C701 on the left side of the PDU panel assembly and the stop light micro relay toward the top center of the PDU panel assembly .

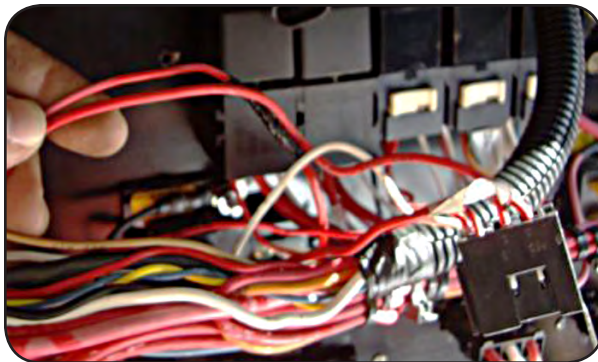
4.4 Locate the Red wire labeled "CC Cancel" in cavity #24 of C701 and the Red wire labeled "Stop Light A" or "Stop Light B" connected to Pin #5 of the Stop Light Relay.

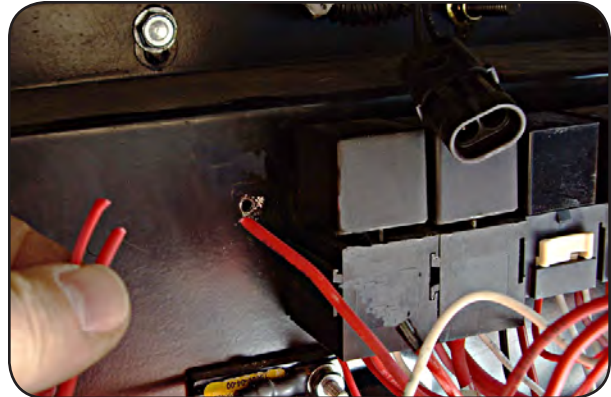
4.6 Fold back and tape to the harness the non -connector end of the red "CC Cancel" wire as it will no longer be used.

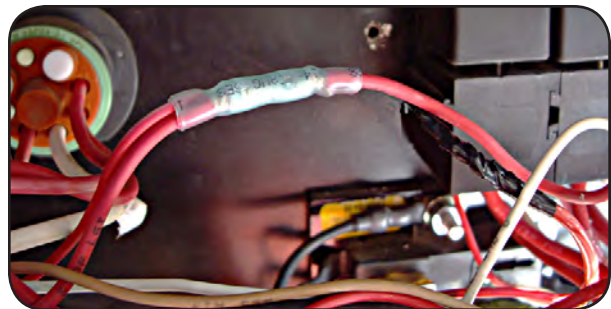
4.7 Strip ends and butt splice together the three remaining wires using a heat shrink butt connector.

4.8 Shrink heat shrink with heat gun, allow to cool.
