## Low Coolant Sensor Leaks

# BULLETIN

**Models Affected:** 2007-2010 Model Year All American, Vision

S 1 0 S A

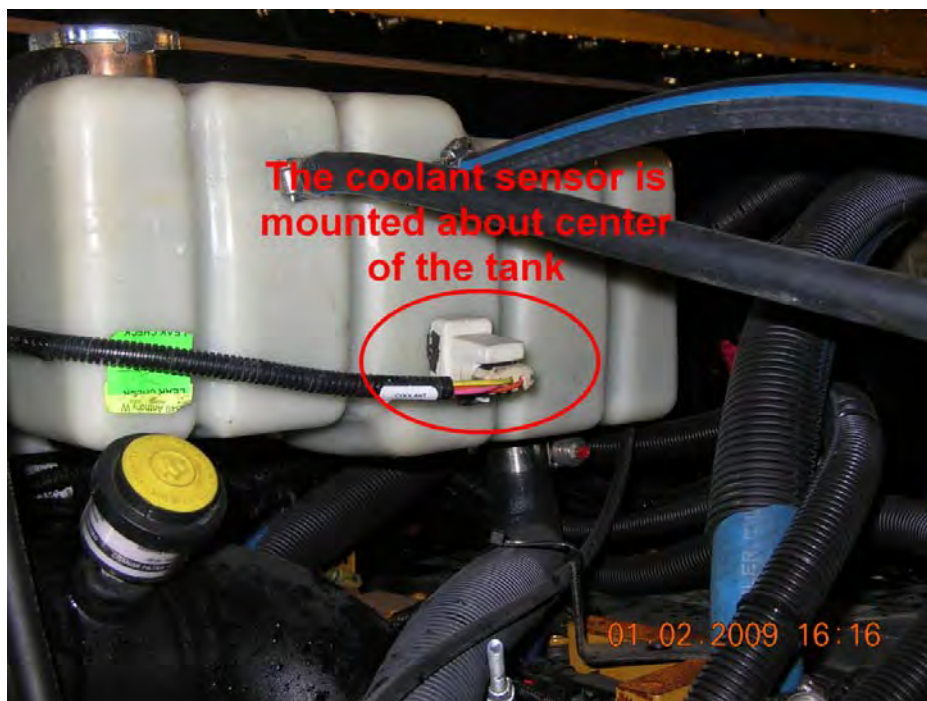
**Figure 1**

1. Secure the vehicle and prepare it for access to the needed area.
2. Park vehicle on level surface. Apply the parking brake, remove key and chock wheels. Disconnect the batteries.
3. Locate low coolant sensor installed in engine coolant surge tank (See figure 1)

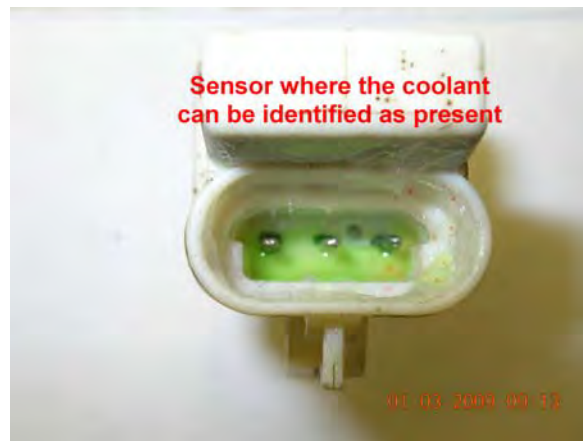
Figure 3

- 4.3 If sign of coolant is found in the connector or sensor pins (see figure 3), replace the leaking sensor with new sensor (10015356). When installing the new sensor, tighten the sensor using the hex nut portion of the sensor to 4.5-6 ft lbs. Clean the harness connector pins, and reconnect low coolant sensor connector to sensor. **If new sensor is installed, connector seal is not removed.**

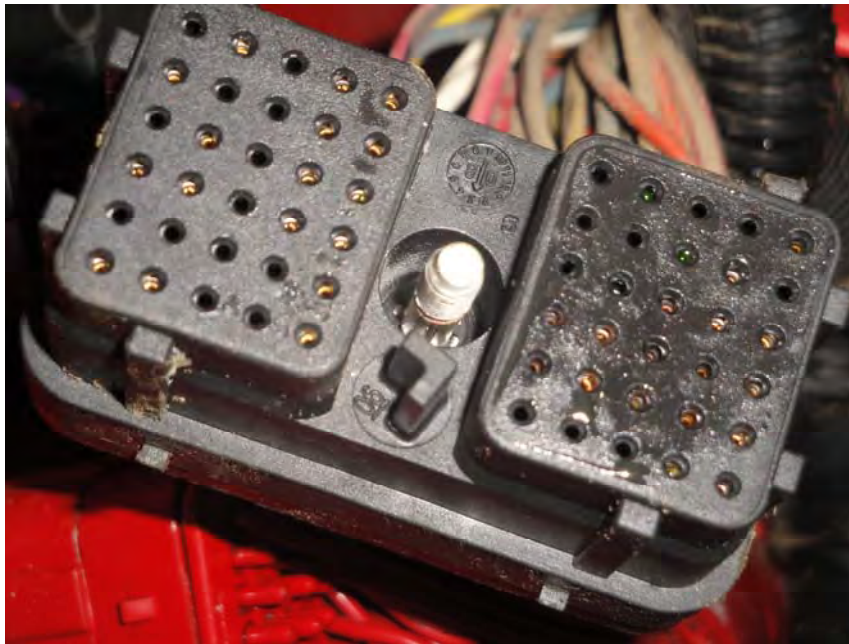
**Figure 4**

- 4.4 Disconnect engine harness connector at the engine ECM and inspect for coolant.
- 4.5 If no coolant is found in the ECM connector or ECM, reconnect the engine ECM connector and torque the center retaining bolt of the ECM harness connector per the following values:  
Caterpillar Engine- 53 in-lb +/- 9 in-lb  
Cummins Engine- 25 in-lb +/- 2 in-lb
- 4.6 Proceed to step 5.
- 4.7 If coolant is found in the ECM connector (See Figure 4) or ECM, clean the ECM pins and replace the Blue Bird ECM harness. Reconnect the engine ECM connector and torque the center retaining bolt of the ECM harness connector per the following values:  
Caterpillar Engine- 53 in-lb +/- 9 in-lb  
Cummins Engine- 25 in-lb +/- 2 in-lb
