BLUE BIRD

# Defroster Fan Fuse Upgrade

# BULLETIN

**MODELS AFFECTED: 2011 MODEL YEAR BBCV "VISION" EQUIPPED WITH FEATURE 30026-06 OR 30026-07 6" AUXILIARY FAN WITH METAL GUARD.**

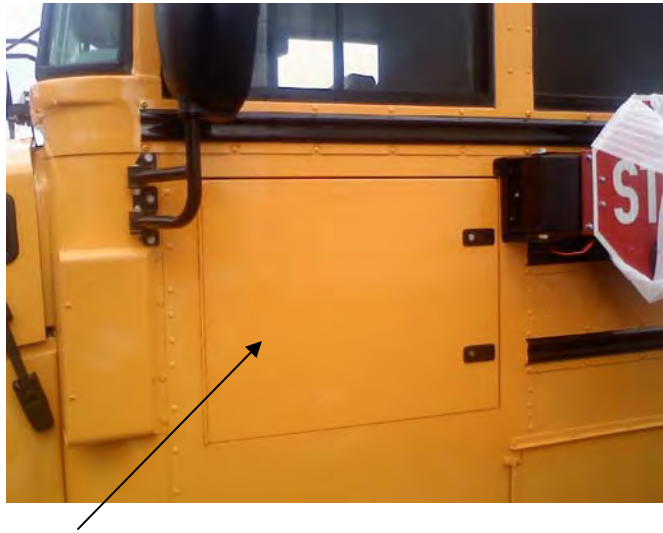
**Access Door**

2. Unlatch and open exterior access door located below driver side window. (See above photo)

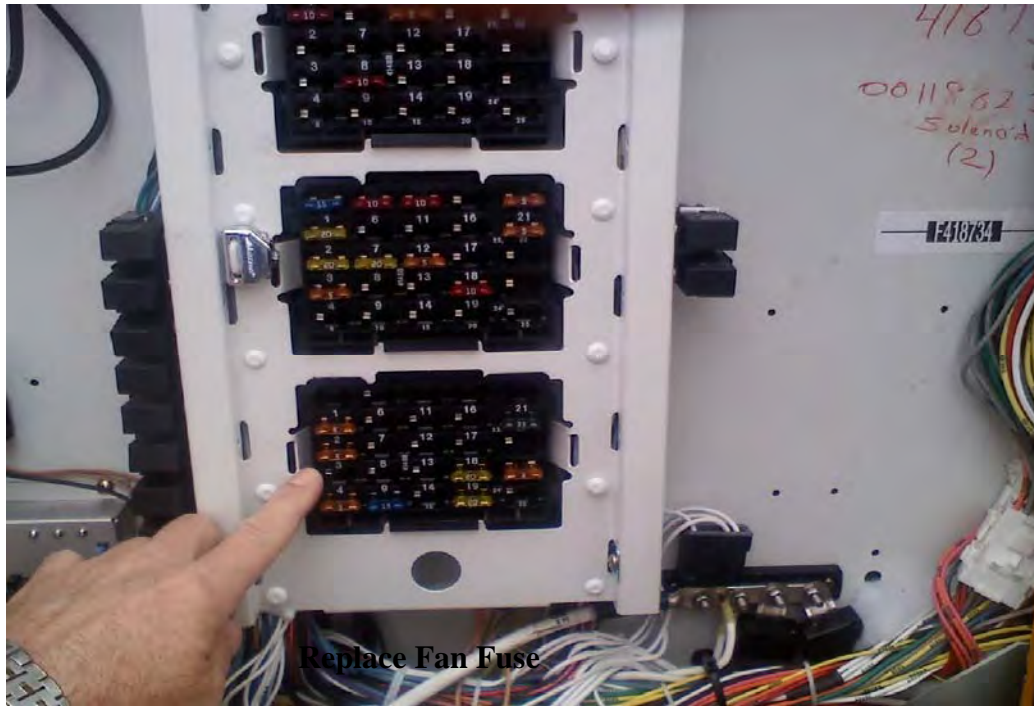
Replace Fan Fuse

The capacity of the five amp fuses may be exceeded when heavy duty fans are started on high speed setting.

3. Replace applicable 5 amp fan fuses with 7.5 amp fuses part number 01696715 in fuse block FB3- cavity 3, 5, 7 as required (if present - see above photo)

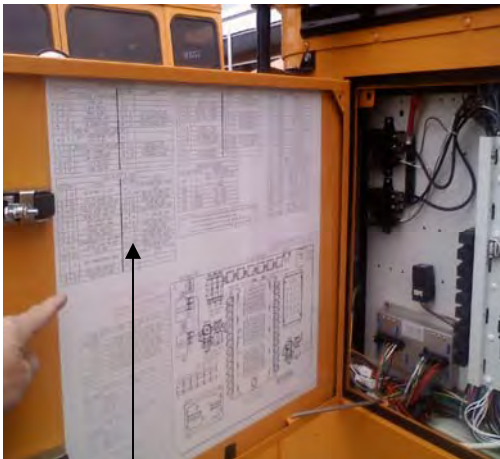
Upper Decal

Place 7.5 amp overlay decals under amperage rating column beside CAV 3, 5, 7

4. Correct upper decal part number 10010169 located on inside of access door. Clean surface of old decal and place new overlay decals (provided) over existing decal on fuse block FB3- cavity 3, 5, 7 (amp column - see above photos) Verify all auxiliary fans operate in both low and high speed.
5. Place bus back in service.
