Exhaust Shield Contacts Chassis Components

BULLETIN

Models Affected: 2011 Model Year BBCV with Cummins ISB-7 Engine, Hydraulic Brakes and Optional Exhaust Shield.

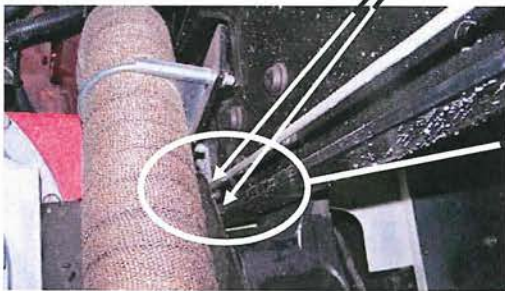
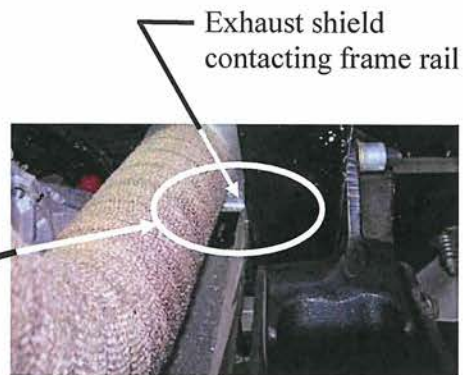
The exhaust pipe shield may contact the chassis frame, hydraulic steel brake line and/or other components.

3. The exhaust pipe and shield is located on the inside of the right frame between the engine and the Diesel Particulate Filter (DPF). Inspect the shield, frame rail and right hand hydraulic brake line for any contact that may have occurred.

Inspect both frame rail and hydraulic brake line for contact with exhaust shield.

4. If contact has been made with hydraulic brake line and there is any damage, replace hydraulic brake line.

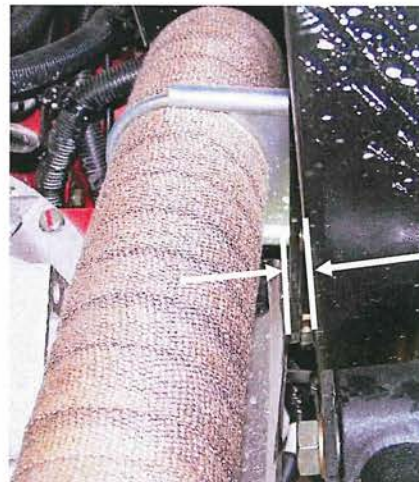
Clearance of $\frac{1}{4}$ " to $\frac{1}{2}$ "

6. After a minimum of $\frac{1}{4}$ " to $\frac{1}{2}$ " clearance has been achieved, place bus back in service.
