CHASSIS TECH TIPS

2011MY Improper Body U-Bolt installation on right side, near fuel lines

All 2011 models

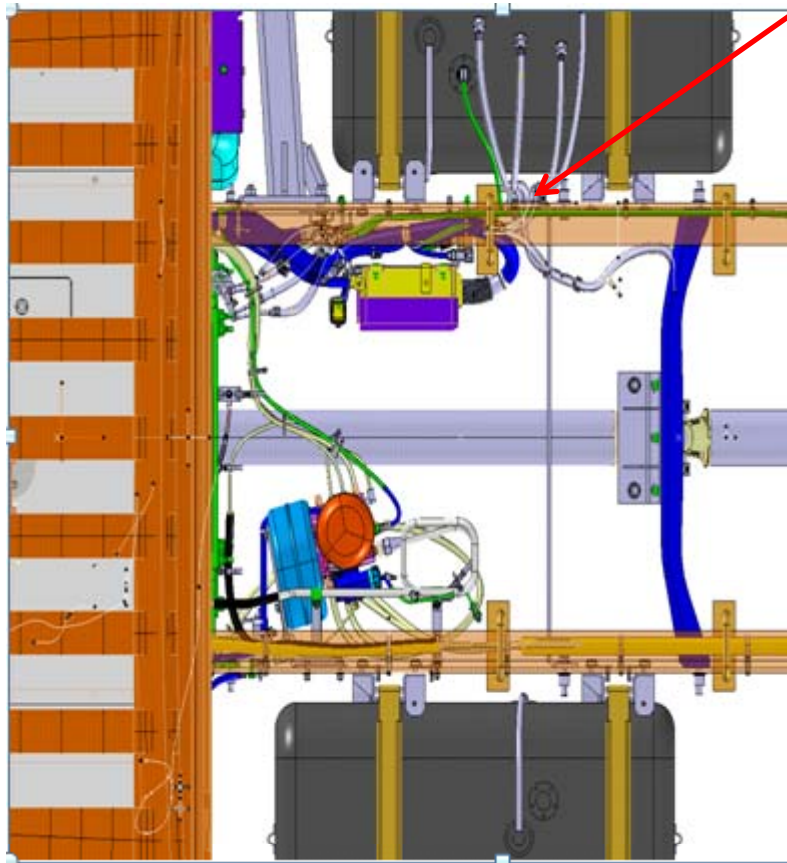
To prevent fuel line collapse caused by an incorrect U-bolt location make sure to locate the U-bolt as shown below, through the harness loop of junction box.

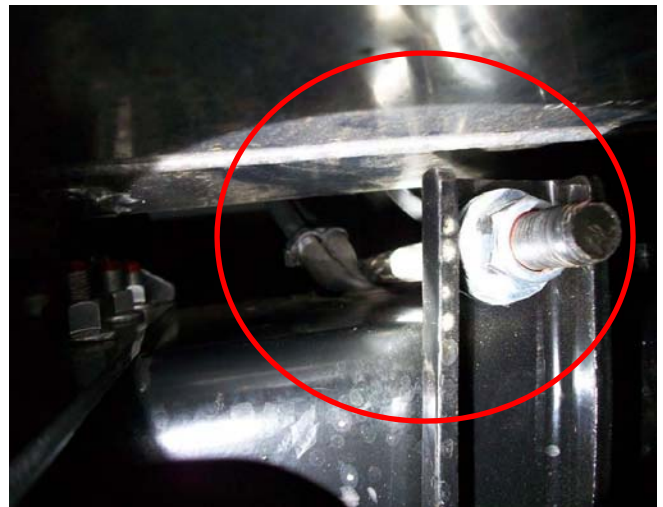
Example of incorrect U-bolt location-between outside frame rail & fuel tank causing collapse of fuel line when placed here.

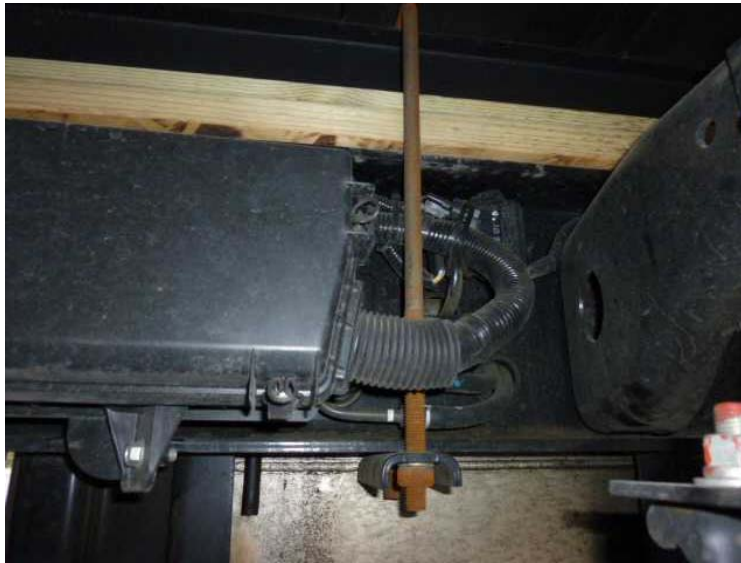
Example of correct U-bolt location –
inside frame rail.

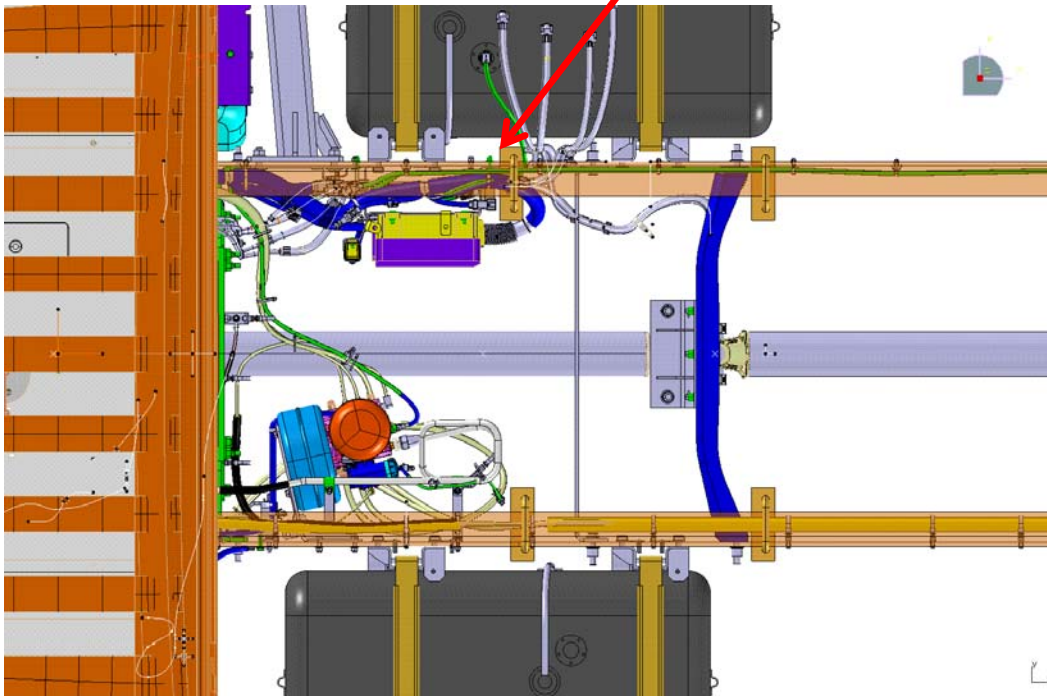
Proper U-bolt location
