Voluntary Recall Bulletin

Subject: Inspection and Replacement of Turbocharger - J05D

Bulletin: RCB-003-11

Affected Models: Certain 2008 - 2010 MY NA6J, NB6J and NC6J models equipped with a J05D engine

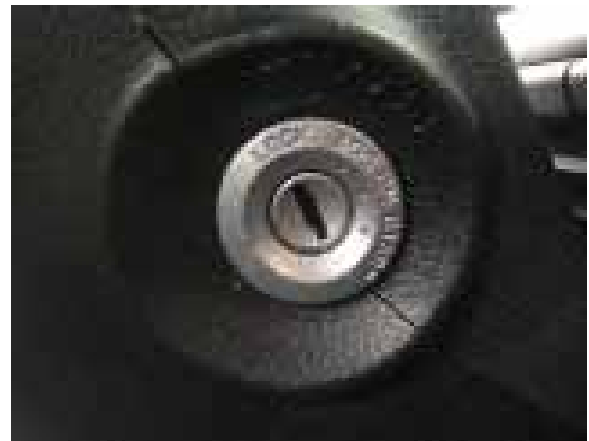
1. Park the vehicle on level ground.
2. Confirm the engine is stopped, the starter switch is in the off (LOCK) position, and the key is removed.

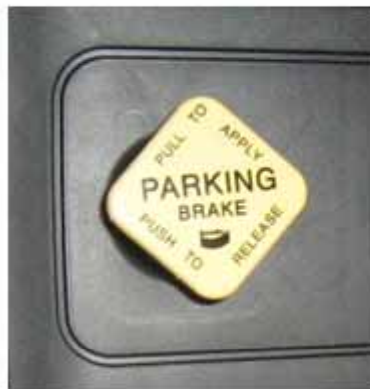
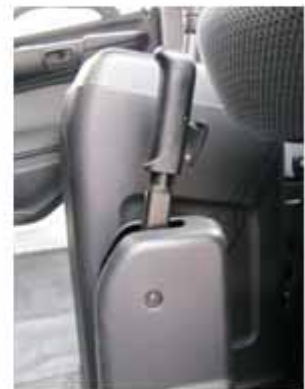
3. Apply the parking brakes.

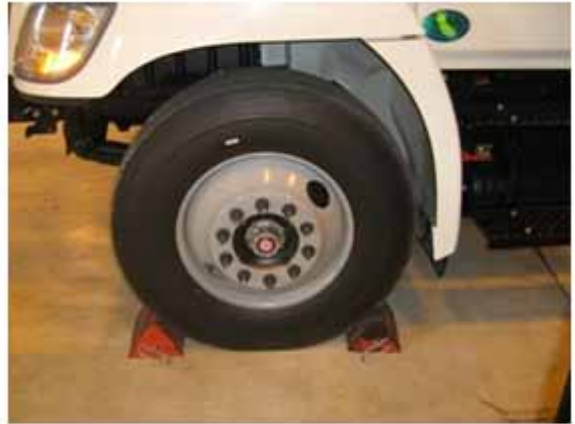
4. Chock all of the wheels.

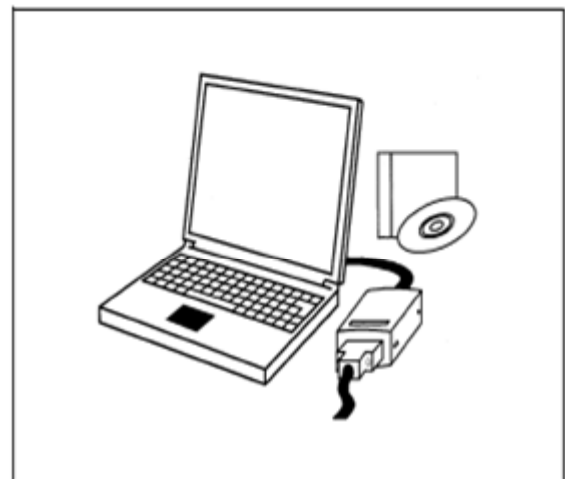
NOTICE: HINO'S DIAGNOSTIC HARWARE AND SOFTWARE

Hino Bowie (09993-E9070)

Cable communication (09042-1220)

Diagnosis software: HINO Diagnostic eXplorer (DX)

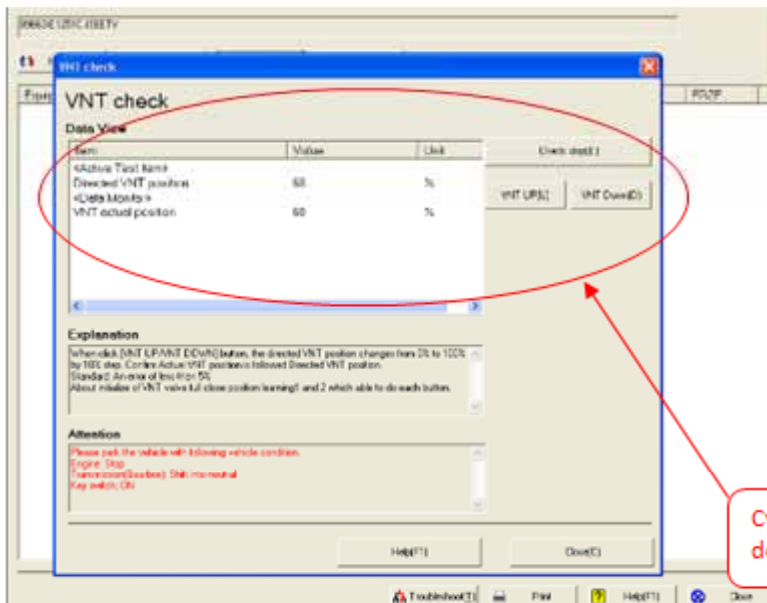
8. Perform the following "VNT Check".

- (i) Select the "VNT Check" in the "Check Functions" menu using the DX.
- (ii) Select "Check Start(E)" and then toggle the VNT turbocharger up and down from 0 to 100 using the "VNT UP(U)" and "VNT DOWN(D)" buttons on the DX.
- (iii) Confirm the "Directed VNT Position" follows the "VNT Actual Position".

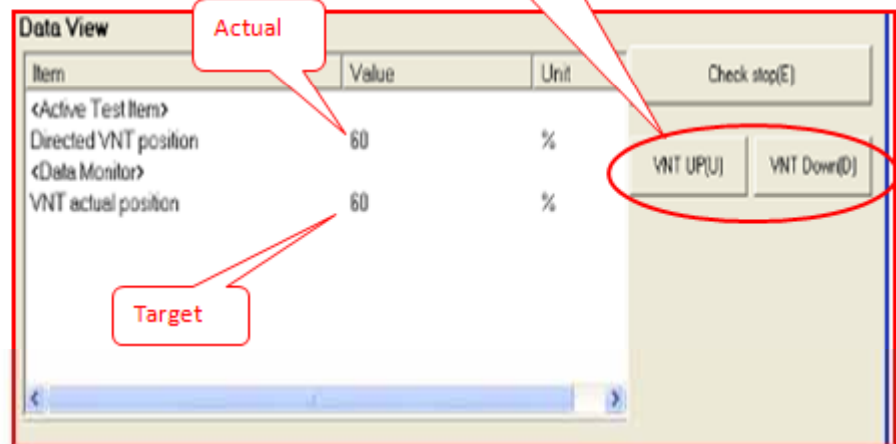
Cycle up to 100 and down to 0 – Ten cycles

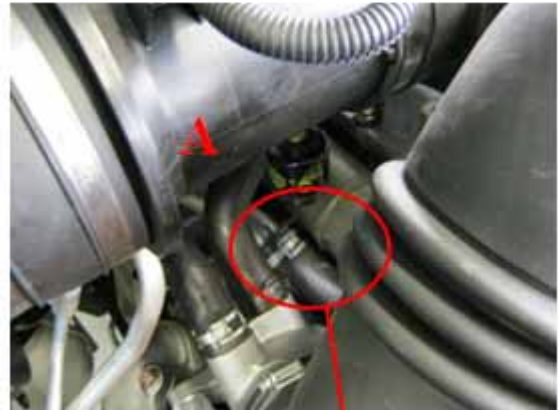
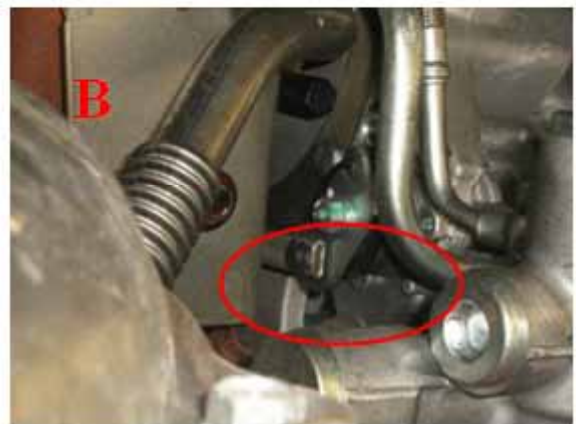
11. Lubricate the VNT turbocharger upper (A) and lower (B) link rod pivots with the aerosol “Loctite Nickel Anti-Seize”, Hino P/N 51286.

(iii) If either DTC’s P0045 / U1123 set again or the “VNT Actual Position” fails to follow the “Directed VNT Position”, replacement of the VNT turbocharger assembly will be required. Please continue to the “**Turbo Replacement Procedure**”. If the “VNT Actual Position” now successfully follows the “Directed VNT Position” and the DTC’s P0045 and/or P0045 U1123 do not reset, please continue to **STEP 12**.

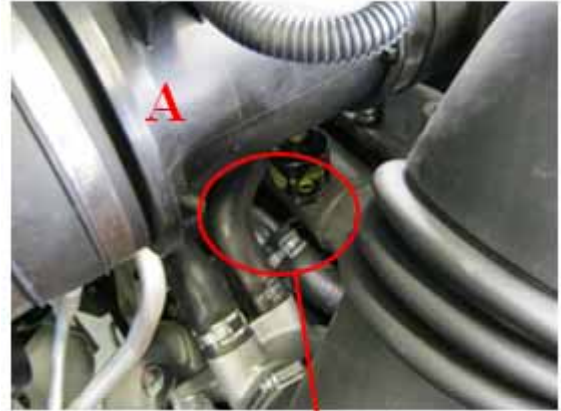
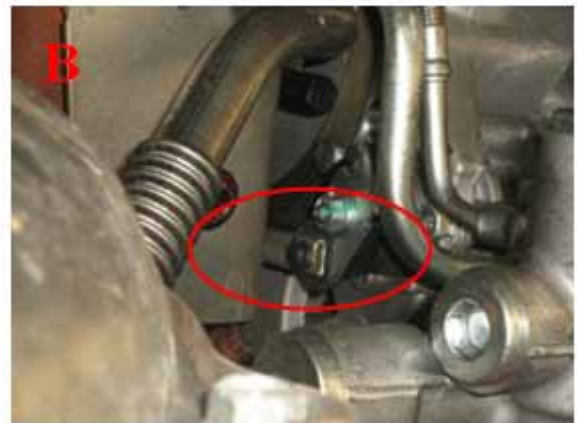
12. Lubricate the VNT turbocharger upper(A) and lower(B) link rod pivots with the aerosol “Loctite Nickel Anti-Seize”, part number 51286 and then cycle the VNT turbocharger 10 times to allow the “Loctite Nickel Anti-Seize” to penetrate and work into the VNT pivot and pivot rod joint. With no current failures found of the VNT turbocharger, VNT turbocharger replacement **WILL NOT** be required at this time. The vehicle can be returned to the customer as no further service will be required.

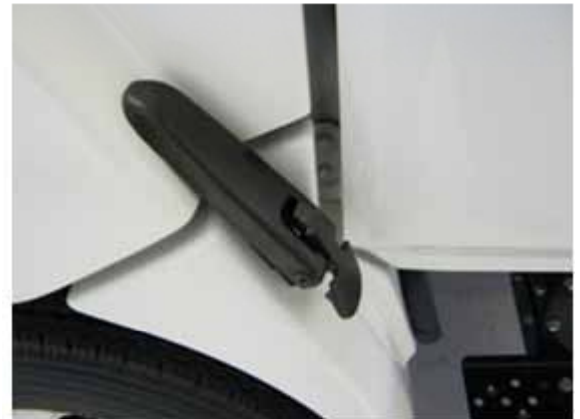
2. Release both hood latches.

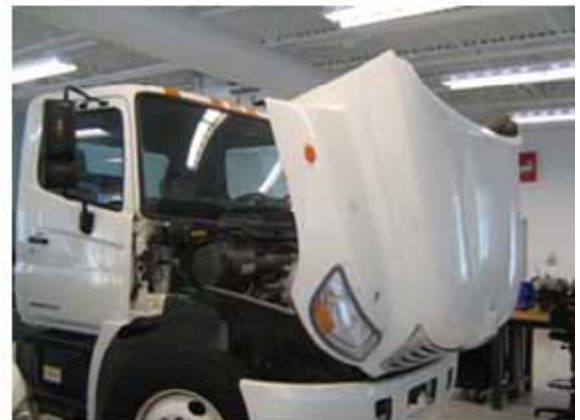
3. Make certain that there is proper clearance around the hood and then raise the hood.

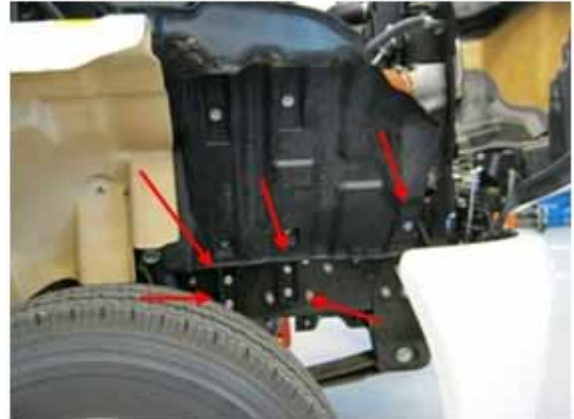
4. Remove the passenger side inner splash shield by removing the 5 bolts that secure the inner shield to the vehicles frame rail.

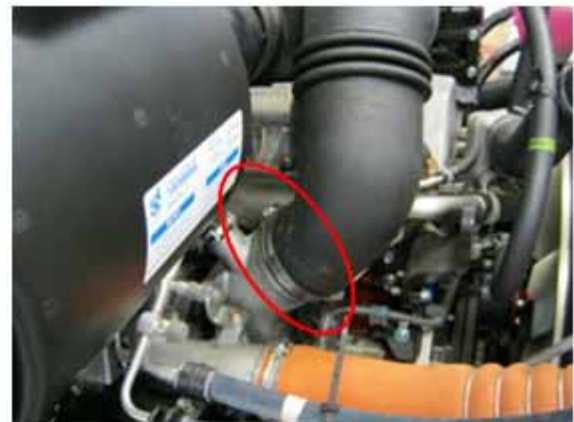
5. Loosen the fresh air inlet hose clamp.

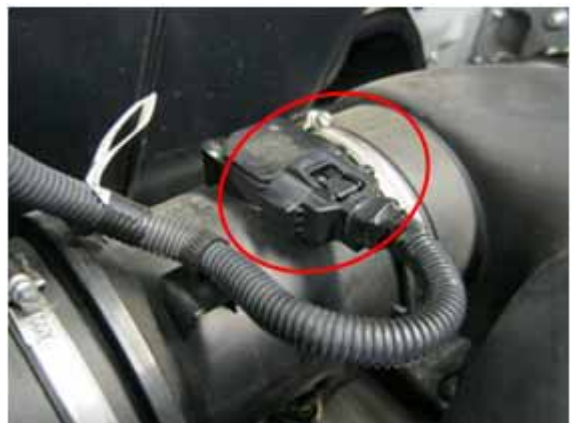
6. Disconnect the Air Flow Sensor electrical connector.

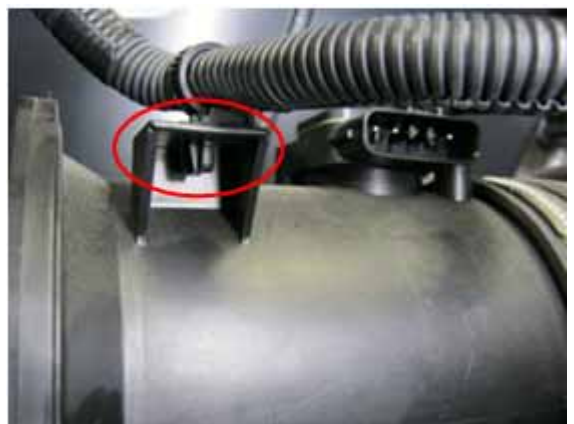
7. Disconnect the Air Flow Sensor harness clip.

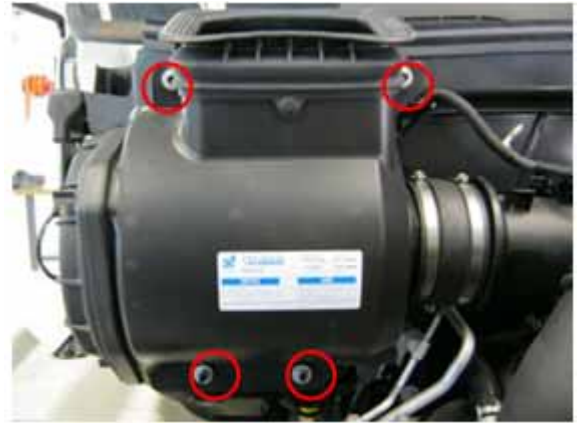
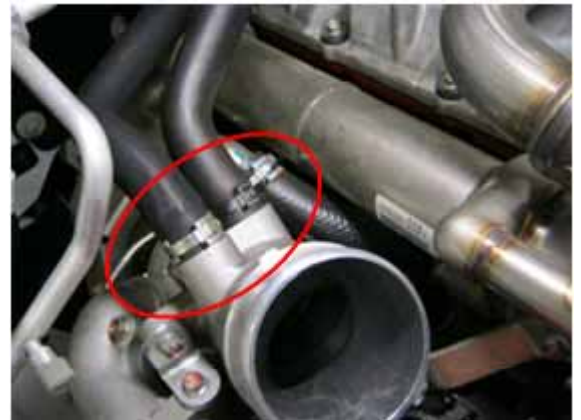
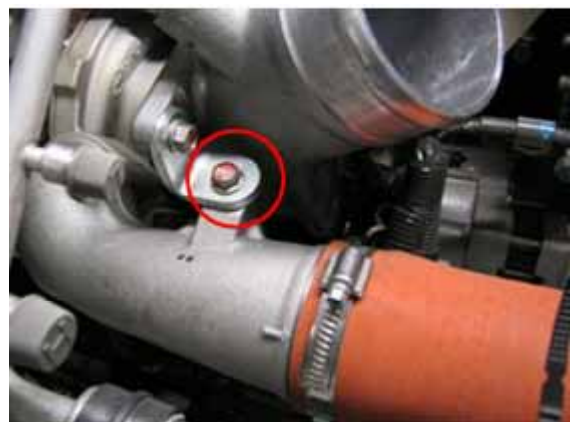
8. Remove the 4 air box bracket nuts and then remove the air box and fresh air hose assembly.

9. Remove both the crankcase and the air compressor breather hose clamps. Disconnect each hose from the VNT turbocharger fresh air inlet air tube.

10. Remove the 2 VNT turbocharger air outlet tube bolts.

11. Remove the VNT turbocharger upper air outlet tube bracket bolt.

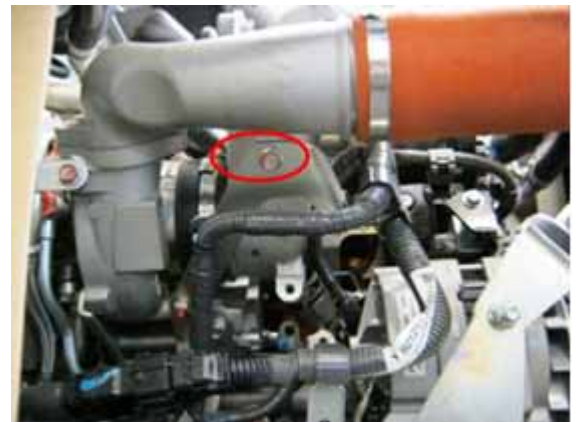
13. Remove the lower VNT turbocharger air outlet tube bracket bolt.

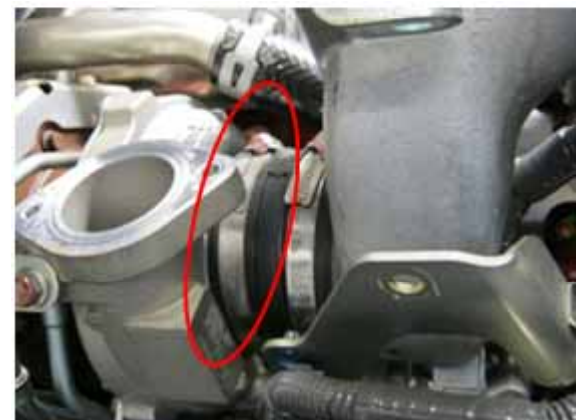
15. Loosen the VNT turbocharger fresh air inlet air hose clamp.

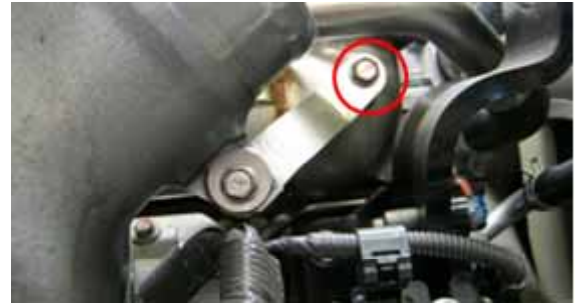
16. Remove the VNT turbocharger fresh air inlet air tube bracket bolt.

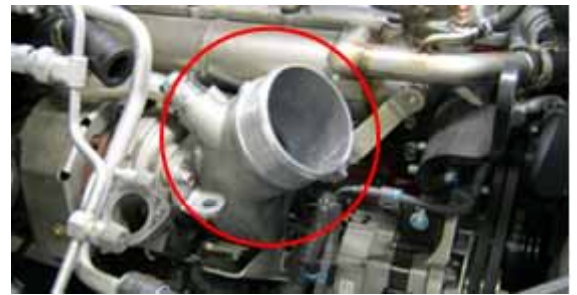
17. Remove the VNT turbocharger fresh air inlet air tube and hose together, as an assembly.

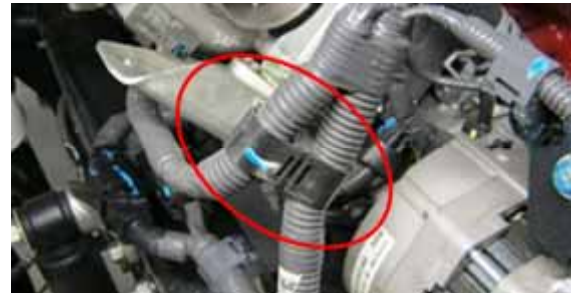
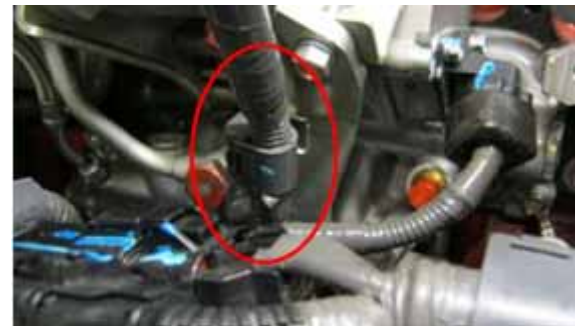
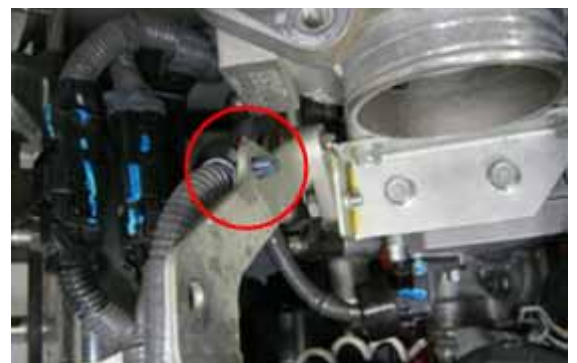
18. Disconnect the harness clips from their brackets.

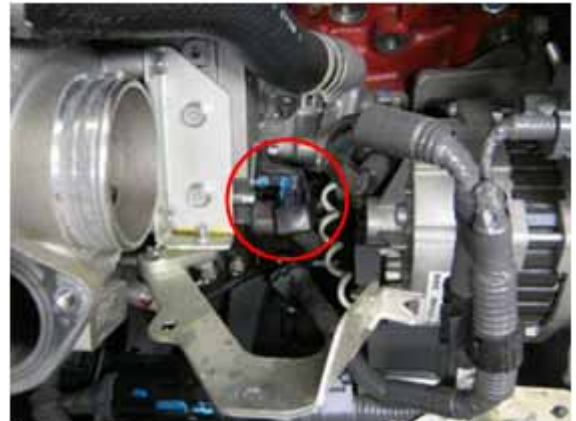
19. Disconnect the REA electrical connector.

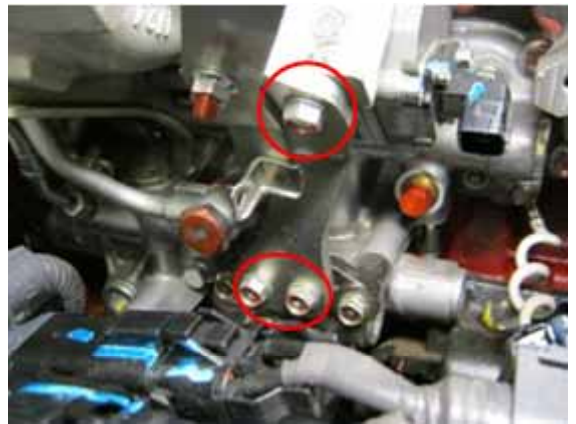
20. Remove the 3 VNT turbocharger support bracket bolts.

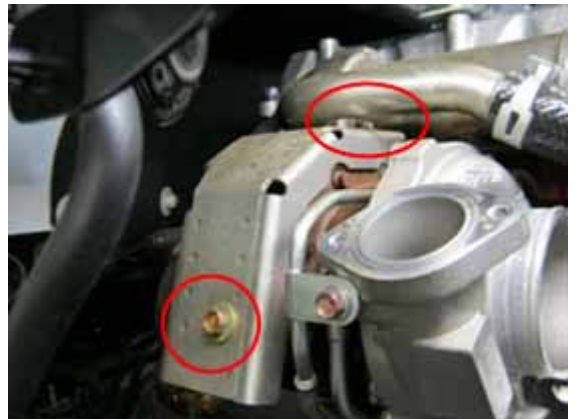
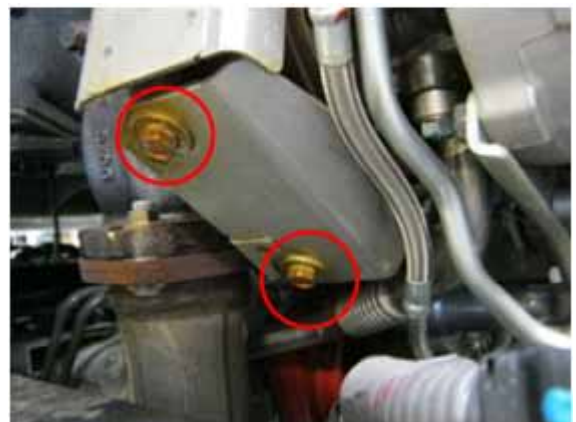
21. Remove the 2 upper and 2 lower VNT turbocharger heat shield bolts. Then remove the upper and lower heat shields.

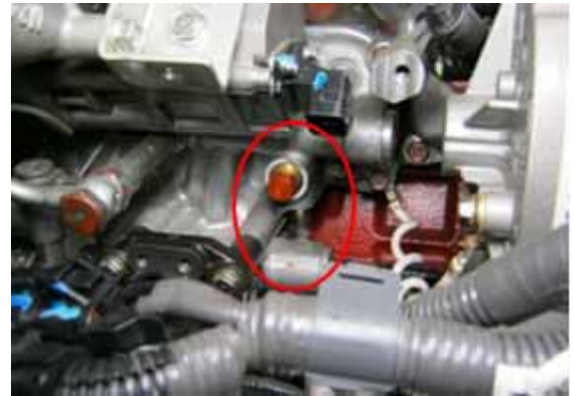
22. Loosen the drain bolt and drain the engine coolant into a approved container.

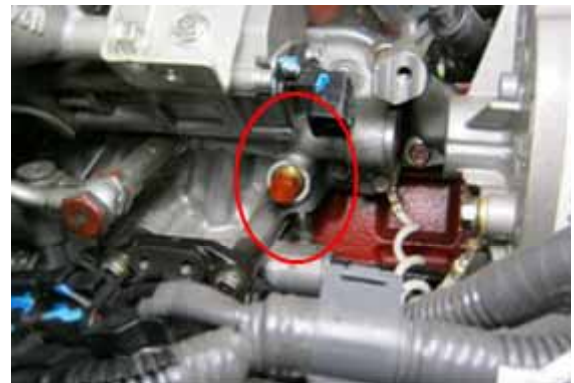
23. Tighten the engine coolant drain bolt to the specified torque.

Specified Torque: 44Nm (32.5 lb. ft.)

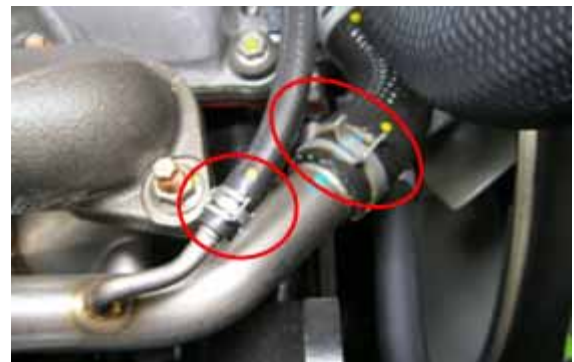
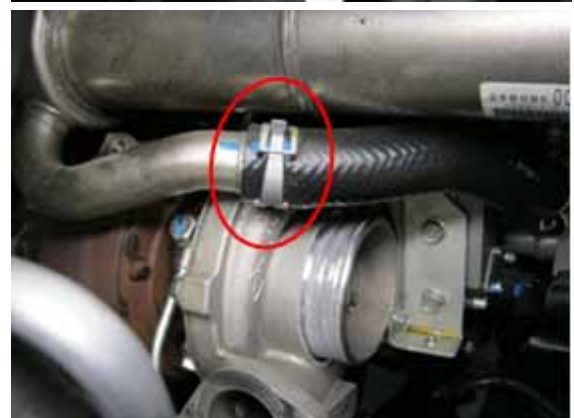
24. Remove the 3 Exhaust Gas Recirculation (EGR) cooler hose clamps and then remove the corresponding hose from each connection.

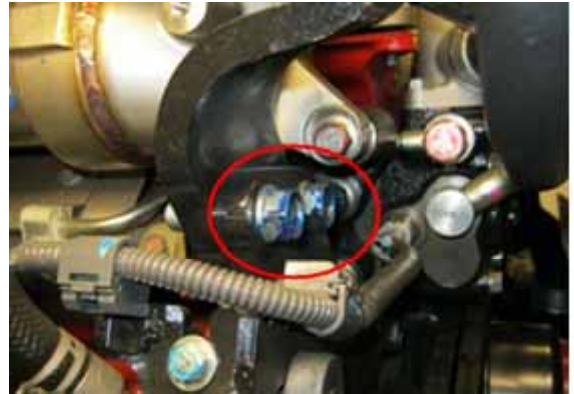
25. Remove the 4 engine hanger bracket bolts.

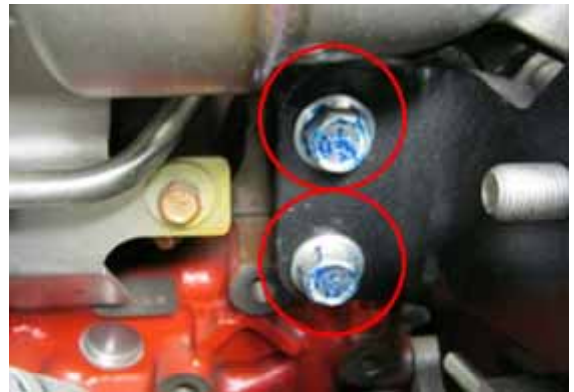
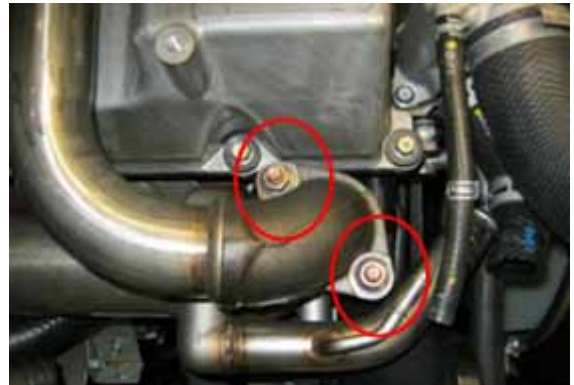
26. Remove the 2 EGR cooler exhaust outlet flange nuts.

NOTICE: Discard the old steel gasket. Do not reuse the discarded steel gasket.

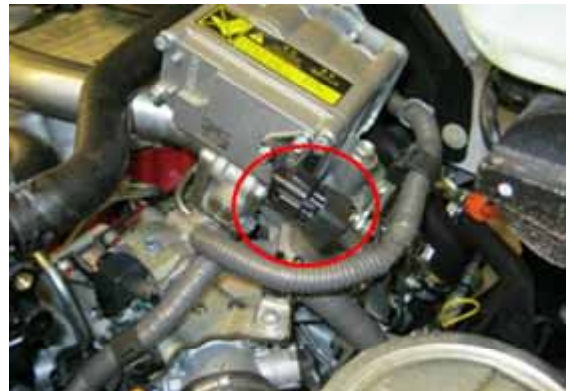
27. Disconnect the EGR valve electrical connector.

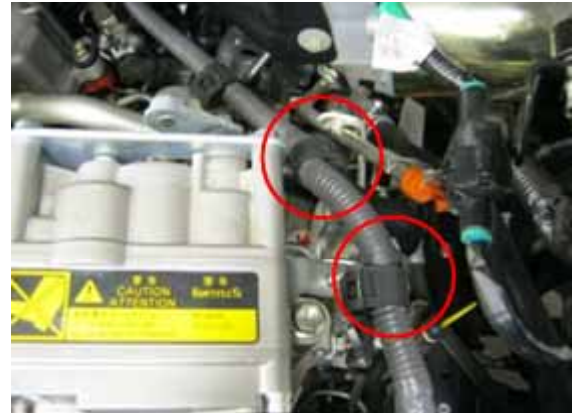
28. Disconnect the 2 harness clips from their bracket.

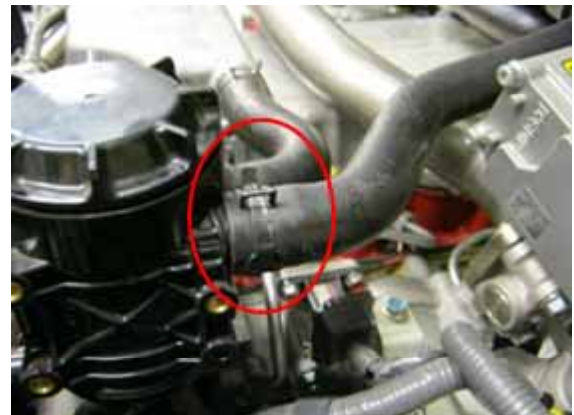
29. Remove the Closed Crankcase Ventilation (CCV) hose clamp and then disconnect the hose from the CCV oil separator.

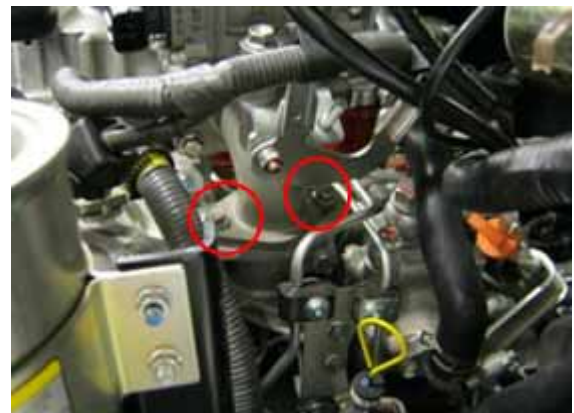
30. Remove the 2 EGR valve flange bolts.

NOTICE: Discard the old steel gasket. Do not reuse the discarded steel gasket.

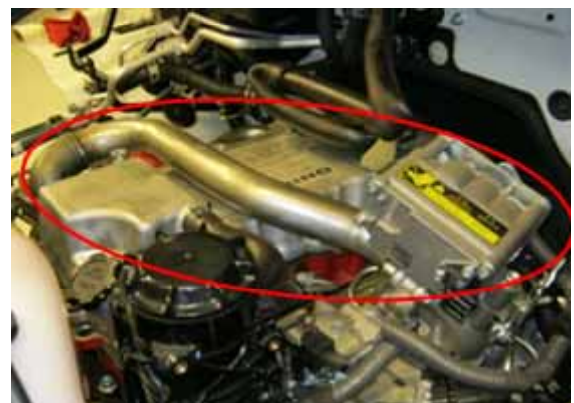
31. Remove the EGR valve and tube assembly.

NOTICE: Discard the old steel gaskets. Do not reuse the discarded steel gasket.

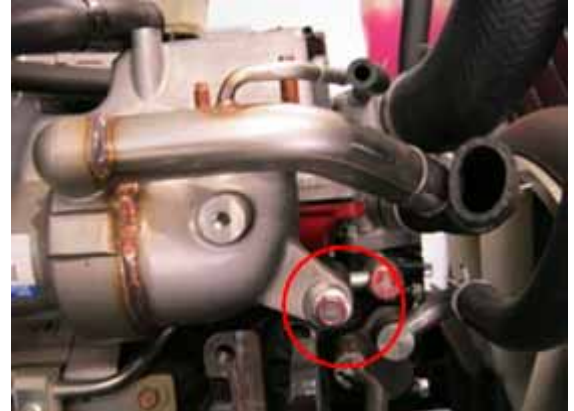
32. Remove the forward EGR cooler mounting bolt.

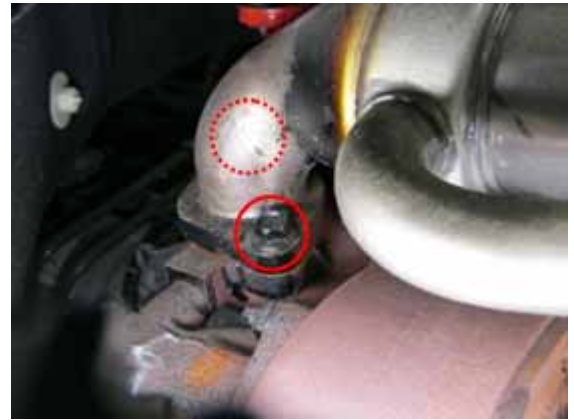
33. Remove the 2 rearward EGR cooler exhaust inlet flange bolts for the EGR cooler and also remove the EGR cooler.

NOTICE: Discard the old steel gasket. Do not reuse the discarded steel gasket.

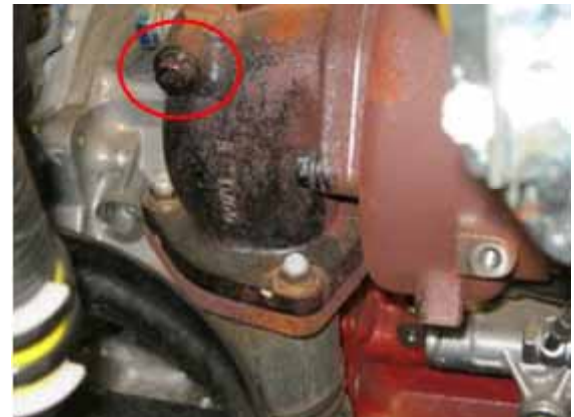
34. Remove the VNT turbocharger outlet elbow support bolt.

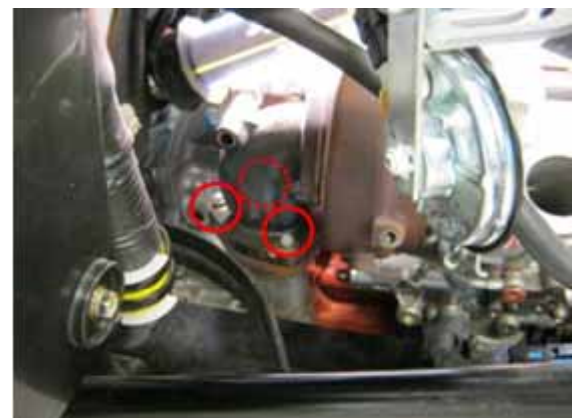
35. Remove the 2 VNT turbocharger outlet exhaust flange nuts and then the VNT turbocharger outlet exhaust flange bolt.

NOTICE: Discard the old steel gasket. Do not reuse the discarded steel gasket.

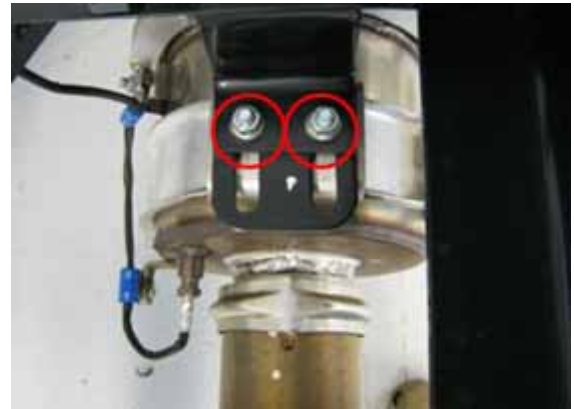
36. Loosen the exhaust Diesel Particulate Filter (DPF) hanger bracket nuts. This will allow the exhaust to pivot rearward for removal of the forward exhaust pipe.

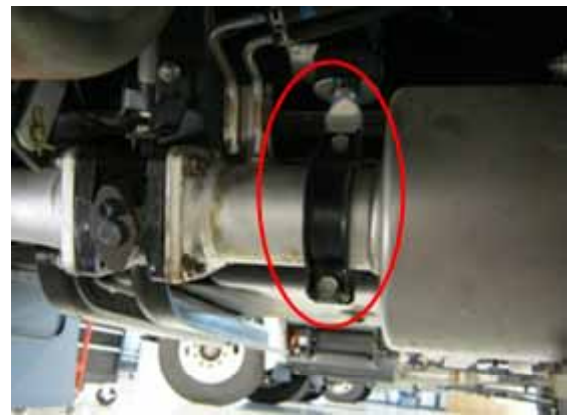
37. Loosen the rear exhaust hanger clamp to allow the exhaust to pivot rearward for removal of the forward exhaust pipe.

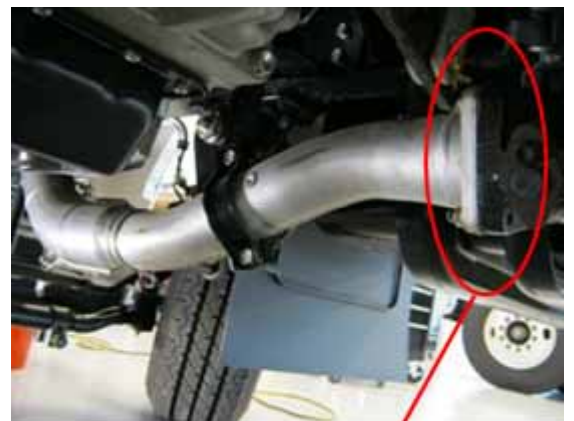
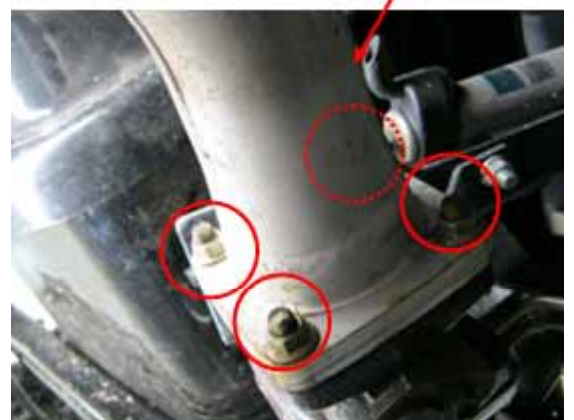
38. Remove the forward exhaust brake flange nuts that secure the forward exhaust pipe.

NOTICE: Discard the old steel gasket. Do not reuse the discarded steel gasket.

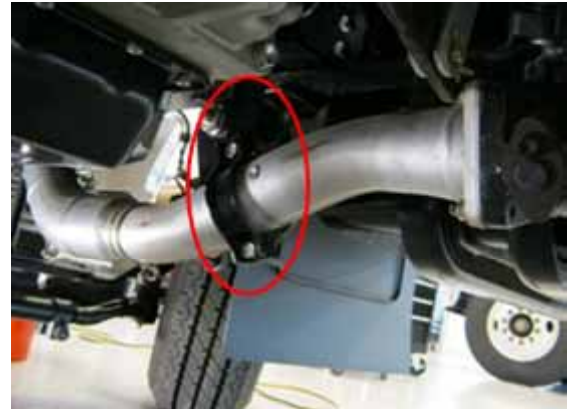
39. Remove the forward exhaust pipe hanger and then remove the forward exhaust pipe between the exhaust brake and VNT turbocharger outlet.

NOTICE: Discard the old steel gasket. Do not reuse the discarded steel gasket.

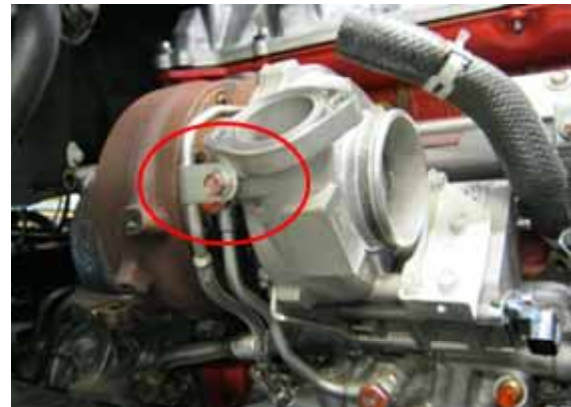
40. Remove the VNT turbocharger oil supply line mounting bracket bolt.

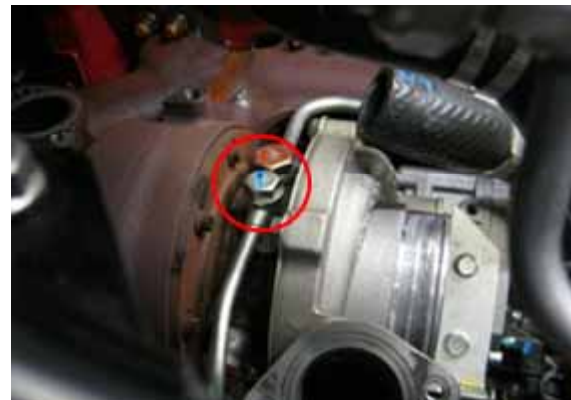
41. Remove the upper VNT turbocharger oil supply line banjo bolt off of the VNT turbocharger.

NOTICE: Discard the old copper sealing washers. Do not reuse the discarded copper sealing washers.

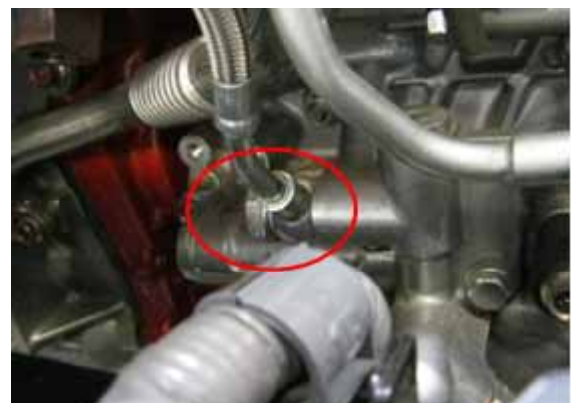
42. Remove first the lower VNT turbocharger oil supply line banjo bolt and then remove the oil supply line for the VNT turbocharger.

NOTICE: Discard the old copper sealing washers. Do not reuse the discarded copper sealing washers.

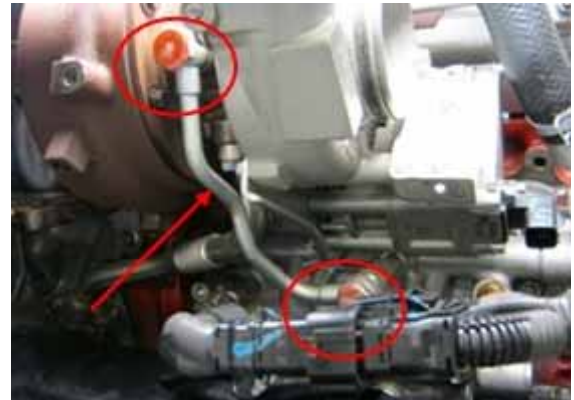
43. Remove the upper and lower coolant line banjo bolts for the VNT turbocharger coolant return line. Remove the VNT turbocharger coolant return line.

NOTICE: Discard the old rubber/aluminum sealing washers. Do not reuse the discarded rubber/aluminum washers.

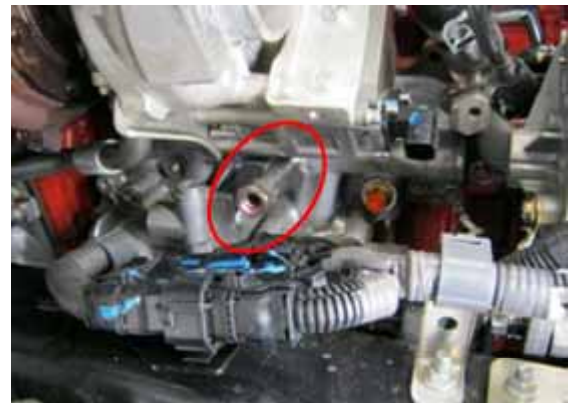
44. Remove the VNT turbocharger coolant return line extension tube.

NOTICE: Discard the old rubber/aluminum sealing washer. Do not reuse the discarded rubber/aluminum washers.

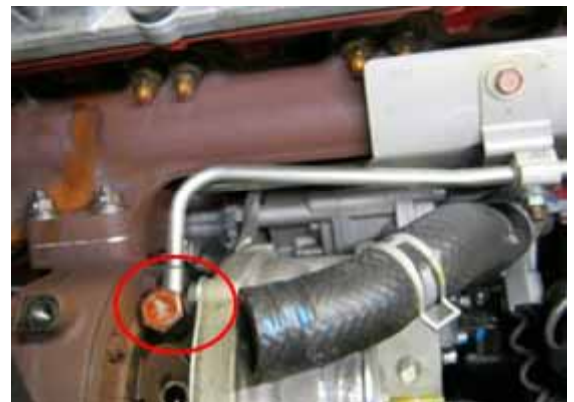
45. Remove the VNT turbocharger coolant supply line banjo bolt.

NOTICE: Discard the old rubber/aluminum sealing washers. Do not reuse the discarded rubber/aluminum washers.

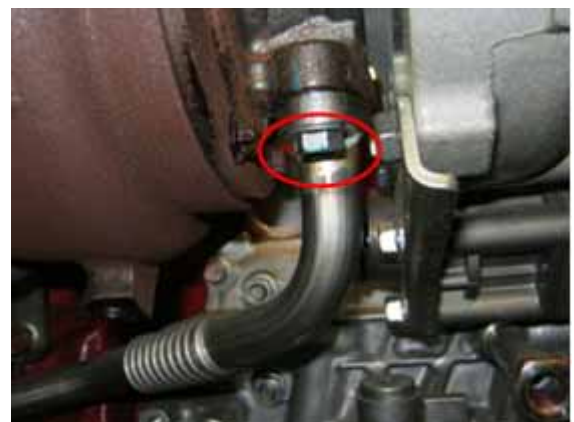
46. Remove the 2 upper VNT turbocharger oil return tube flange bolts.

NOTICE: Discard the old gasket. Do not reuse the discarded gasket.

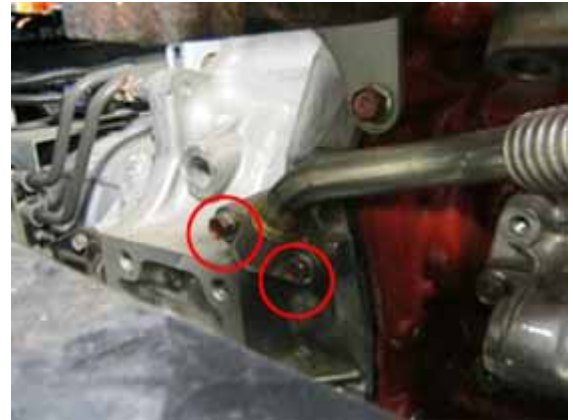
47. Remove the 2 lower VNT turbocharger oil drain tube flange bolts and then remove the VNT turbocharger oil return tube.

NOTICE: Discard the old gasket. Do not reuse the discarded gasket.

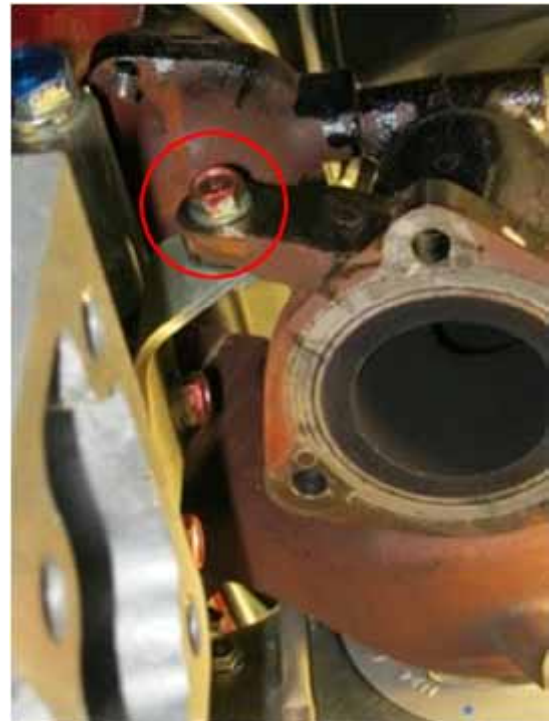
48. Remove the VNT turbocharger support bracket bolt.

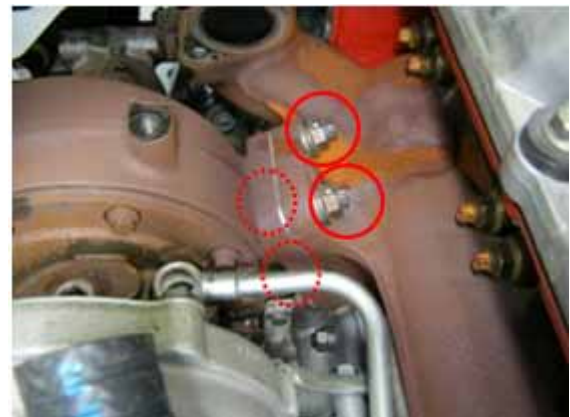
49. Remove the 4 VNT turbocharger flange nuts at the exhaust manifold-to-VNT turbocharger inlet flange and then remove the VNT turbocharger.

NOTICE: Discard the old steel gasket. Do not reuse the discarded steel gasket.

NOTICE: You must save the steel washers which will be needed and reused upon assembly.

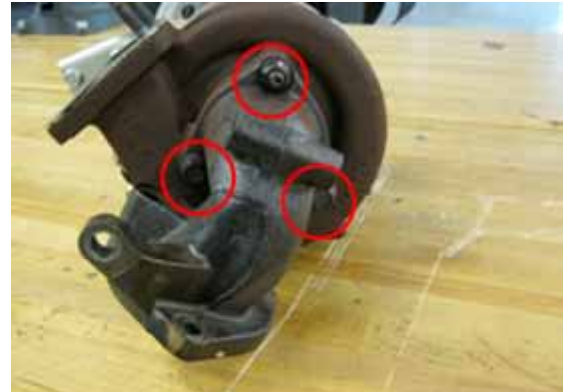
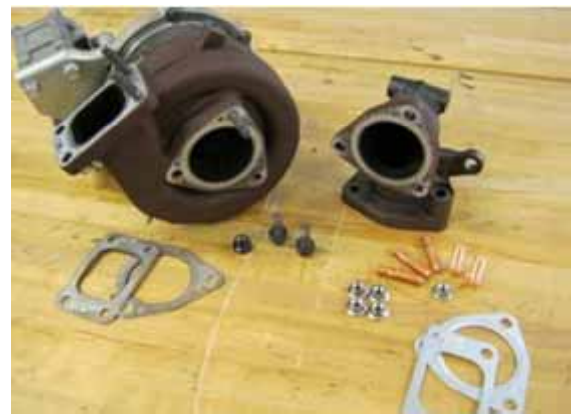
50. Remove the 2 VNT turbocharger elbow flange bolts and then the VNT turbocharger elbow flange nut.

NOTICE: Discard the old steel gasket. Do not reuse the discarded steel gasket.

NOTICE: You must save the steel washers which will be needed and reused upon assembly.

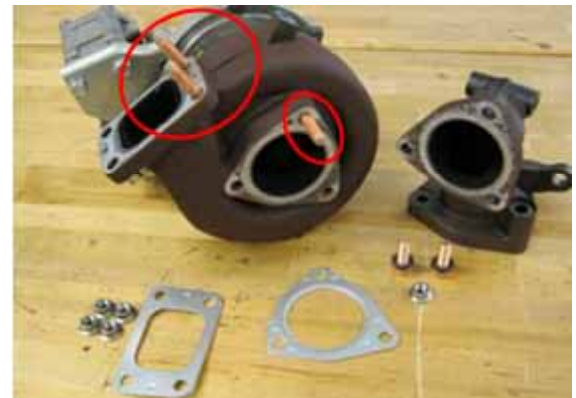
1. Install the new studs onto the VNT turbocharger.

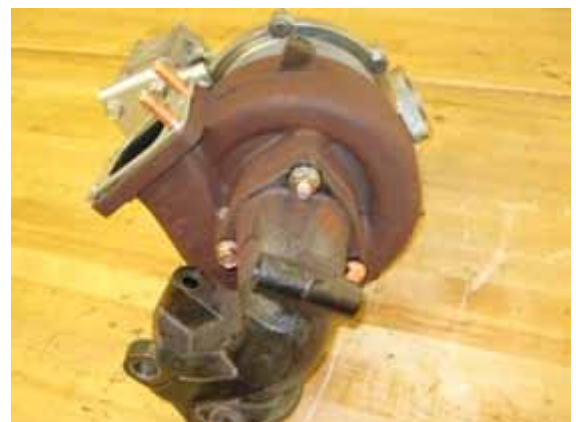
2. Install the VNT turbocharger elbow onto the VNT turbocharger with a new steel flange gasket. Tighten the single nut and 2 bolts to the specified torque.

Specified Torque: 41 lb. ft. (56 Nm)

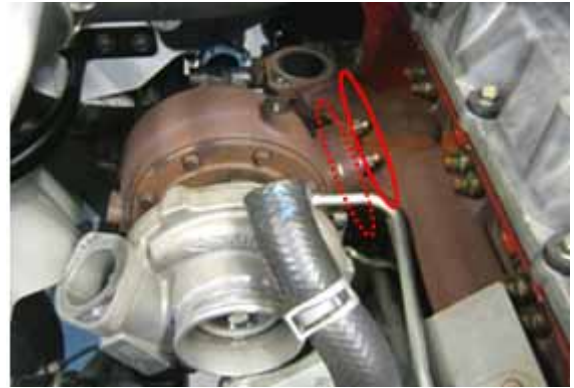
3. Install the VNT turbocharger onto the exhaust manifold outlet-to-VNT turbocharger exhaust inlet flange. Make certain that a new steel flange gasket is installed. Tighten the 4 flange nuts to the specified torque.

Specified Torque: 41 lb. ft. (56 Nm)

NOTICE: Make certain that a new steel flange gasket is installed. Do not install the old steel flange gasket.

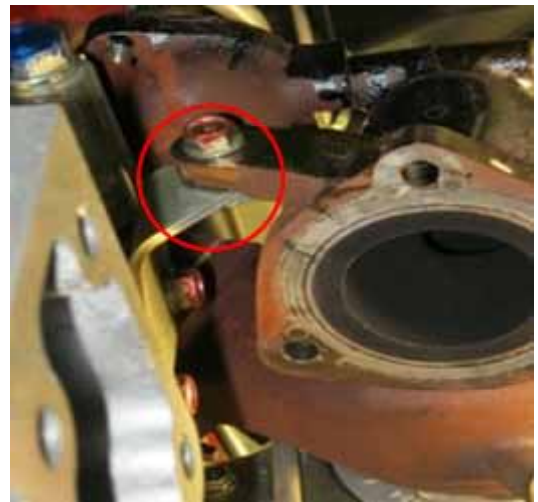
4. Install and tighten the VNT turbocharger support bracket bolt to the specified torque.

Specified Torque: 41 lb. ft. (55 Nm)

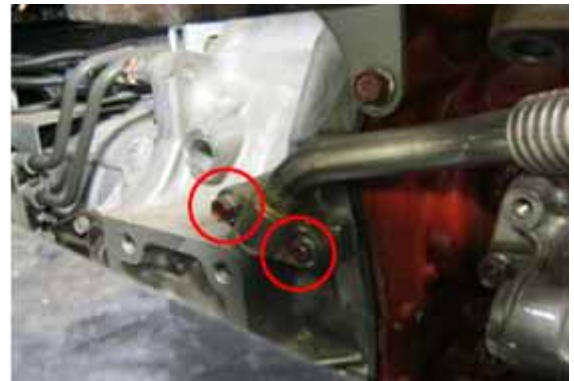
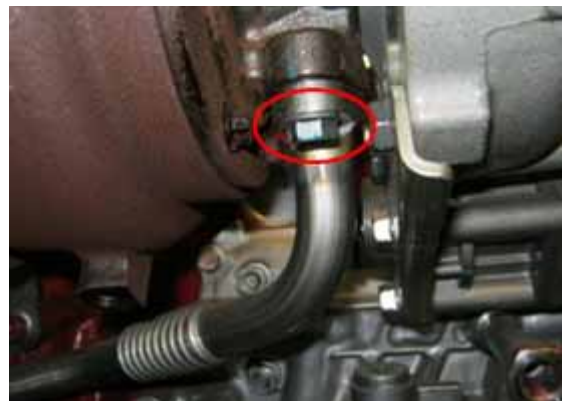
5. Install the VNT turbocharger oil drain tube and then 4 oil drain tube flange bolts. Make certain that new gaskets are used and that all 4 bolts are threaded in by hand. Once all 4 bolts are hand tight, tighten the VNT turbocharger oil drain tube flange bolts to the specified torque.

Specified Torque: 21 lb. ft. (28.5 Nm)

NOTICE: Make certain new flange gaskets are installed. Do not install the old flange gaskets.

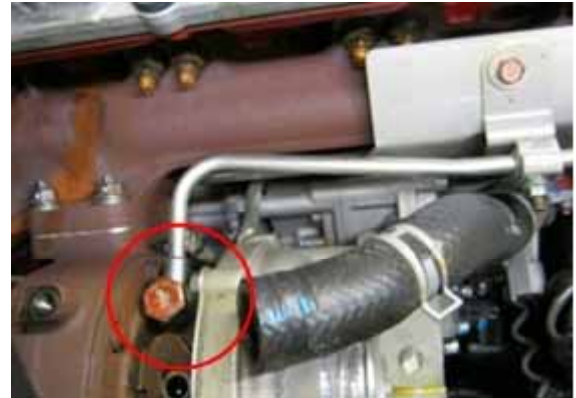
6. Install the VNT turbocharger coolant supply line banjo bolt with new sealing washers and tighten to the specified torque.

Specified Torque: 18.5 lb. ft. (25 Nm)

NOTICE: Make certain that new rubber/aluminum sealing washers are used upon reassembly. Do not install the old rubber/aluminum sealing washers.

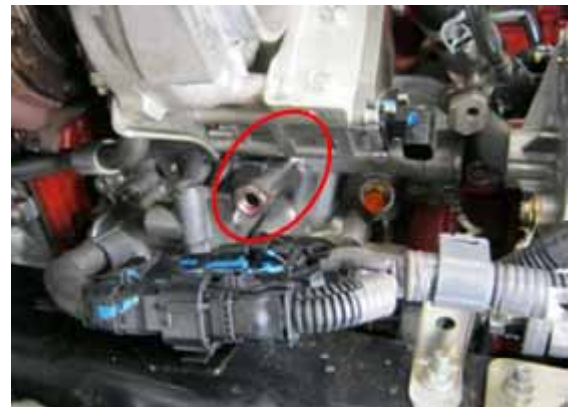
7. Install the VNT turbocharger coolant return line extension tube with new sealing washers and tighten to the specified torque.

Specified Torque: 18.5 lb. ft. (25 Nm)

NOTICE: Make certain that new rubber/aluminum sealing washers are used upon reassembly. Do not install the old rubber/aluminum sealing washers.

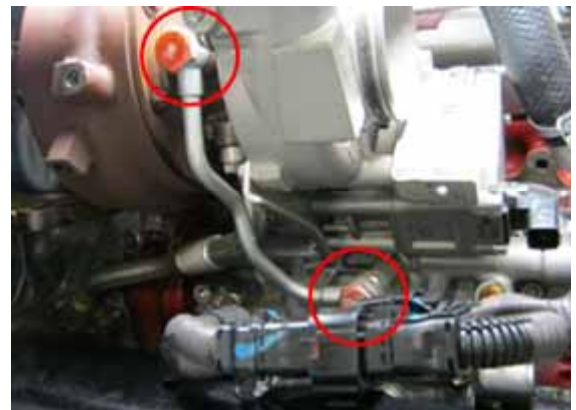
8. Install the VNT turbocharger coolant return line along with the upper and lower banjo bolts. Make certain new sealing washers are installed and the banjo bolts are tightened to the specified torque.

Specified Torque: 18.5 lb. ft. (25 Nm)

NOTICE: Make certain that new rubber/aluminum sealing washers are used upon reassembly. Do not install the old rubber/aluminum sealing washers.

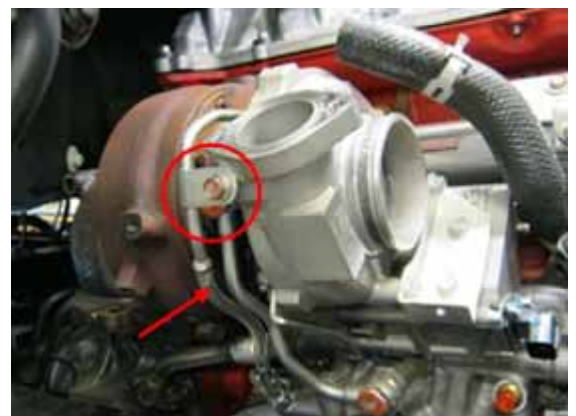
9. Install the VNT turbocharger oil supply line and oil supply line mounting bracket bolt. Only tighten the mounting bracket bolt by hand at this time.

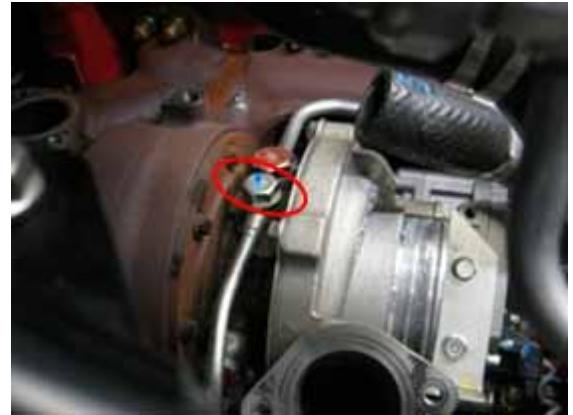
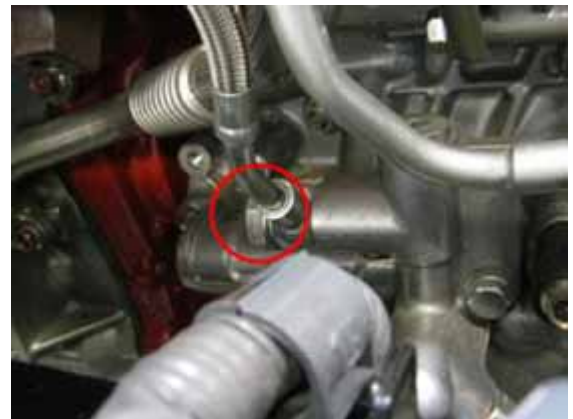
10. Install the VNT turbocharger oil supply line upper and lower banjo bolts. Make certain that new sealing washers are installed and the banjo bolts are tightened to the specified torque.

Specified Torque: 18.5 lb. ft. (25 Nm)

NOTICE: Make certain that new copper sealing washers are used upon reassembly. Do not install old copper sealing washers.

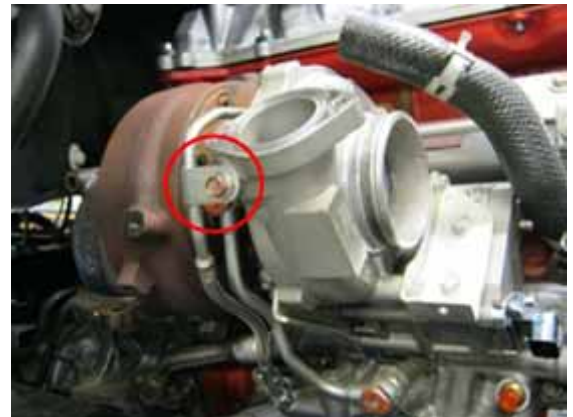
11. Tighten the VNT turbocharger oil supply line mounting bracket bolt to the specified torque.

Specified Torque: 21 lb. ft. (28.5 Nm)

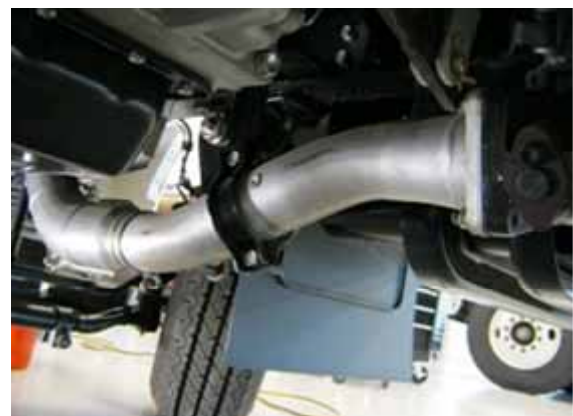
12. Install the forward exhaust pipe. Make certain that the flange gasket between the VNT turbocharger and forward exhaust pipe along with the flange gasket between the forward exhaust pipe and exhaust brake have been replaced.

NOTICE: Make certain that new steel flange gaskets are installed. Do not install old steel flange gaskets.

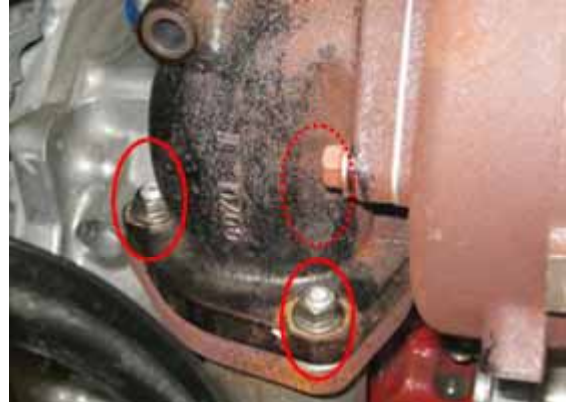
13. Install the 2 VNT turbocharger outlet exhaust flange nuts and the VNT turbocharger exhaust flange bolt. Tighten to the specified torque.

Specified Torque: 52 lb. ft. (70 Nm)

NOTICE: Make certain that new steel flange gaskets are installed. Do not install old steel flange gaskets.

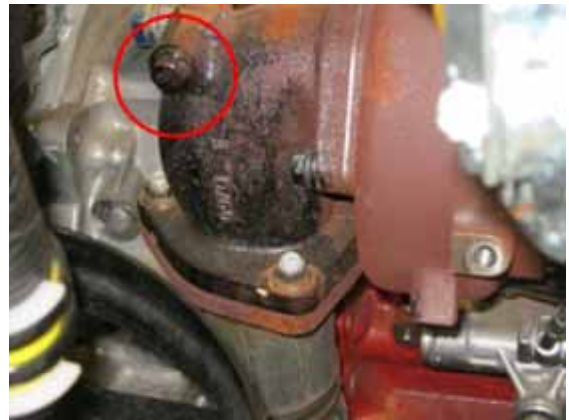
14. Install the exhaust support bolt and tighten to the specified torque.

Specified Torque: 41lb. ft. (55 Nm)

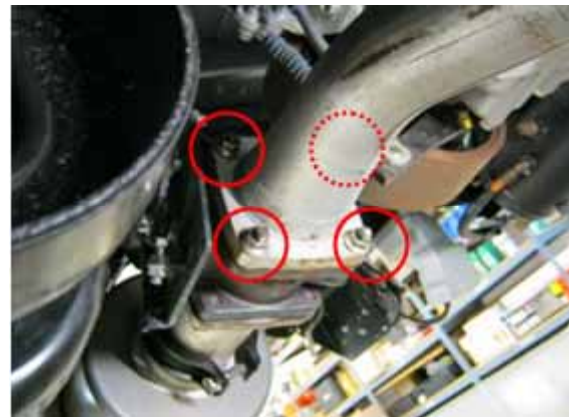
15. Install the 4 forward exhaust pipe flange nuts at the exhaust brake and tighten to the specified torque.

Specified Torque: 52 lb. ft. (70 Nm)

NOTICE: Make certain that new steel flange gaskets are installed. Do not install old steel flange gaskets.

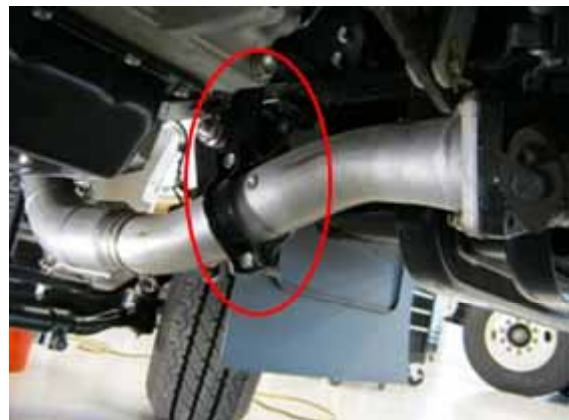
16. Center and tighten the forward exhaust hanger clamp to the specified torque. The upper clamp bolt will require tightening first and then the lower hanger clamp bolt last.

Specified Torque: 38 lb. ft. (51 Nm) -Upper-
Specified Torque: 21 lb. ft. (29 Nm) -Lower-

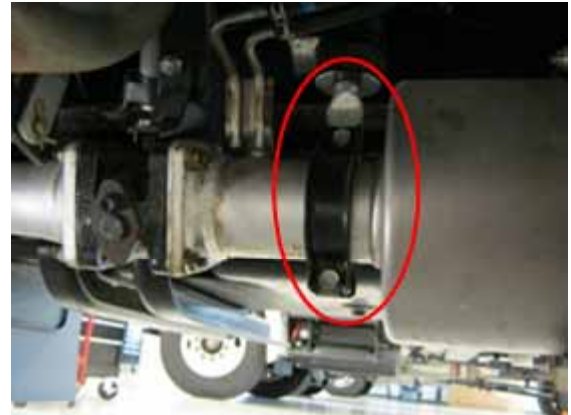
17. Center and tighten the rear exhaust hanger clamp to the specified torque. The upper clamp bolt will require tightening first and then the lower hanger clamp bolt last.

**Specified Torque: 38 lb. ft. (51 Nm) -Upper-
Specified Torque: 21 lb. ft. (29 Nm) -Lower-**
