Voluntary Recall Bulletin

Subject: Inspection and Replacement of Turbocharger - J05D

Bulletin: RCB-003-11

Affected Models: Certain 2008 - 2010 MY NA6J, NB6J and NC6J models equipped with a J05D engine

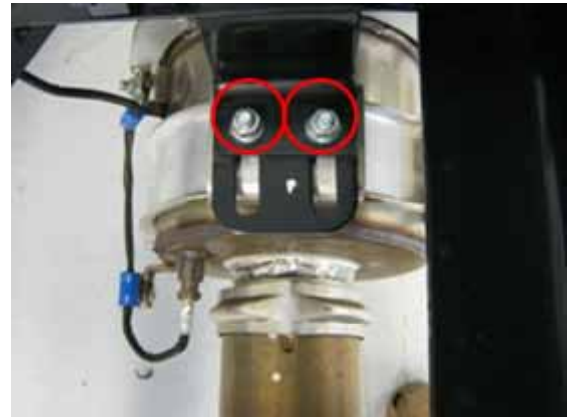
18. Tighten the DPF hanger bracket nuts to the specified torque.

Specified Torque: 44 lb. ft. (60 Nm)

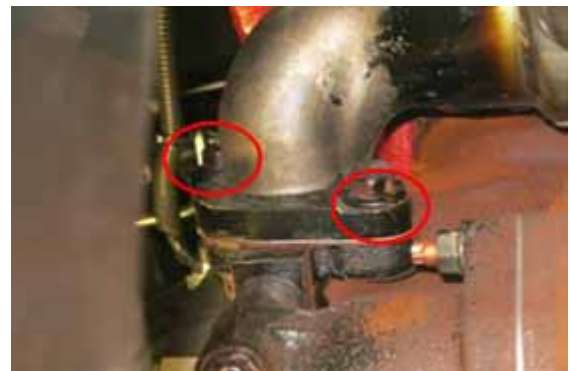
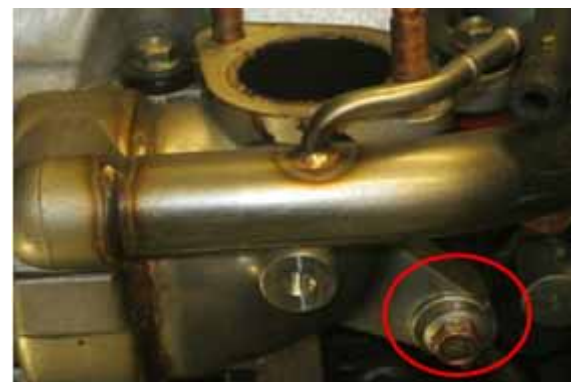
19. Install the EGR cooler along with the new steel flange gasket. Hand tighten the 2 flange bolts along with the forward EGR cooler mounting bolt. Tighten the 3 bolts to the specified torque.

Specified Torque: 41 lb. ft. (55 Nm)

NOTICE:. Make certain that a new steel flange gasket is installed. Do not install the old steel flange gasket.

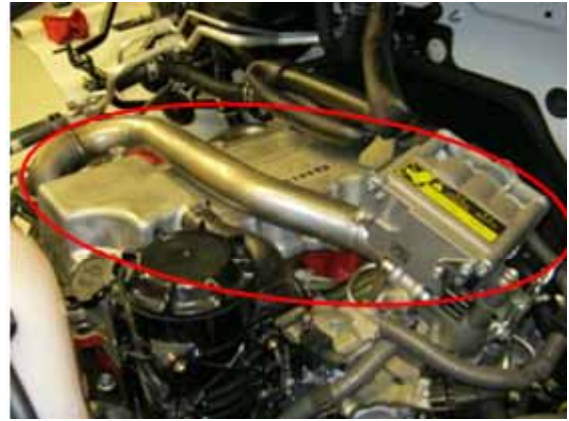
20. Install the EGR valve and tube assembly.

NOTICE: Make certain that new steel flange gaskets are installed. Do not install the old steel flange gaskets.

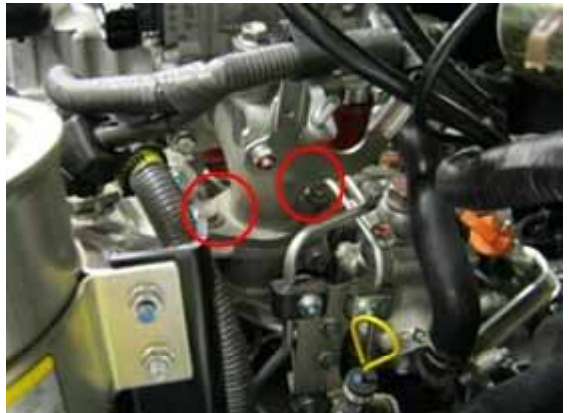
21. Install the 2 EGR valve flange bolts along with a new flange gasket. Tighten the bolts to the specified torque.

Specified Torque: 41 lb. ft. (55 Nm)

NOTICE: Make certain that a new steel flange gasket is installed. Do not install the old steel flange gasket.

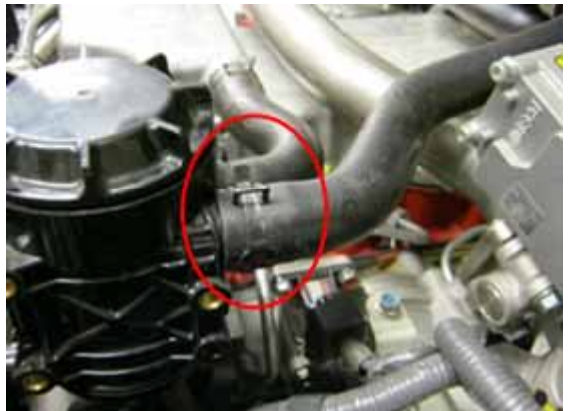
22. Install the CCV hose and position the clamp to secure the hose.

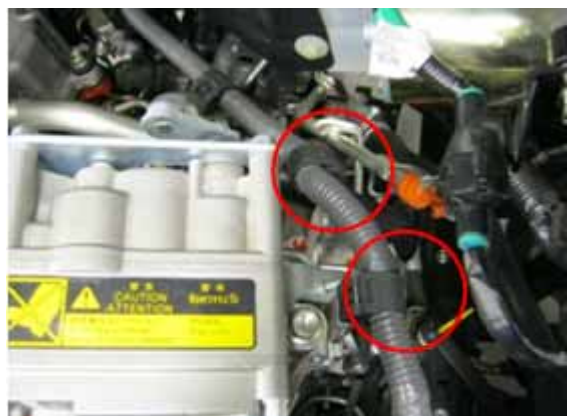
23. Connect the 2 harness clips onto their bracket.

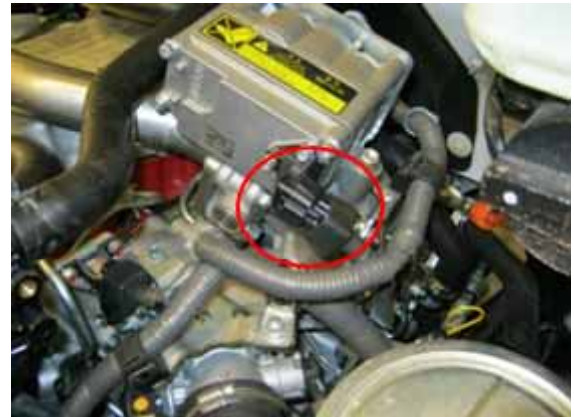
24. Connect the EGR valve electrical connector.

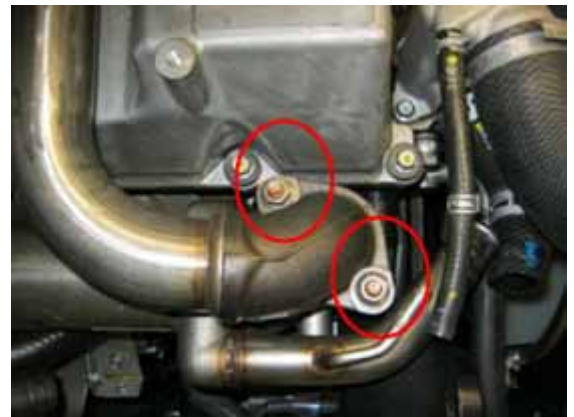
25. Install the 2 EGR cooler outlet flange nuts along with a new steel flange gasket. Tighten to bolts to the specified torque.

Specified Torque: 41 lb. ft. (55 Nm)

NOTICE: Make certain that a new steel flange gasket is installed. Do not install the old steel flange gasket.

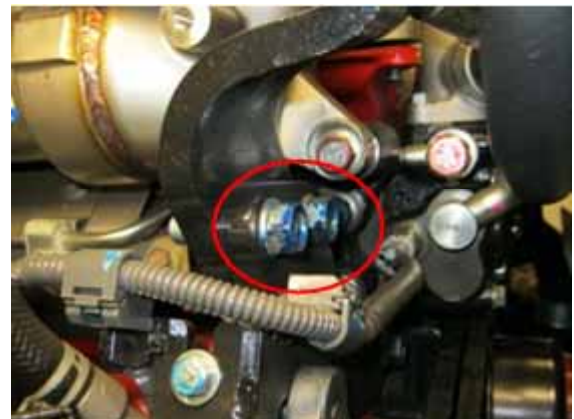
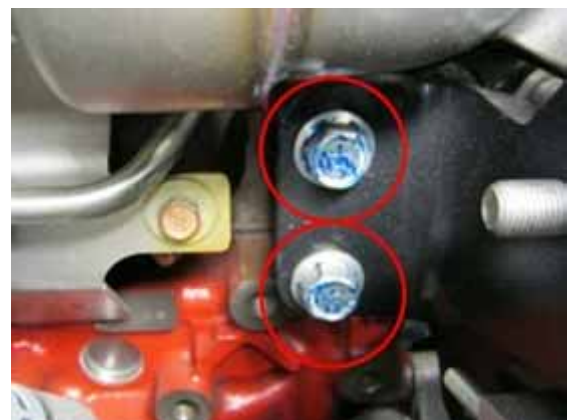
26. Install the 4 engine hanger bracket bolts and tighten to the specified torque.

Specified Torque

12mm x 1.25: 100 lb. ft. (136 Nm)

12mm x 1.50: 51 lb. ft. (68.5 Nm)

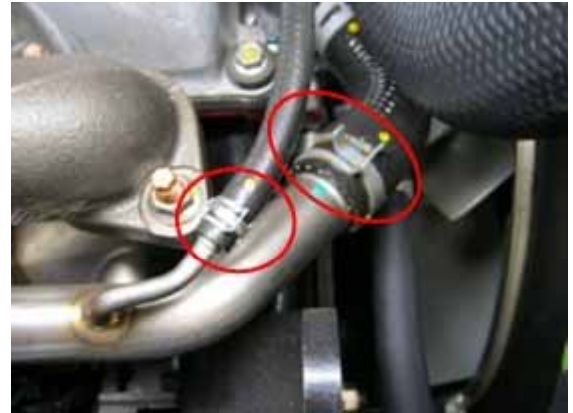
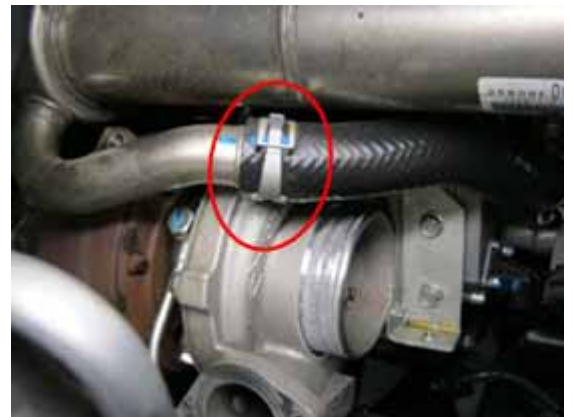
27. Reconnect the 3 EGR cooler coolant hoses and then position the spring clamps to secure each coolant hose.

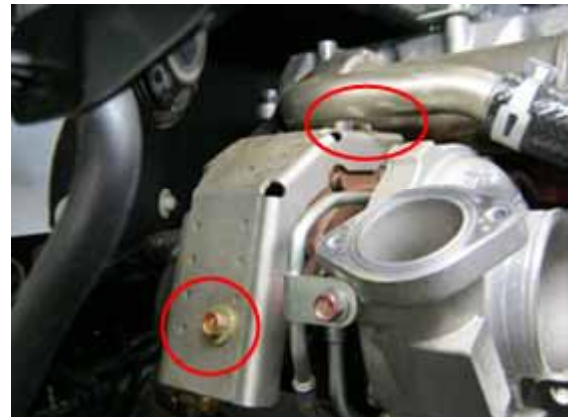
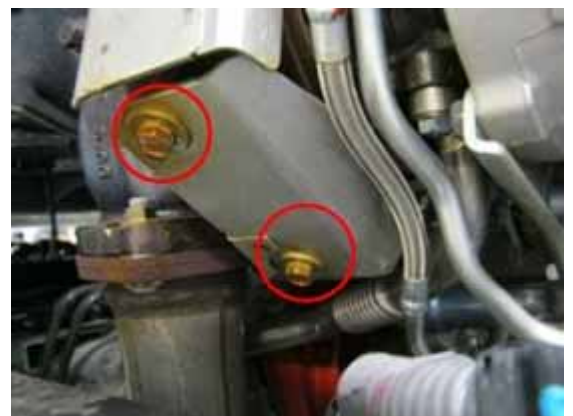
28. Install the upper and lower VNT turbocharger heat shields and bolts. Tighten the bolts to the specified torque.

Specified Torque: 21 lb. ft. (28.5 Nm)

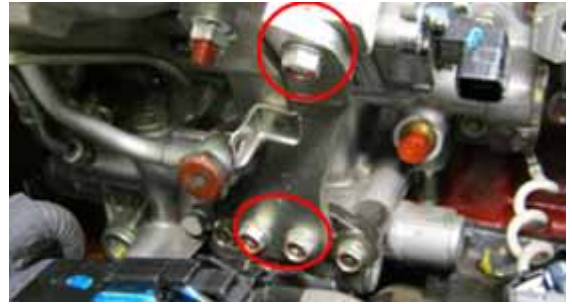
29. Install the 3 VNT turbocharger support bracket bolts and tighten to the specified torque.

Specified Torque: 21 lb. ft. (28.5 Nm)

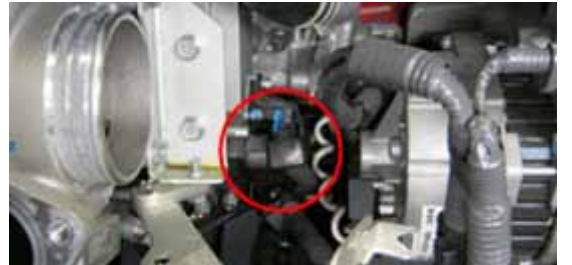
30. Reconnect the REA electrical connector.

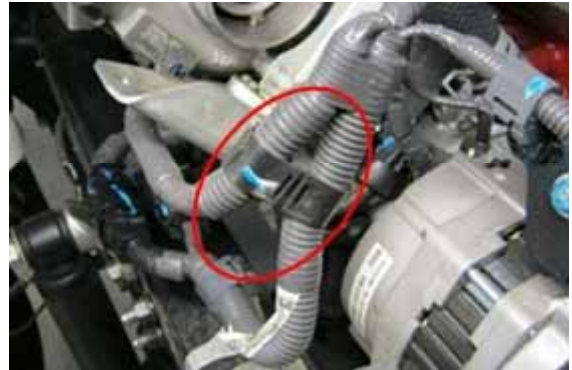
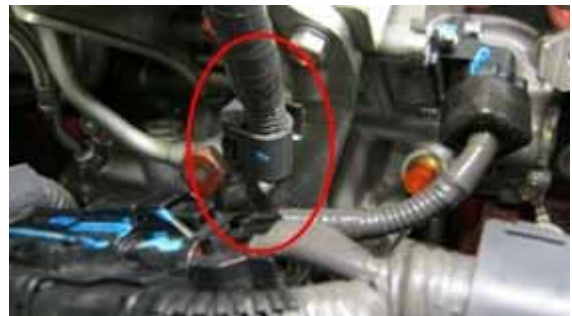
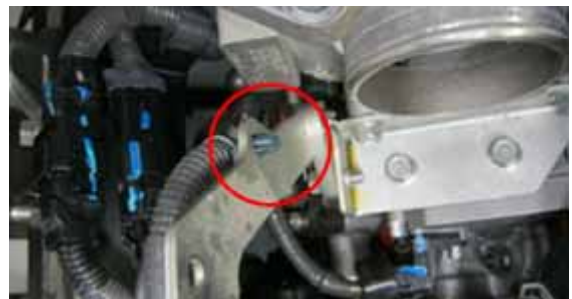
31. Reconnect the 3 harness clips to their bracket.

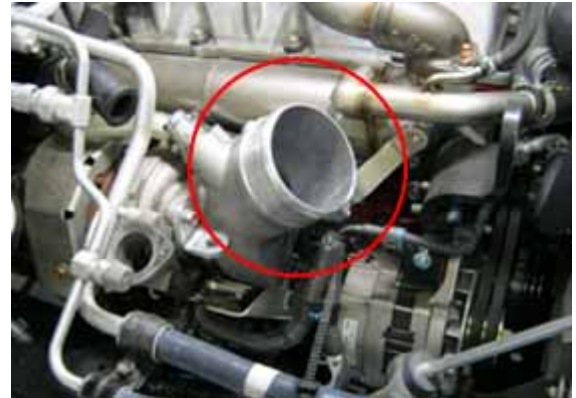
32. Install the VNT turbocharger air inlet air tube and hose assembly.

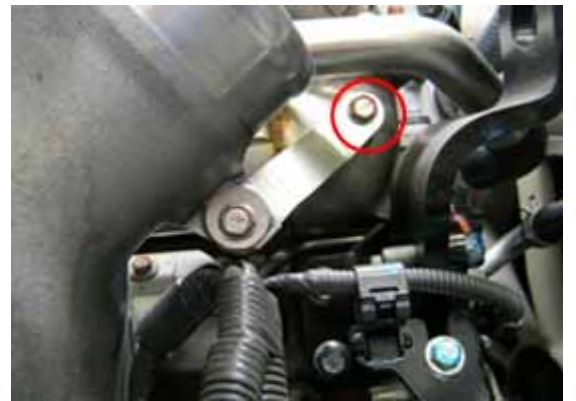
33. Install the VNT turbocharger fresh air inlet air tube bracket bolt and tighten to the specified torque.

Specified Torque: 21 lb. ft. (28.5 Nm)

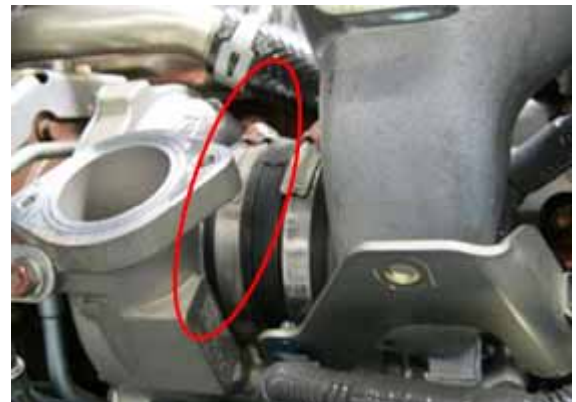
34. Position and tighten the VNT turbocharger fresh air inlet air hose clamp to the specified torque.

Specified Torque: 4 lb. ft. (5 Nm)

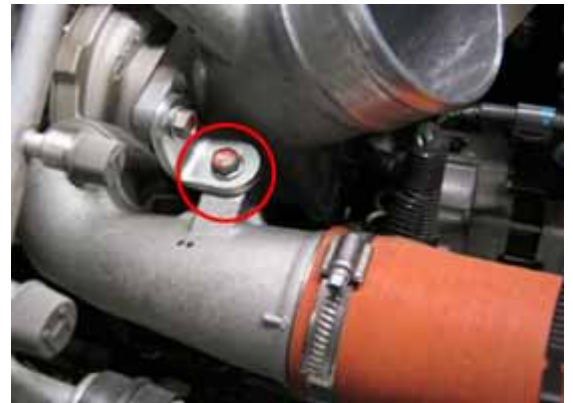
37. Install the VNT turbocharger upper outlet tube bracket bolt and tighten to the specified torque.

Specified Torque: 21 lb. ft. (28.5 Nm)

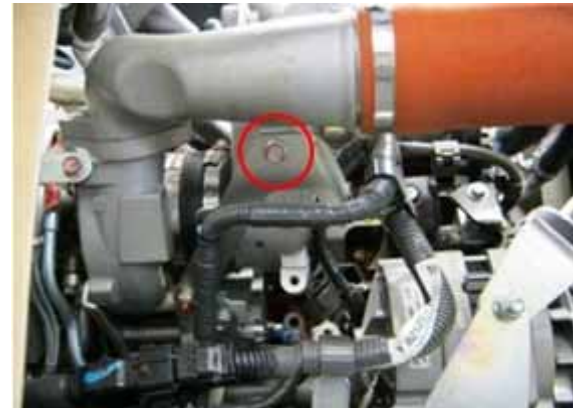
38. Install the lower VNT turbocharger outlet tube bracket bolt and tighten to the specified torque.

Specified Torque: 21 lb. ft. (28.5 Nm)

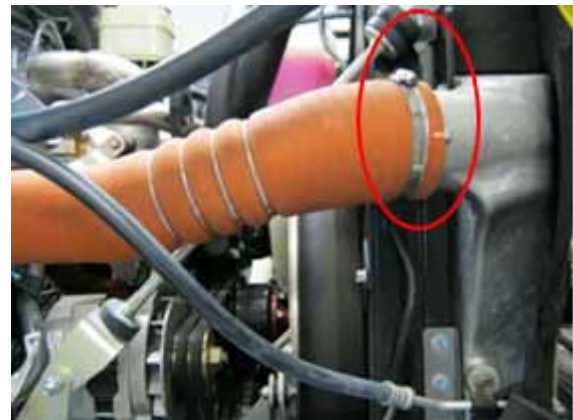
39. Tighten the VNT turbocharger outlet hose clamp at the air cooler.

Specified Torque: 5 lb. ft. (6 Nm)

NOTICE: Make certain that both mating surfaces of the hose connection are free from grease before reassembly.

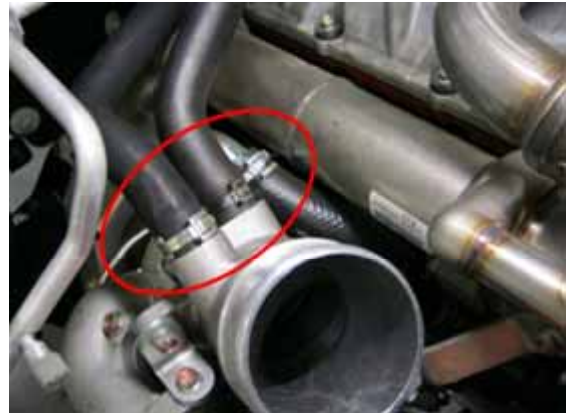
- 40.** Install the crankcase and air compressor breather hoses. Position both clamps to secure each hose.

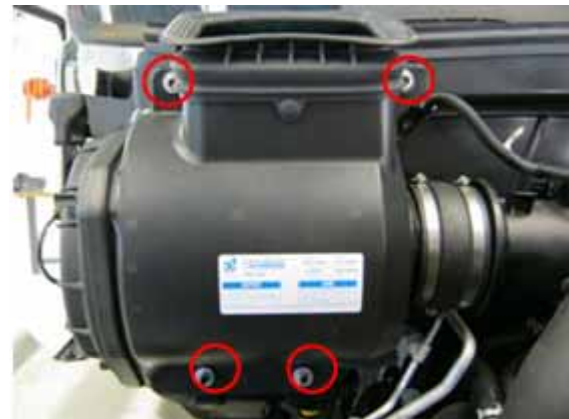
- 41.** Install the air box and fresh air hose assembly. Install the spacers, rubber bushings and 4 nuts. Tighten to the specified torque.

Specified Torque: 18 lb. ft. (25 Nm)

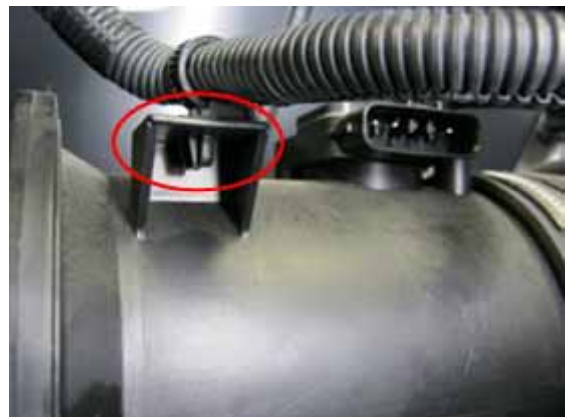
- 42.** Connect the Air Flow Sensor harness clip.

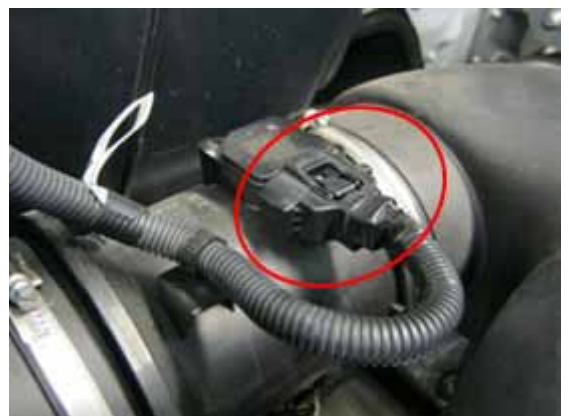
- 43.** Connect the Air Flow Sensor electrical connector.

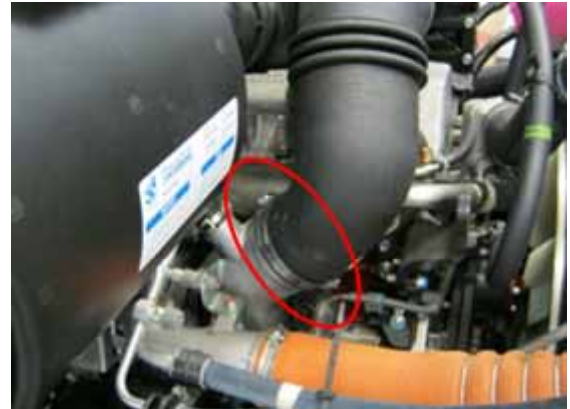
44. Install the fresh air inlet tube and tighten the hose clamp to the specified torque.

Specified Torque: 4 lb. ft. (5 Nm)

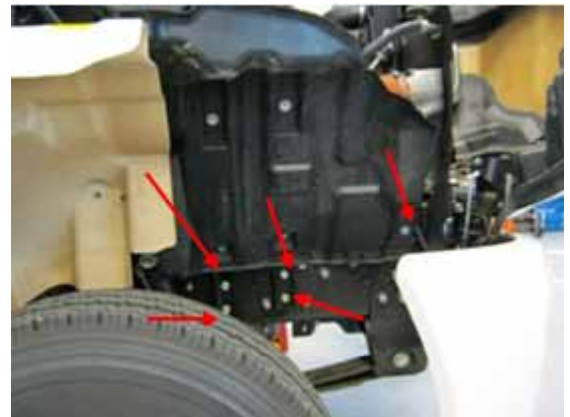
45. Install the passenger side inner splash shield and tighten the bolts to the specified torque.

Specified Torque:

10mm x 1.25: 44 lb. ft. (60 Nm)

8mm x 1.25: 21 lb. ft. (28.5 Nm)
