## SERVICE CAMPAIGN BULLETIN

**TITLE :** IRIS reception and operational stability issues

**DOCUMENT # :** 11 M 012

**AFFECTED VEHICLES :** 12C Coupe

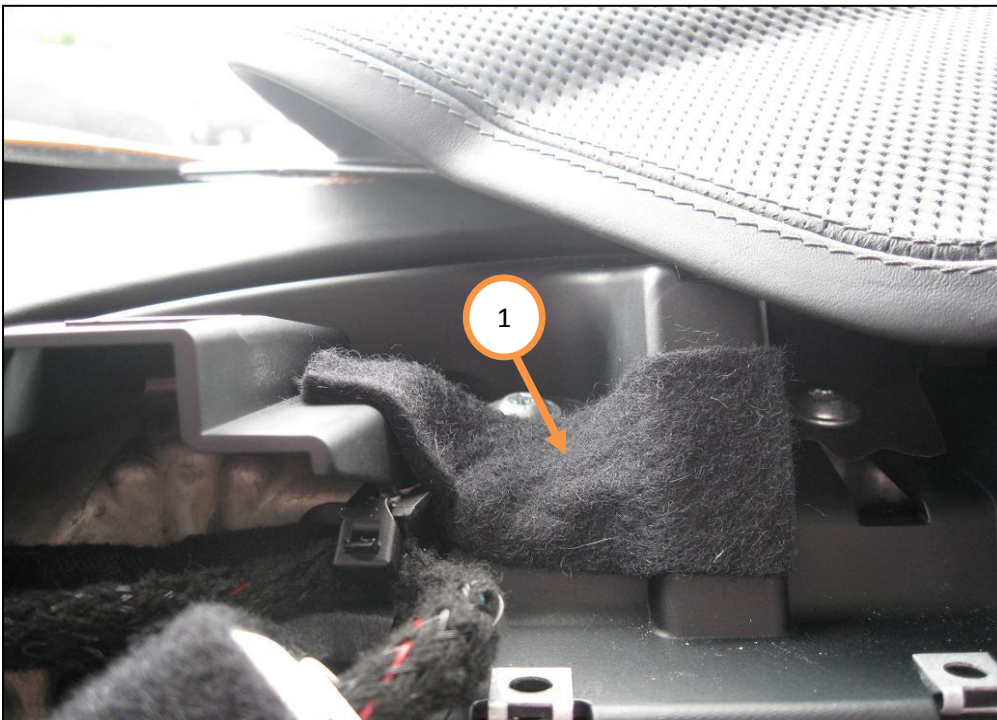
14. Apply 120mm of felt tape to the facia assembly as shown (1).

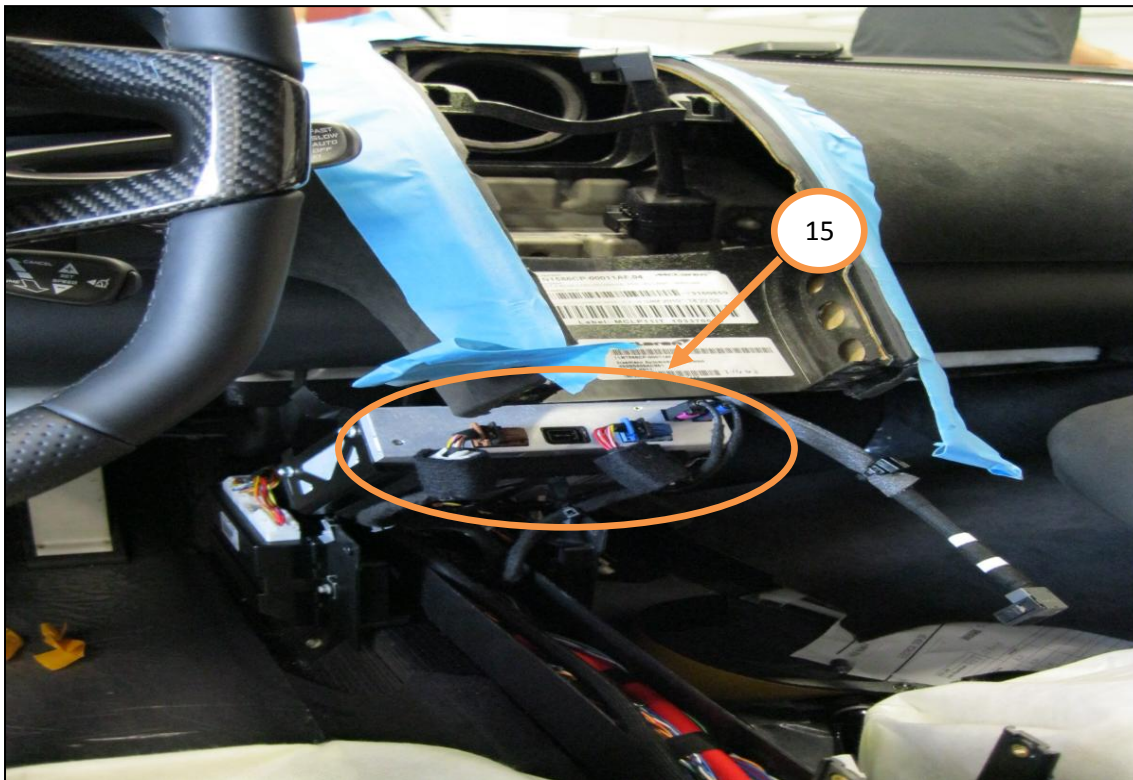
23. The image is displayed below of the fitted ferrites and felt tape attached to the IRIS branches with the connectors inserted into HVAC control unit (15).

**Care point:** Ensure that the ferrite is closed firmly.
