## SERVICE CAMPAIGN BULLETIN

**TITLE :** Fitment of Cobra Tracker RF aerial extension to left hand drive vehicles

**DOCUMENT # :** 11 Q 002

**AFFECTED VEHICLES:** 12C Coupe

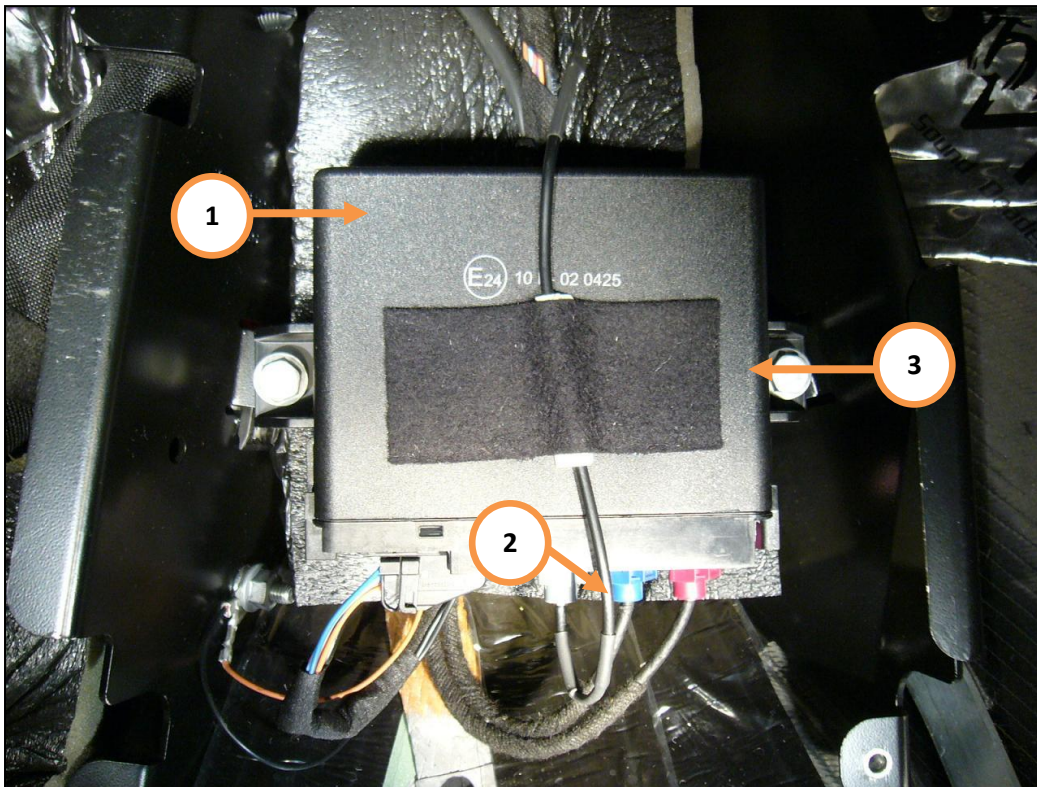
1. The existing Cobra Tracker Module (1) RF antenna (2) and felt tape (3) are fitted to the vehicle as shown:

**SITUATION :** Quality Engineering at McLaren Automotive have identified that an incorrectly routed RF antenna can lead to erroneous Cobra Tracker faults.

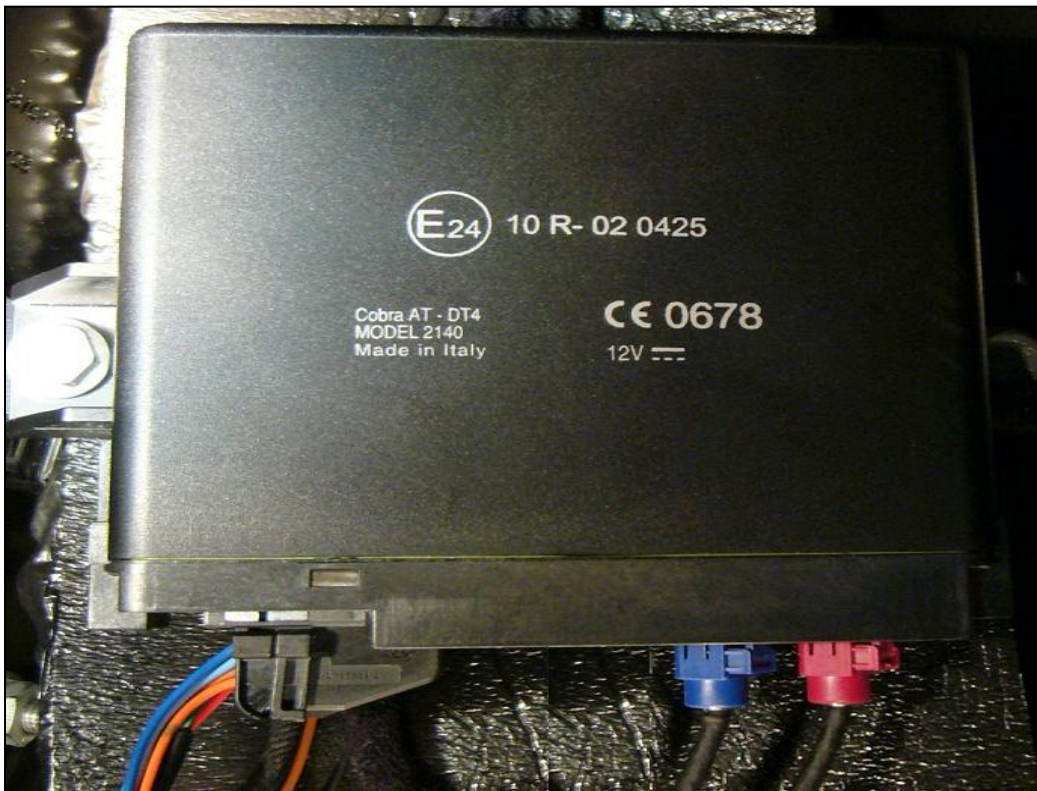
2. Remove the RF antenna and felt tape as shown. At this point remove the Cobra Tracker unit.

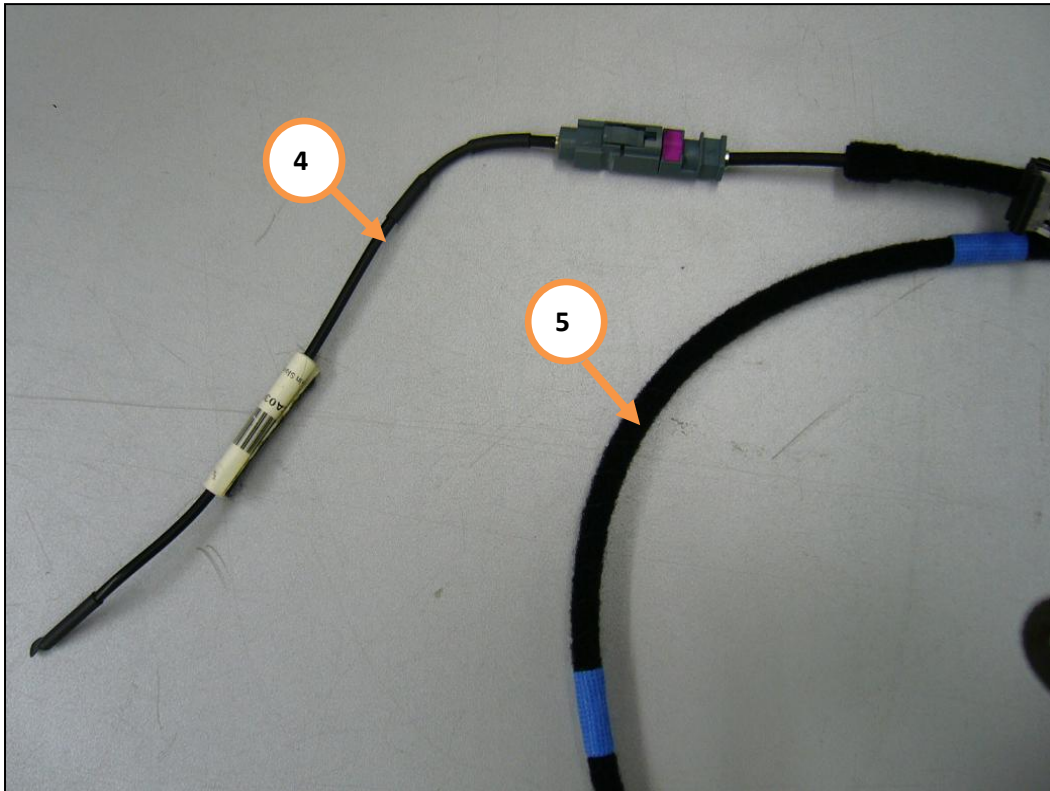
3. Fit original RF antenna (4) from the Cobra Tracker module to the new Extension cable (5).

**Care point:** The original RF antenna should be threaded in first.

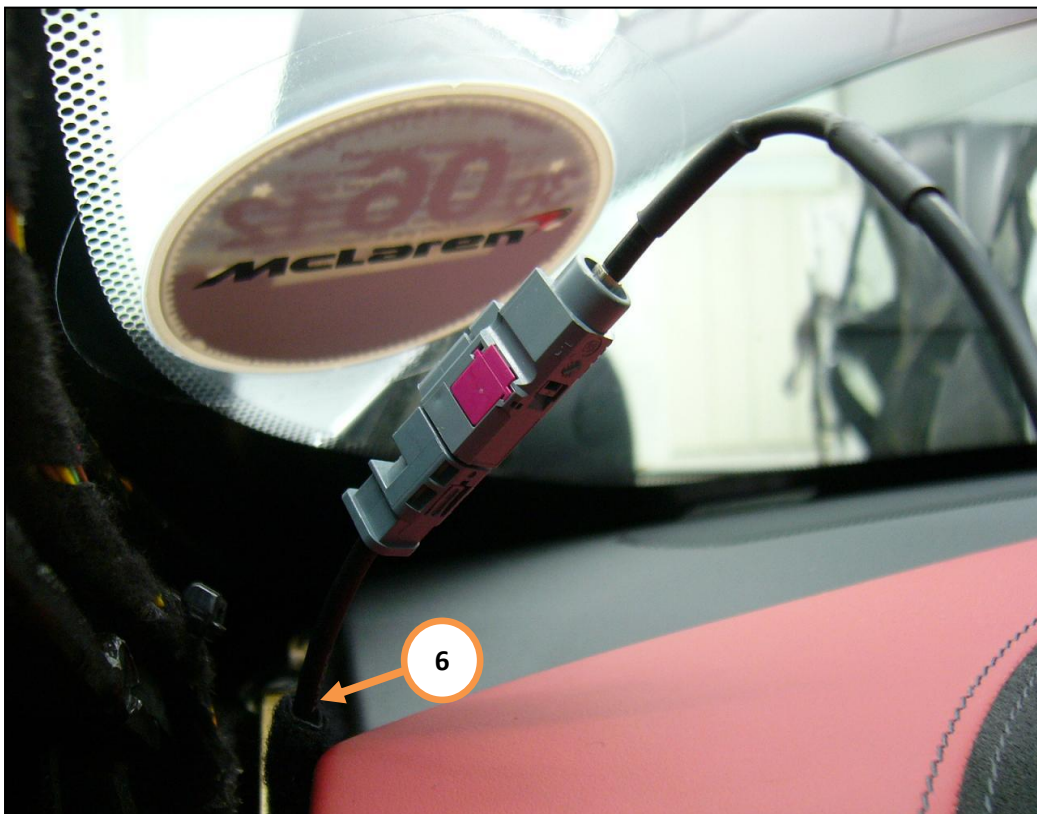
4. Thread the extension cable between the A-Pillar casting and the fascia (6).

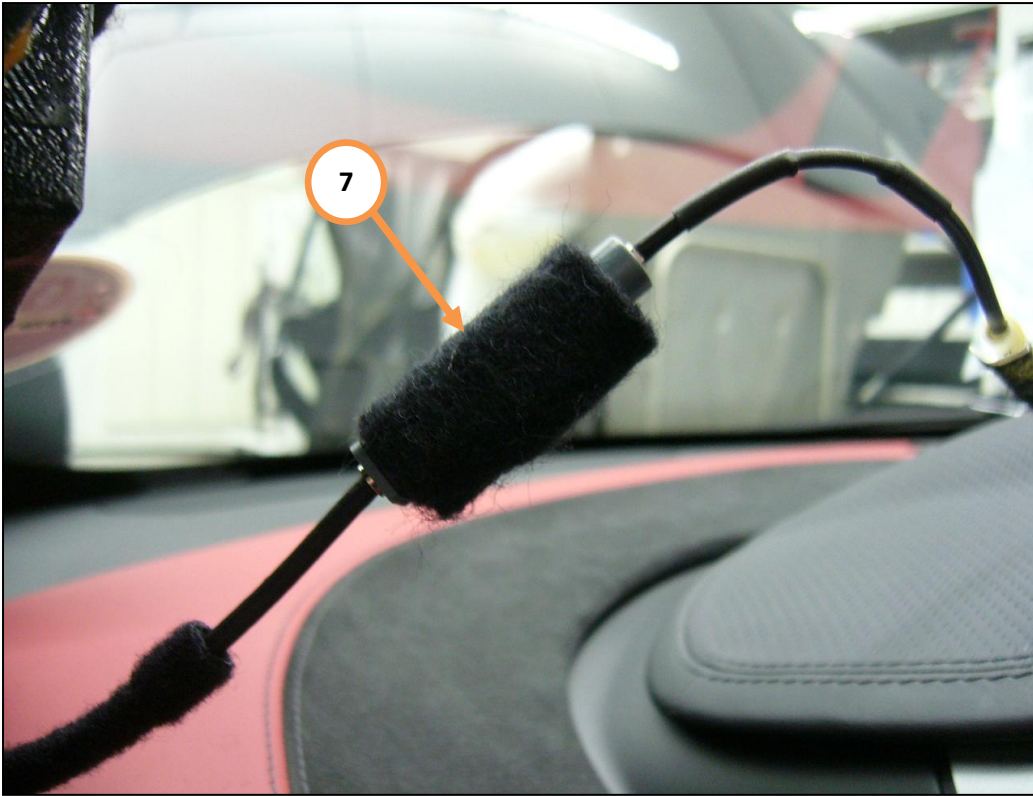
5. Wrap the inline connection with Felt Tape (7) to prevent noise and vibration issues by rattling against the A-Pillar.

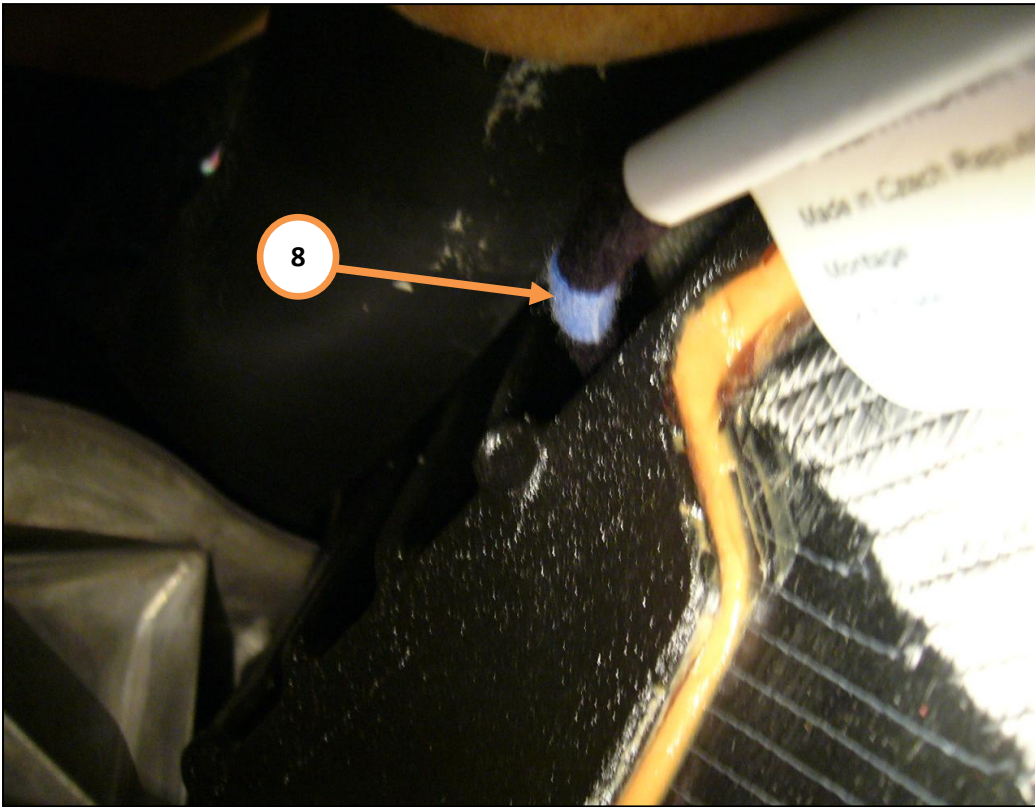
8. Working under the facia pull the extension cable through until the label and blue band (8) are visible.

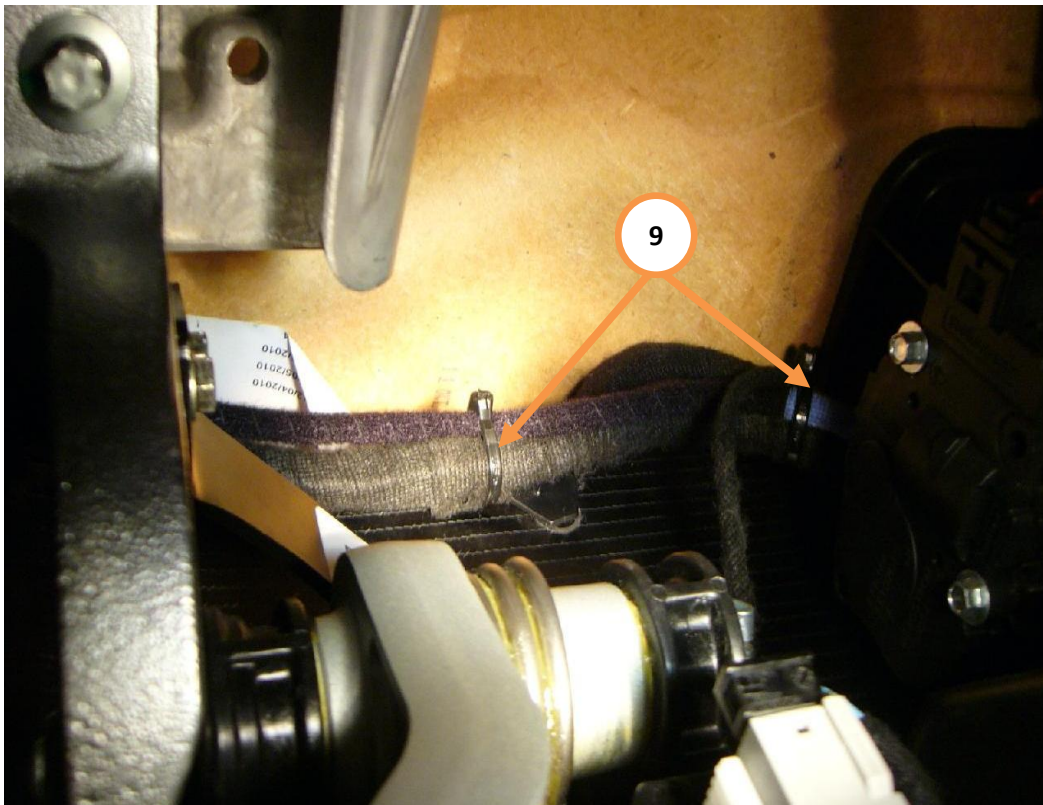
9. Tie wrap extension cable to the main body harness (9).

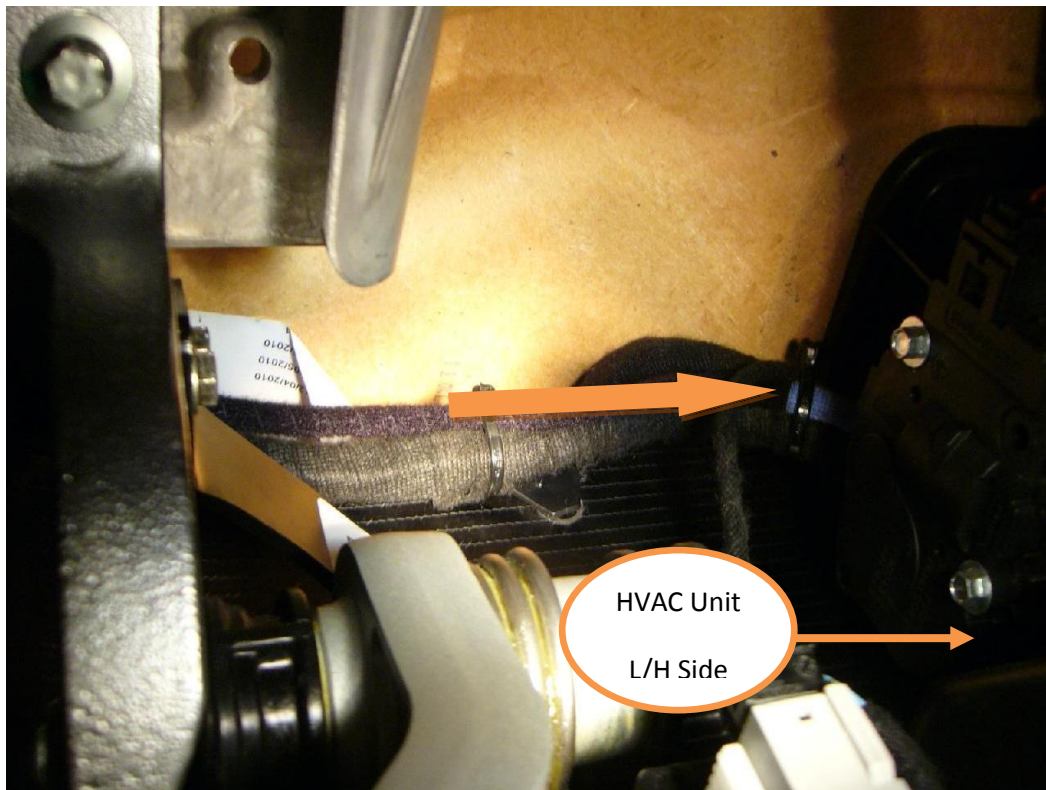
10. Pass extension cable over the left hand side of the HVAC unit following the main body of the direction of the arrow.

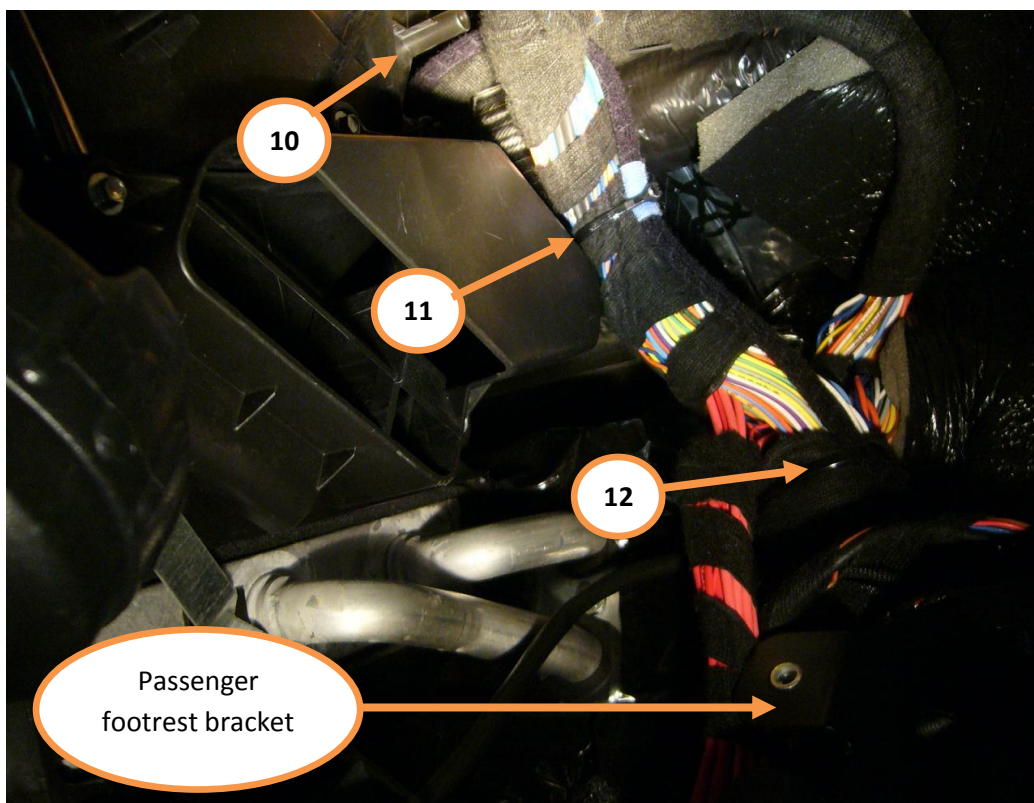
11. Retrieve antenna extension from the right hand side of the HVAC unit (10). Tie wrap antenna extension to the main body harness around the blue band (11) then route the antenna extension towards the passenger foot rest bracket following the main body harness (12).

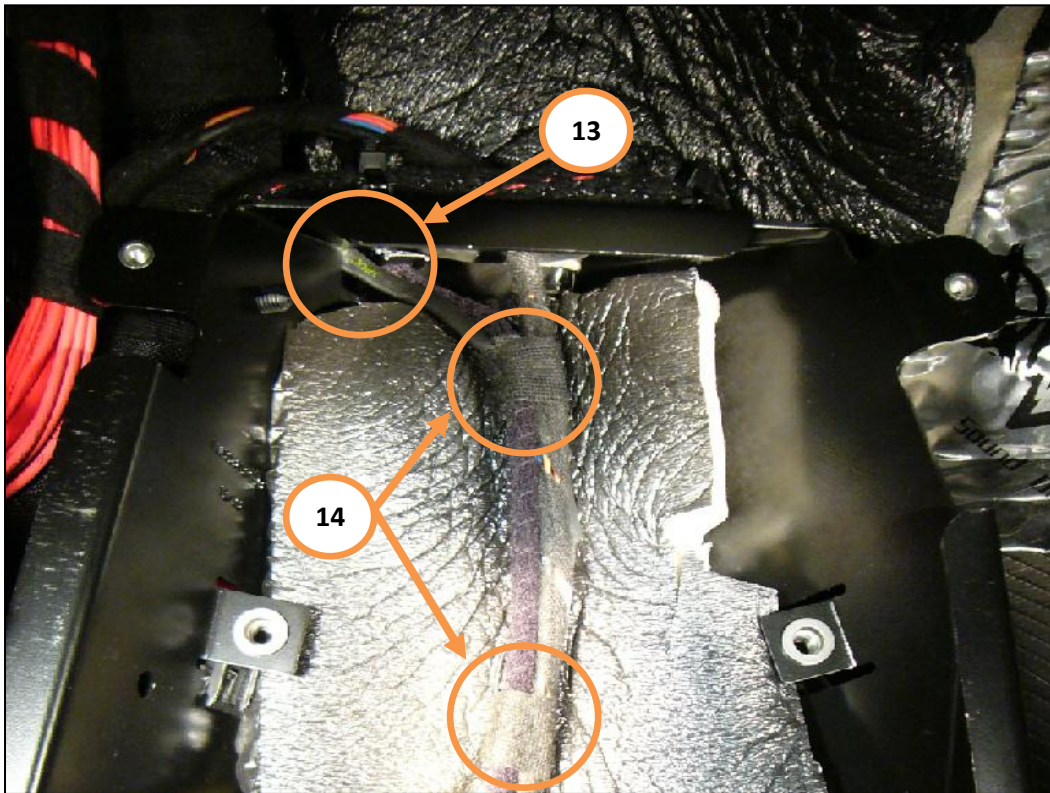
12. Clip the antenna extension to the passenger footrest bracket using the edge clip supplied on the cable (13).  
Spot tape the antenna extension cable to the main body harness using 19 mm Fleece tape (14).

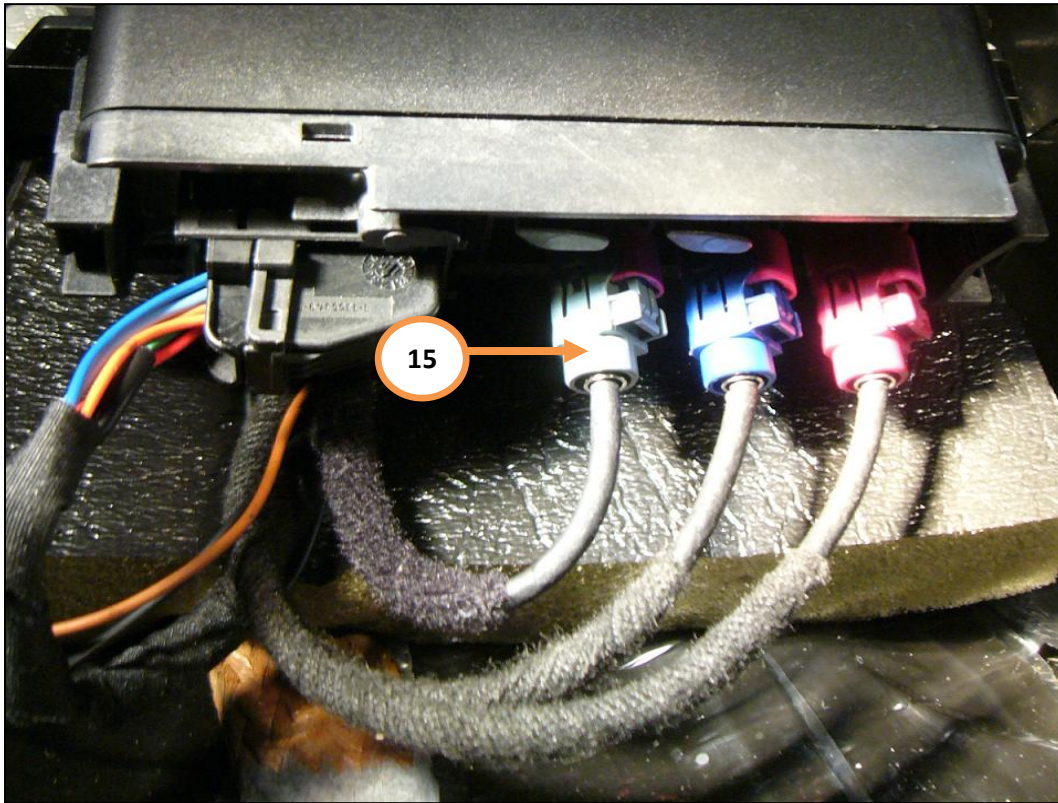
13. Re-fit tracker module ensuring that the fixings are tightened to 6 Nm. The new antenna extension fits into the Tracker Module as shown (15).

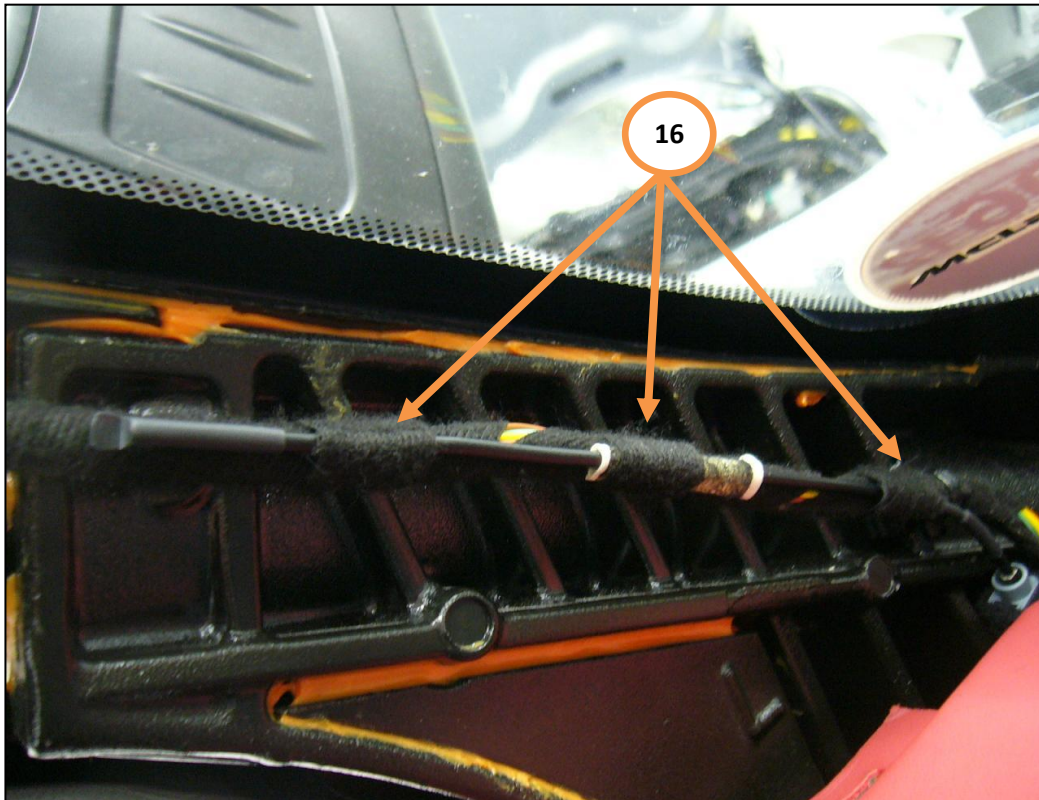
14. Spot tape the original RF antenna to the roof harness using 19 mm fleece tape (16).
