Service Bulletin

Bulletin No.: PI0809

Subject: Whistle or Whine Type Noise Coming from Front Windshield at Highway Speeds

Models: 2012 Chevrolet Cruze
Condition/Concern

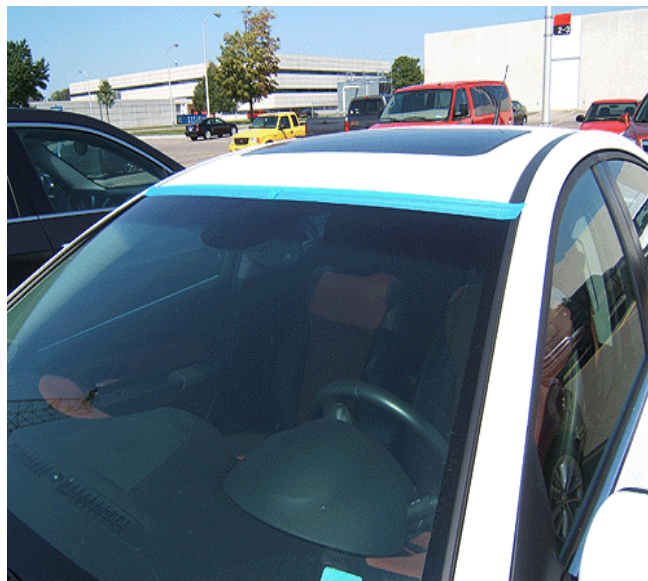
2907759

Some customers may comment on a whistle or whine type noise coming from the front windshield area at highway speeds. The noise is most prevalent at the top of the windshield on the passenger side. This condition is most noticeable in ambient temperatures greater than 26°C (80°F).

This condition may be caused by the windshield lace (upper outer molding) vibrating against the roof panel.

2. With the condition confirmed, apply tape along the top of the windshield upper outer molding (lace) as shown.
3. Road test the vehicle again to verify the noise has been eliminated with the tape in place.
4. Continue road testing the vehicle. Remove the tape in sections starting in the middle and working toward the outside. Using this method, determine where the noise is originating.
5. With the area identified, mark the section that is causing the noise. Remove the masking tape.
