# Service Bulletin

Bulletin No.: PI0830

**Subject:** Water Intrusion (Leak), Rear Side Door Stationary Window

**Models:** 2012 Chevrolet Sonic Sedan

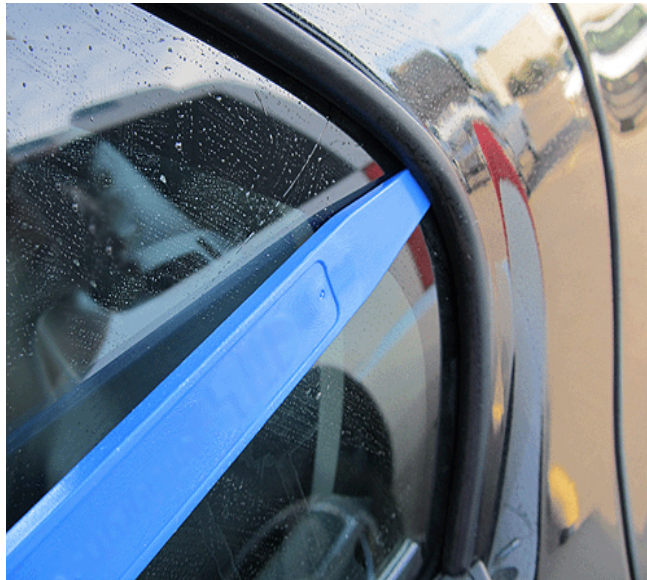
2914589

Some customers may comment on a water intrusion (leak) condition on the left or right rear door around the perimeter of the stationary window.

This condition may be the result of a poor fit between the glass and rubber seal. This condition only occurs on sedan bodied vehicles. The hatchback uses a different window assembly.

1. Remove the outer window sealing strip (belt molding) on the affected door. Refer to Rear Side Door Window Outer Sealing Strip Replacement (Sedan) in SI. Use care to not damage the sealing strip when removing.
