# Service Bulletin

Bulletin No.: PI0852

**Subject:** Carpet Pulls Loose from Under Console

**Models:** 2012-2013 Chevrolet Corvette  
Built Prior to October 15, 2012

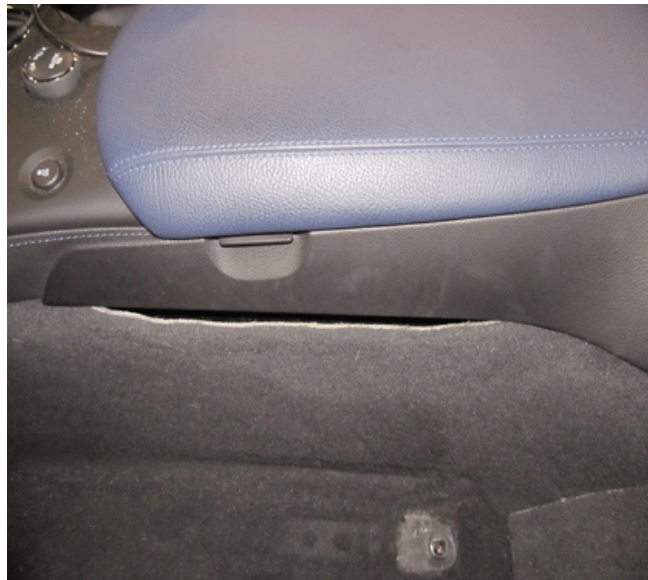
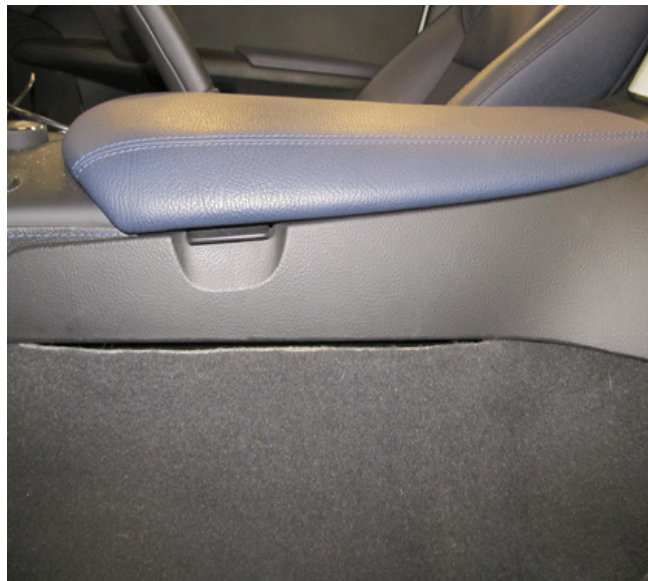
Some customers may comment that the carpet is loose and pulled away from under the console and will not stay tucked in.

Technicians should cut slots in the carpet at the door inside manual release actuator and shift the carpet to fit under console following the procedure below:
