# Service Bulletin

Bulletin No.: PI0869

**Subject:** Driver Carpet Footrest Cover Loose or Dislodged from Carpet Base

**Models:** 2013 Cadillac ATS  
Built Prior to October 8, 2012

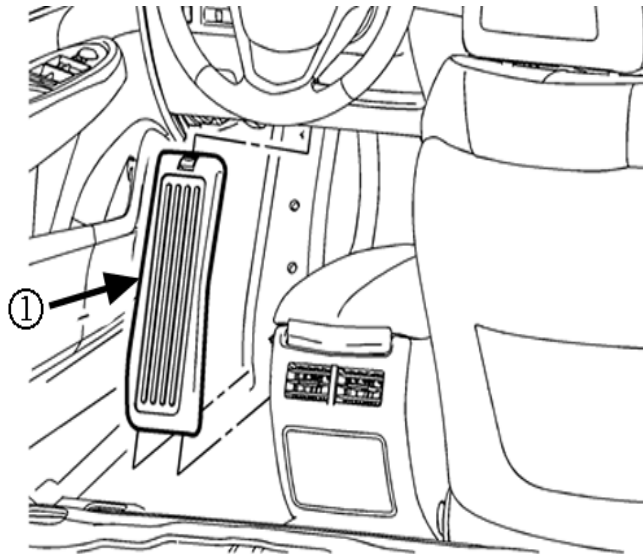
3213875

1. Completely remove the footrest cover (1) from the carpet base. Refer to Driver Footrest Replacement in SI.

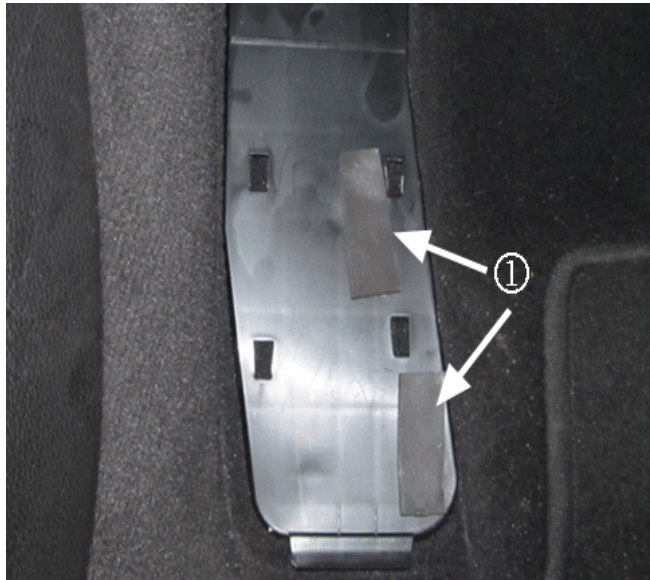
3213877

2. Inspect the carpet footrest base for any foam tape (1) or adhesive residue and remove as necessary. Clean the base with rubbing alcohol or equivalent.
3. Before the hot melt is applied, practice installing the cover several times to the base. Note that the cover has retaining tabs that must slide into the lower edge of the base first, then snap into the base at the top.

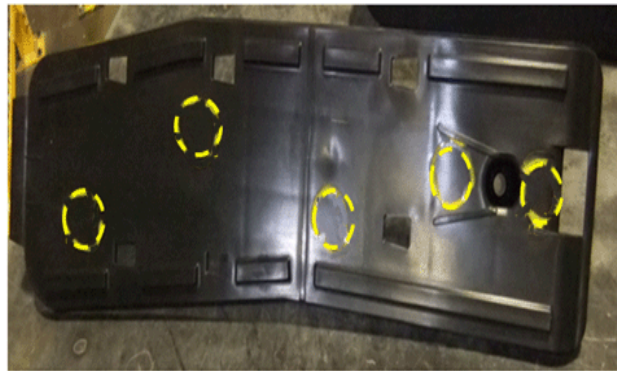
3213878

**Note:** The approximate locations for the hot melt application are shown in the illustration above.

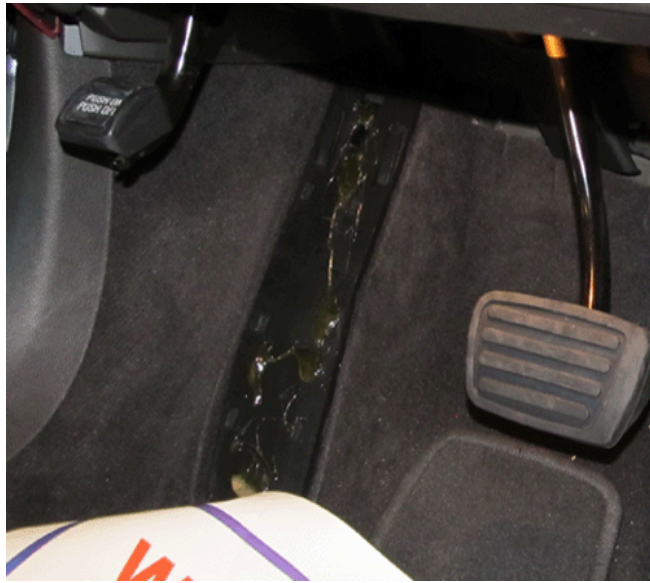
3213879

4. Using a heat gun, carefully apply five nickel size pools of hot melt to the carpet base. Apply quickly to help minimize the glue running down the base.

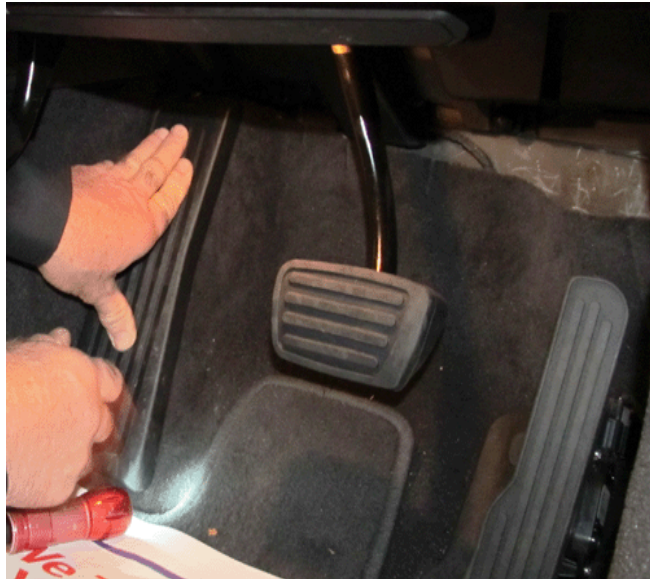
3213880

**Note:** The hot melt should cure in approximately 30 seconds, plus another 15 seconds to ensure the glue is cooled and cured.

5. Immediately install the cover to the base, then firmly press and hold the cover to the base for approximately 45 seconds. Do not disturb the cover for a few minutes, allowing it to fully cure.
