Service Bulletin

Bulletin No.: PIC5136L

Subject: Clicking Noise From Front Wheels

Models: 2009 - 2013 Cadillac CTS-V Models
Built Prior to VIN Breakpoint D0106083

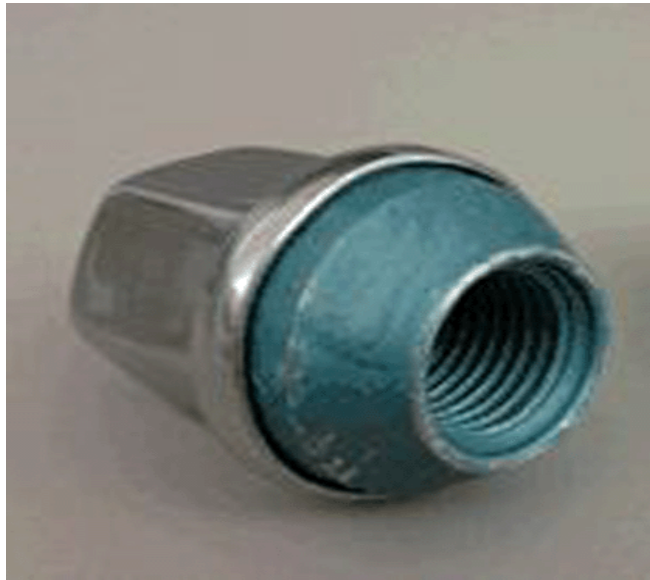
2905436

4. Reinstall wheels using replacement wheel nuts with P/N 9598179 (quantity 20 required for all 4 wheels) (these can be identified with a blue color on the inboard conical portion of the nut (see pic) and torque them to 190 Nm.

Note: If a car had the 2-piece rotors installed (P/N 20795300 & 20795302) prior to the release of these "blue cone" wheel nuts and has a repeat wheel click concern, perform this cleaning procedure, replace the wheel nuts with the new blue cone nuts, and torque to 190 Nm.
