# Service Bulletin

Bulletin No.: 12-09-41-001A

**Subject:** Information on Counterfeit Airbag Modules

**Models:** 2010-2011 Buick LaCrosse  
2006-2010 Chevrolet Aveo  
2011-2012 Chevrolet Camaro, Cruze, Volt

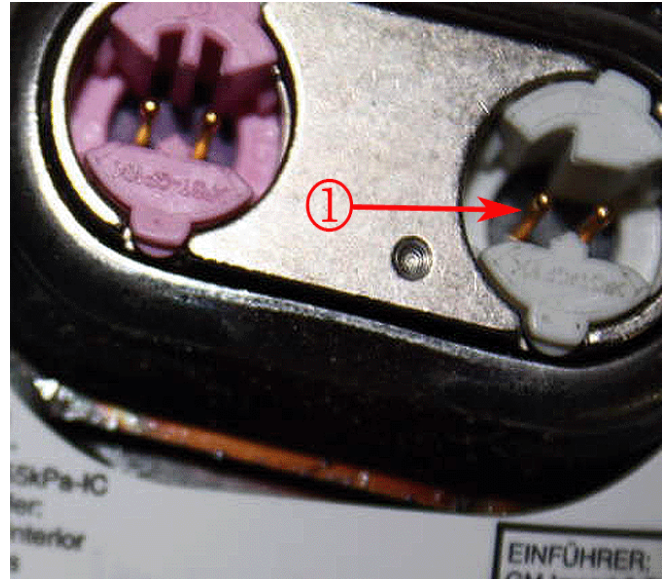
2918044

Vehicles that are the subject of this service information all have airbag modules equipped with "shorting bars" (2) incorporated in the electrical connectors. Grounding terminals or "shorting bars" on the inflator wire connectors prevent the air bag from deploying when disconnected from the vehicle system are missing this counterfeit airbag.

### Shorting Bars Missing

In the photos above you can identify the grounding terminals or shorting bars (2). In all cases the shorting bars appear as a gold plated U-shaped piece of metal on genuine GM airbags. Counterfeit modules (1) often omit these secondary contacts.

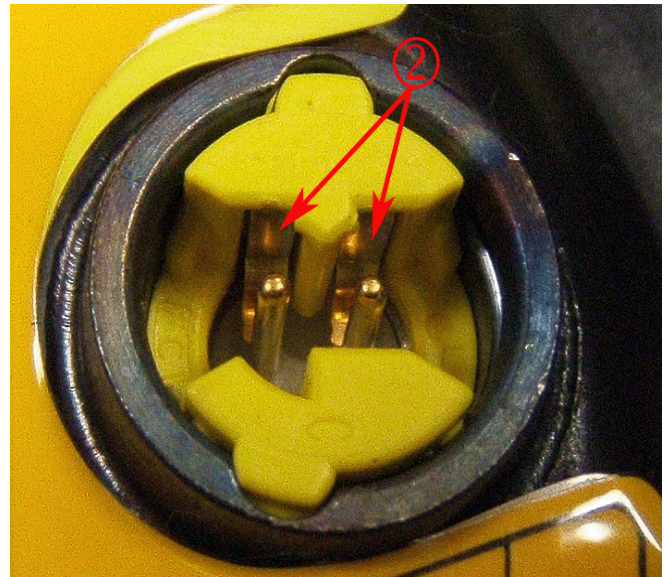
2918141

### Shorting Bars Present

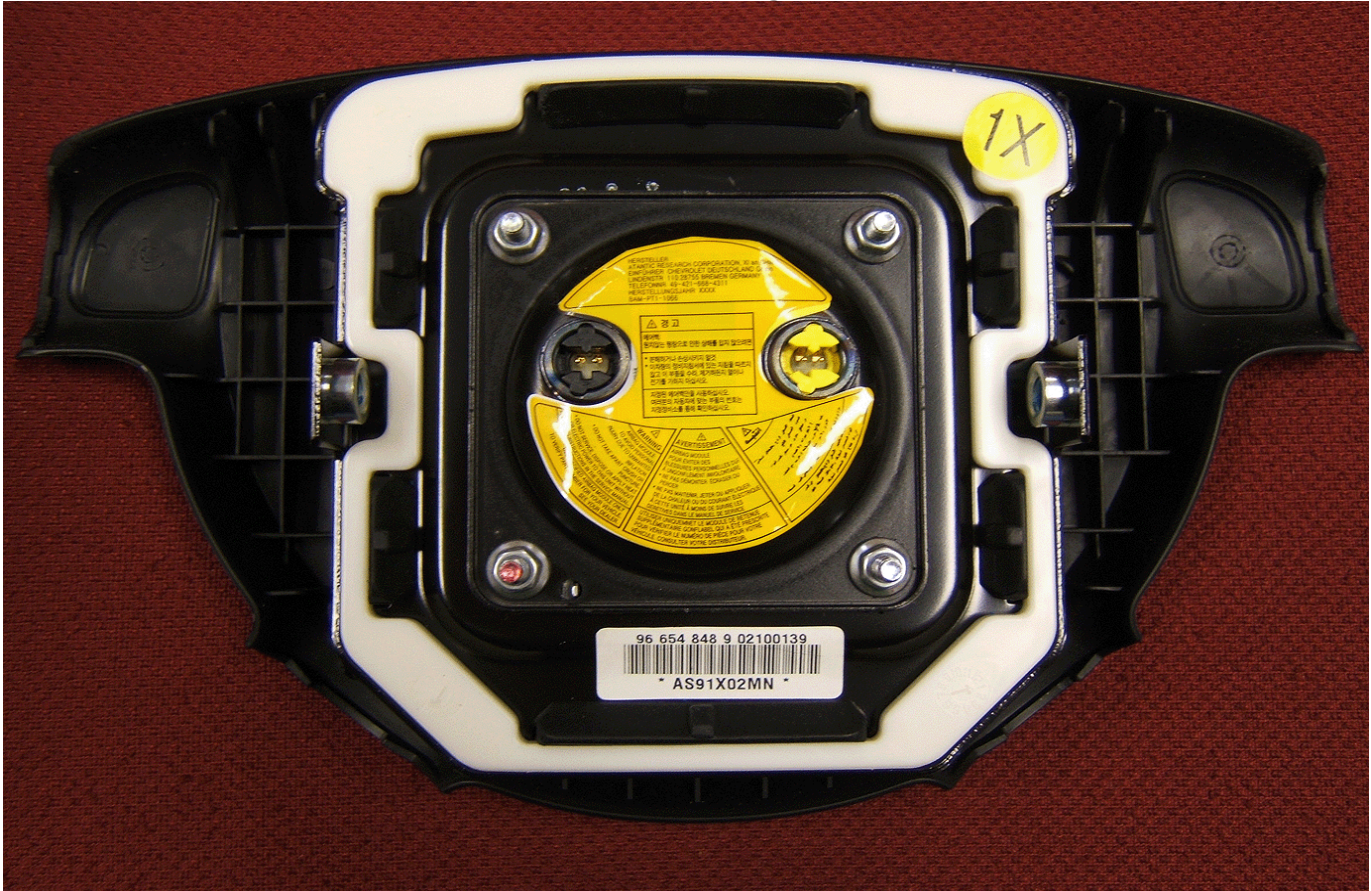
2918128

The Chevrolet Aveo uses a metal backed airbag module that is painted black. The physical appearance of the module should exactly match the picture below.

**Genuine Aveo Airbag Module**

Look for inconsistent materials, stickers, additional holes in the module, or any signs of tampering.

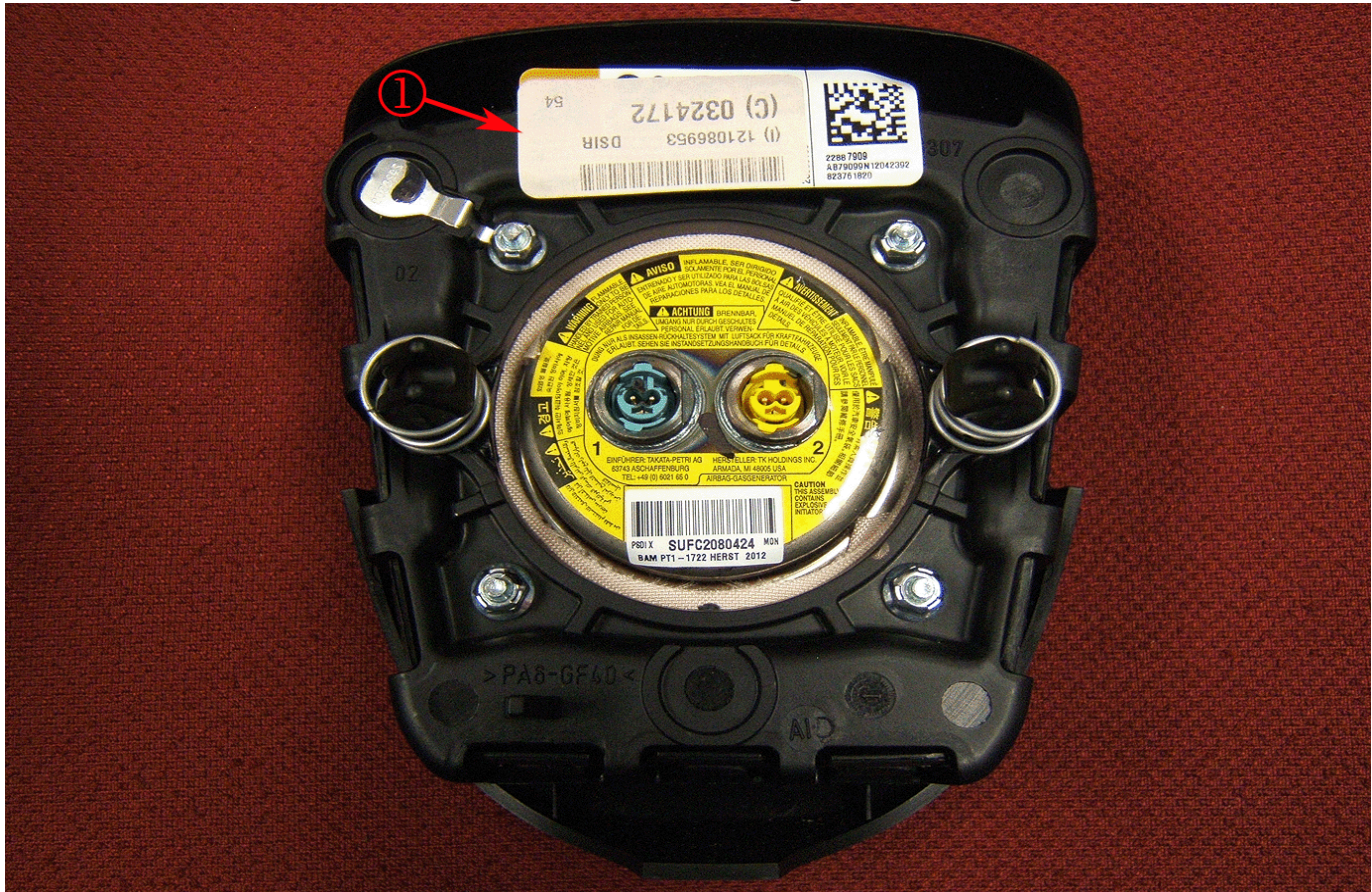
2918131

The Chevrolet Camaro uses a plastic backed airbag module black in color. The physical appearance of the module should exactly match the picture below.

## Genuine Camaro Airbag Module

Look for inconsistent materials used, variation in the caution sticker, additional holes in the module, or any signs of tampering. The paper label (1) may be present, removed or placed at a different location on the module. This paper label should not be considered critical in validating the authenticity of this module.

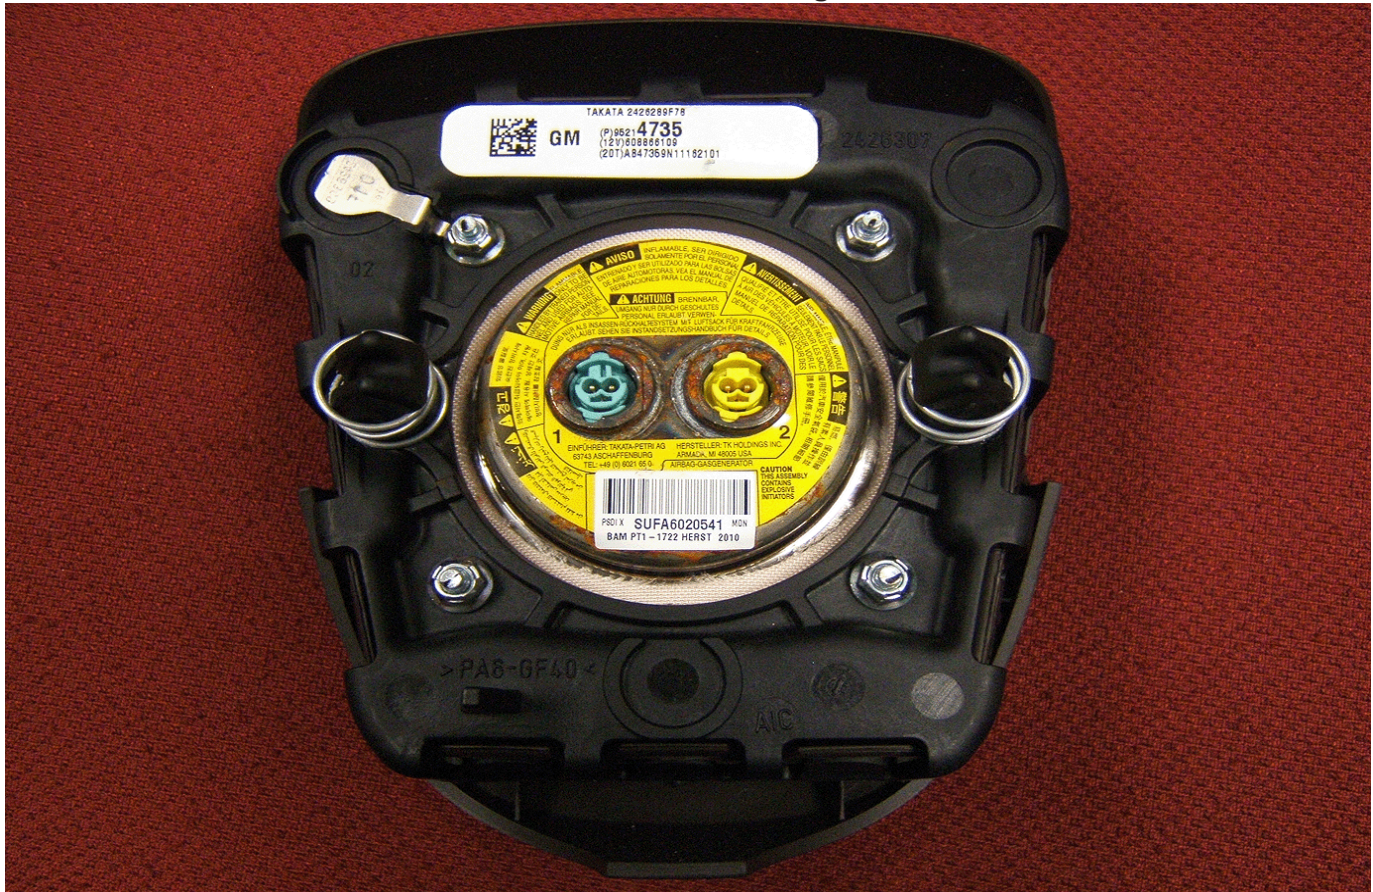
2918132

The Chevrolet Cruze / Volt uses a plastic backed airbag module black in color. The physical appearance of the module should exactly match the picture below. One

**Important:** This example shows corrosion on the bare metal near the electrical contacts. This is a normal condition you may encounter, and is not an indication of counterfeit, remanufactured or reclaimed parts. The corrosion does not affect operation of the airbag module.

## Genuine Cruze / Volt Airbag Module

Look for inconsistent materials, stickers, additional holes in the module, or any signs of tampering.

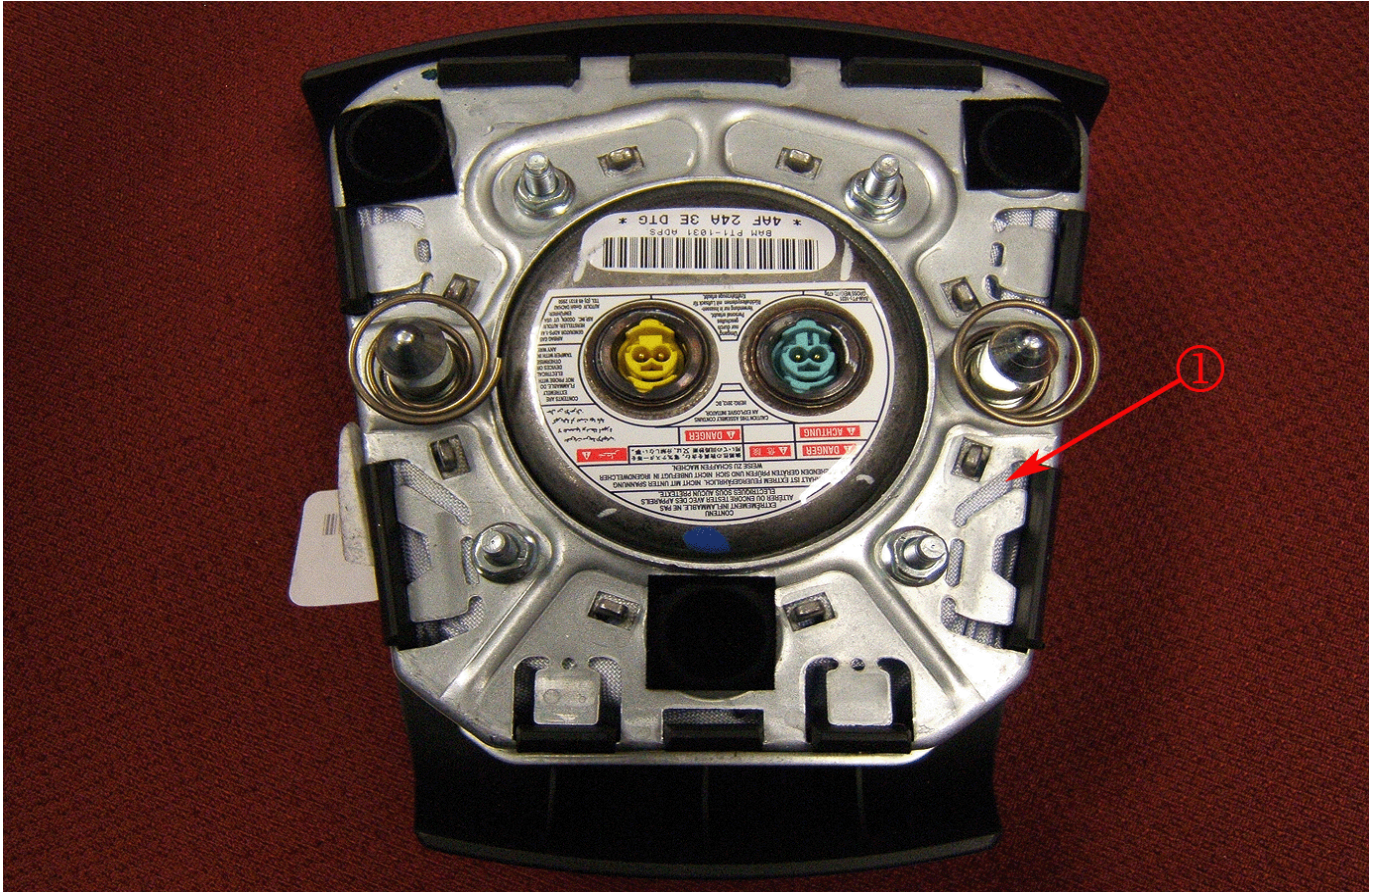
2918125

The Buick LaCrosse uses an unpainted metal backed airbag module. The physical appearance of the module should exactly match the picture below. Various part numbers are used for each application but the physical appearance is the same.

**Important:** This type of module allows the airbag (1) to be visible at several points around the edge of the module. Confirm the module has an airbag installed.

## Genuine LaCrosse Airbag Module

Look for inconsistent materials, stickers, additional holes in the module, or any signs of tampering.
