Service Bulletin

Bulletin No.: 12-09-41-001

Subject: Information on Counterfeit Airbag Modules

Models: 2006–2010 Chevrolet Aveo
2010–2011 Buick Lacrosse
2011–2012 Chevrolet Cruze
2011–2012 Chevrolet Volt
2011–2012 Chevrolet Camaro

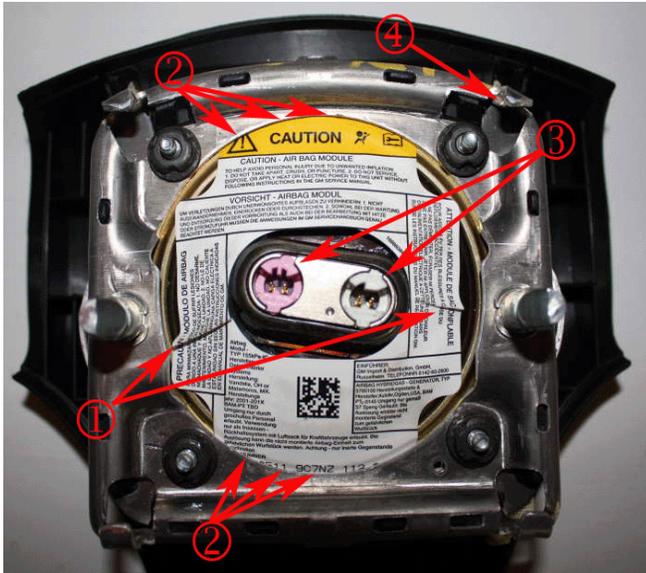
Counterfeit Airbag Module

The pictured airbag module above is a confirmed counterfeit part. Please note the following:

- The caution label applied to the back of the module is the incorrect size and shape for the module. In order to place it in the intended location the label had to be folded over (1) in two places. Additionally, caution labels, will not be tucked under the backing plate (2) as shown.
- The electrical connectors (3) on the back of the airbag module will be color coded and match the connector color on the vehicle side. These connectors are keyed for each vehicle application and should not show any signs of being re-machined or tampered with.
- Examine the module for tool marks visible on the fasteners and/or grinder marks visible on the air bag backing plate. A counterfeit air bag may have numerous holes (4) drilled/cut into it, which allows the counterfeit air bag to be installed into a wider range of vehicles.

Once the airbag module is removed there are several clues you can use to identify a counterfeit airbag module. It may be more useful to rely on the visual indications noted below as opposed to confirming part numbers or molded-in identifiers since the counterfeiter may have reproduced a correct part number or have correct molding marks because some portion of the module may be a reclaimed OEM component.

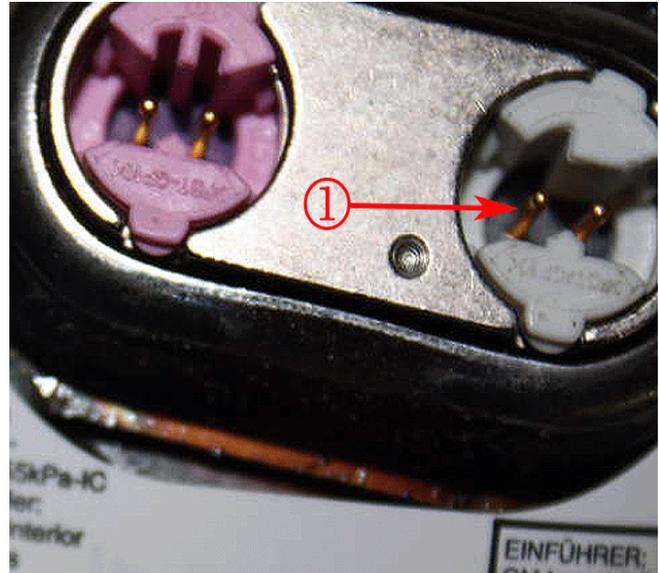
Shorting Bars Missing

Vehicles that are the subject of this service information all have airbag modules equipped with “shorting bars” (2) incorporated in the electrical connectors. Grounding terminals or “shorting bars” on the inflator wire connectors prevent the air bag from deploying when disconnected from the vehicle system are missing this counterfeit airbag.

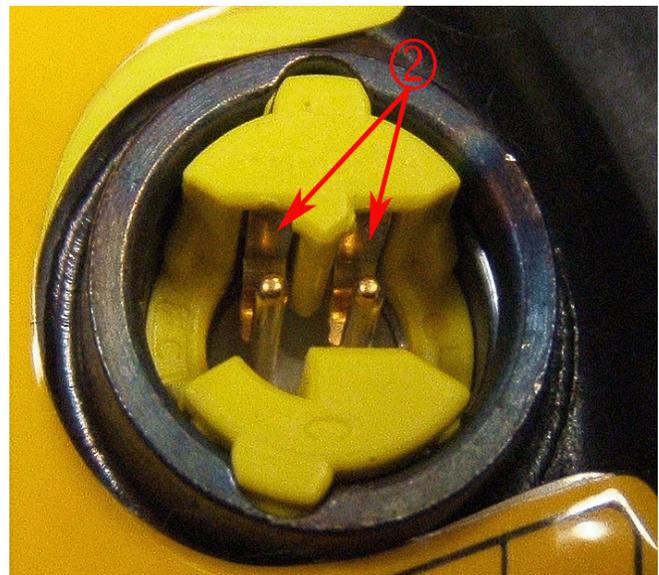
Shorting Bars Present

In the photos above you can identify the grounding terminals or shorting bars (2). In all cases the shorting bars appear as a gold plated U-shaped piece of metal on genuine GM airbags. Counterfeit modules (1) often omit these secondary contacts.

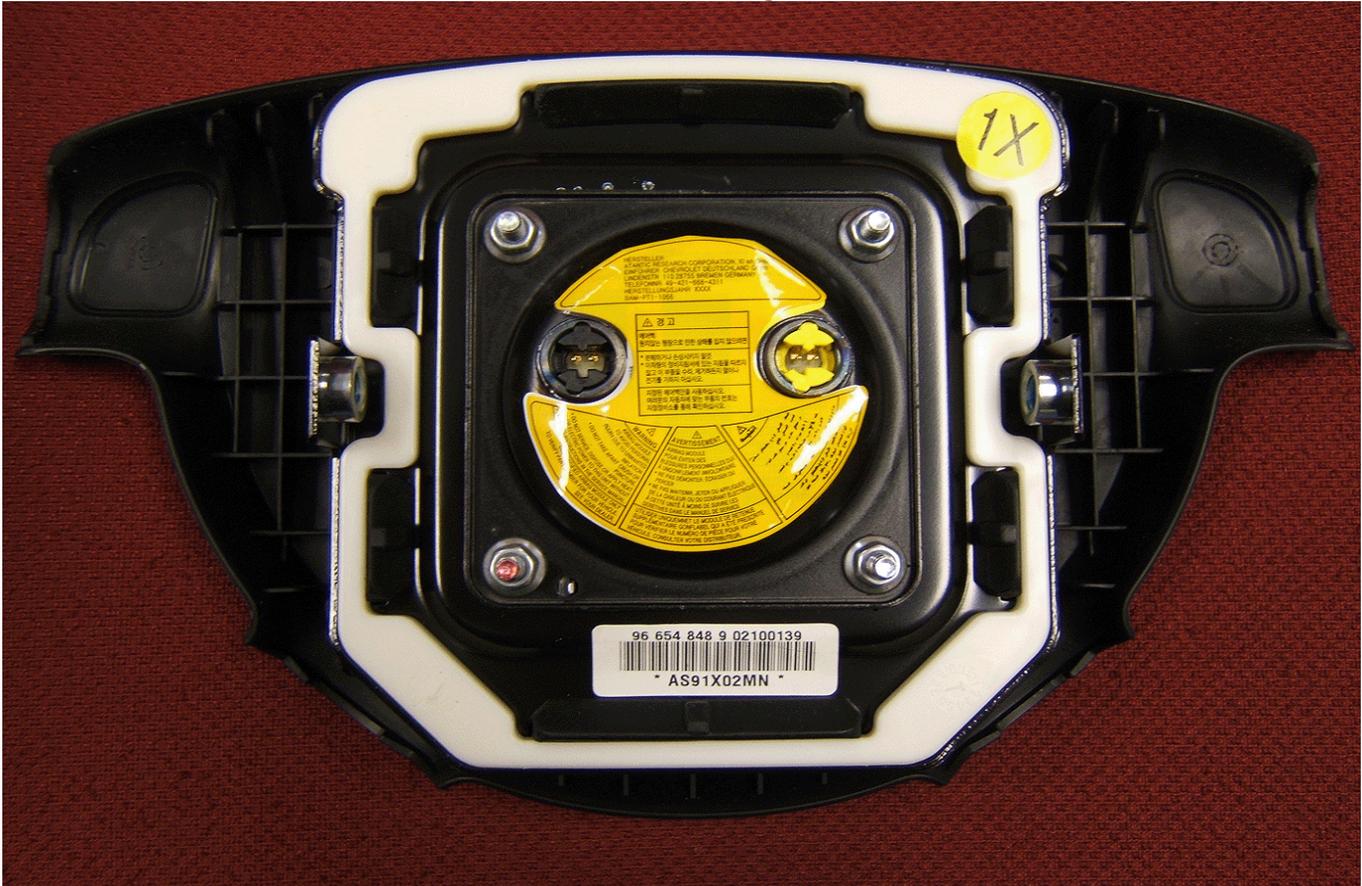
Genuine Aveo Airbag Module

The Chevrolet Aveo uses a metal backed airbag module that is painted black. The physical appearance of the module should exactly match the picture below.

Look for inconsistent materials, stickers, additional holes in the module, or any signs of tampering.

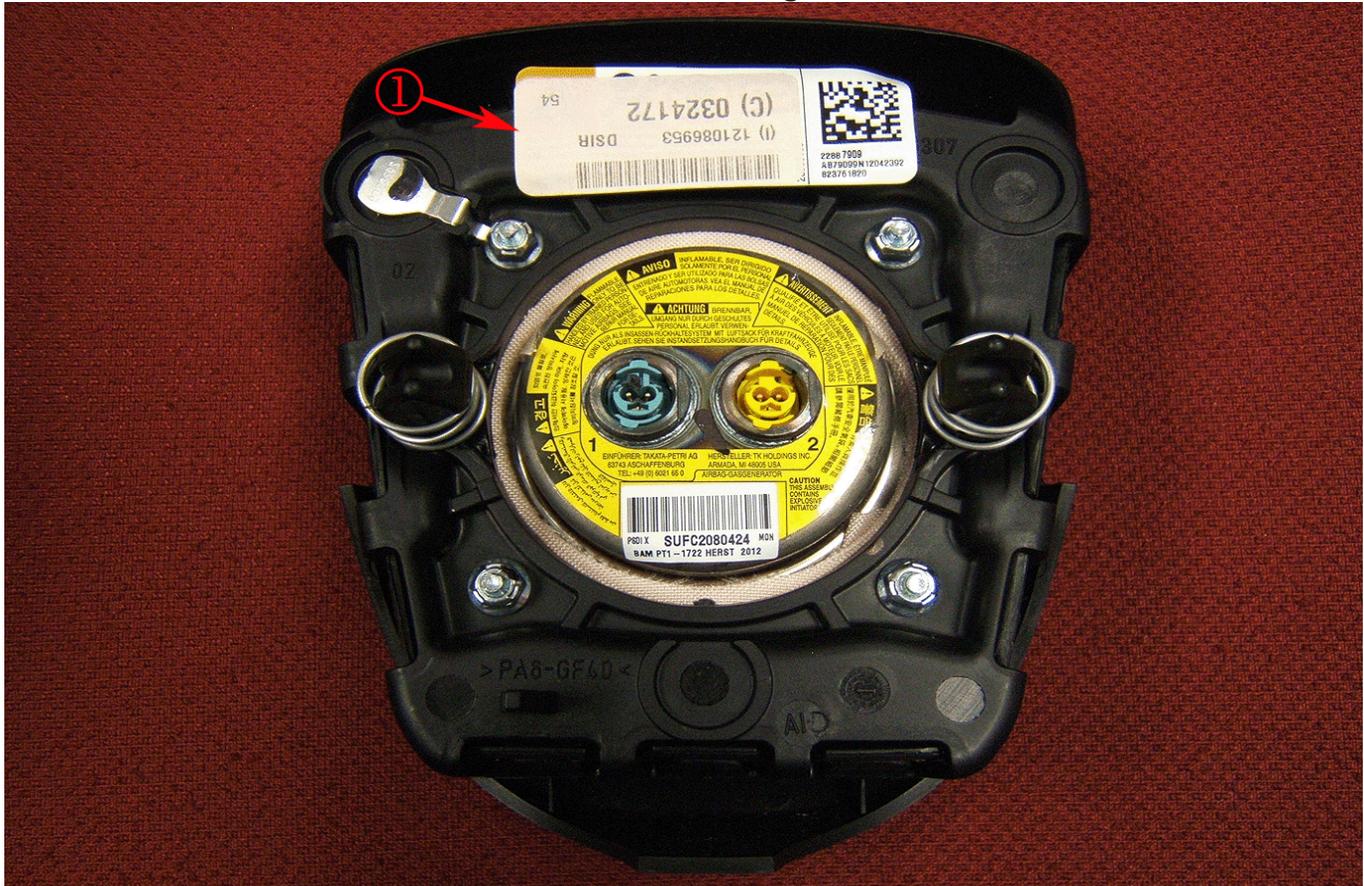
Genuine Camaro Airbag Module

The Chevrolet Camaro uses a plastic backed airbag module black in color. The physical appearance of the module should exactly match the picture below.

Look for inconsistent materials used, variation in the caution sticker, additional holes in the module, or any signs of tampering. The paper label (1) may be present, removed or placed at a different location on the module. This paper label should not be considered critical in validating the authenticity of this module.

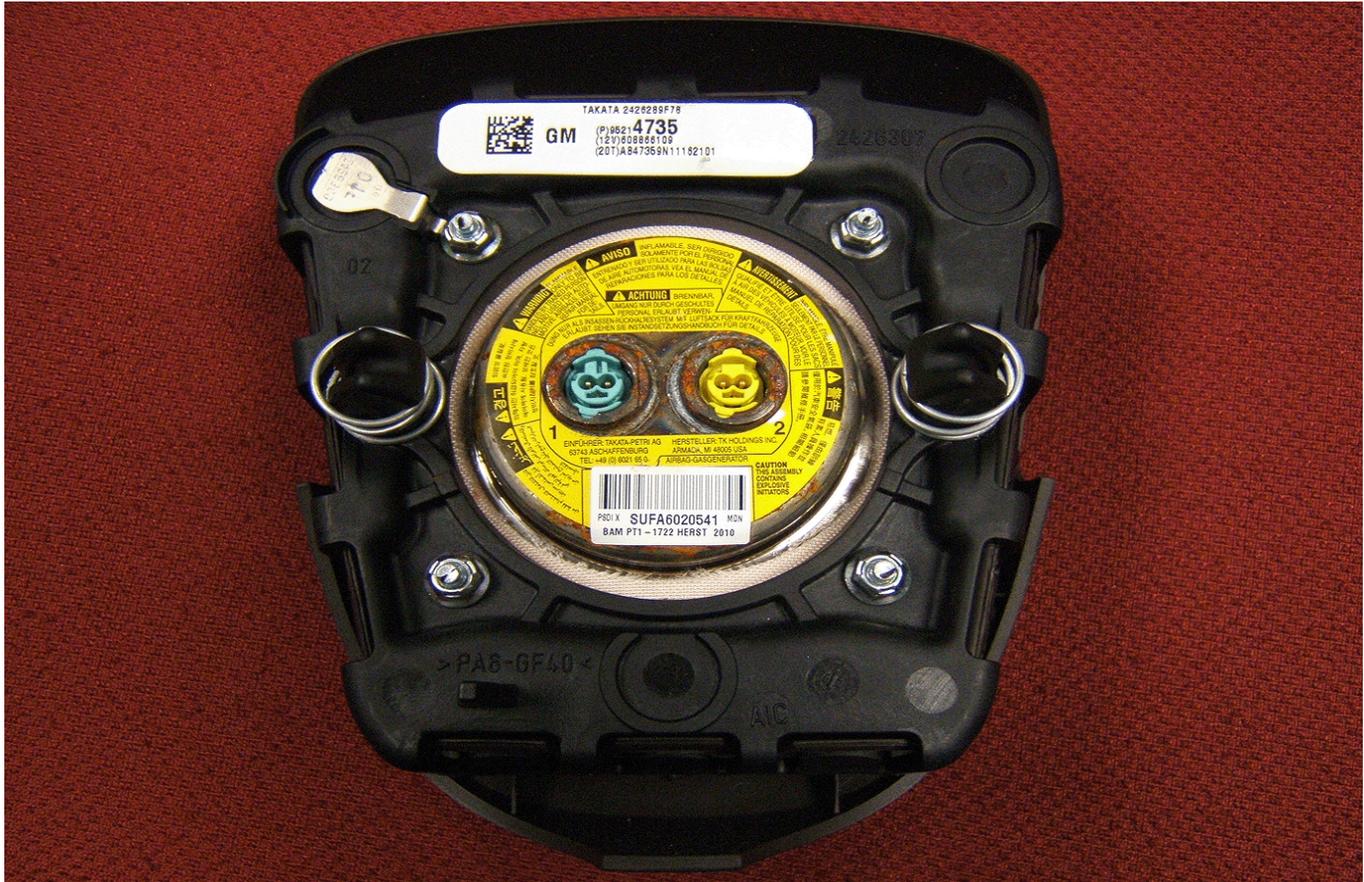
Genuine Cruze / Volt Airbag Module

The Chevrolet Cruze / Volt uses a plastic backed airbag module black in color. The physical appearance of the module should exactly match the picture below. One example is shown for both vehicles. Various part numbers are used for each application but the physical appearance is the same.

Important: This example shows corrosion on the bare metal near the electrical contacts. This is a normal condition you may encounter, and is not an indication of counterfeit, remanufactured or reclaimed parts. The corrosion does not affect operation of the airbag module.

Look for inconsistent materials, stickers, additional holes in the module, or any signs of tampering.

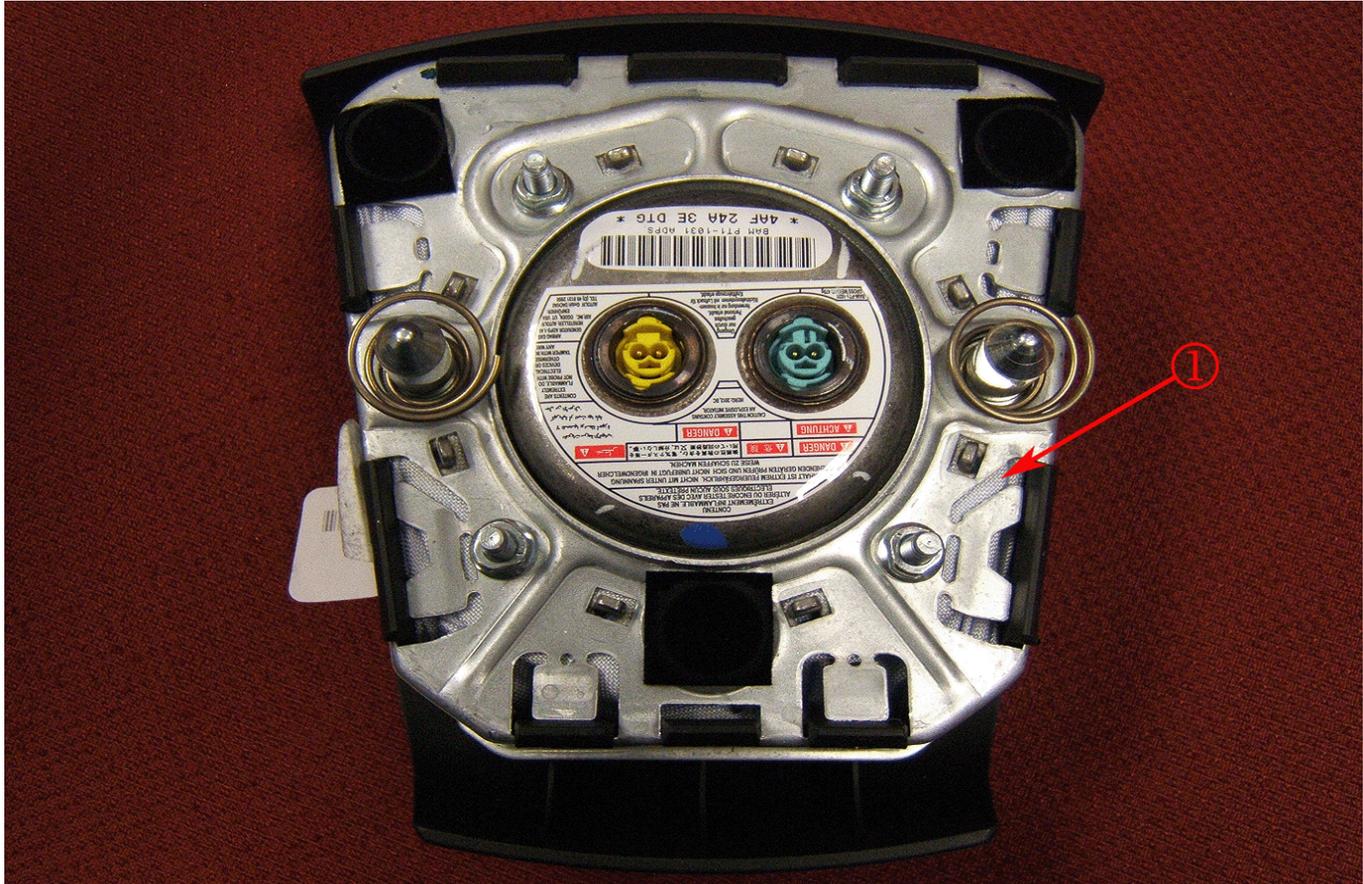
Genuine Lacrosse Airbag Module

The Buick Lacrosse uses an unpainted metal backed airbag module. The physical appearance of the module should exactly match the picture below. Various part numbers are used for each application but the physical appearance is the same.

Important: This type of module allows the airbag (1) to be visible at several points around the edge of the module. Confirm the module has an airbag installed.

Look for inconsistent materials, stickers, additional holes in the module, or any signs of tampering.
