**WB43 - Replacing Transfer Case (Workshop Campaign)**

Vehicle Type: **Cayenne S (92A)**

Model Year: **2011**

Concerns: **Transfer case**

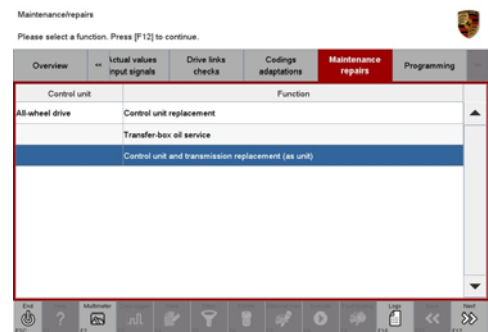
*All-wheel control unit - Maintenance/repairs*

- 2 When the question "Create Vehicle Analysis Log (VAL)?" appears, either press **[F12]** to create a VAL or press **[F11]** if you do not want to create a VAL.
- 3 Press **[>>]** to acknowledge the message informing you that campaigns for the vehicle are stored in the PIWIS information system.
- 4 Select the ⇒ **'Maintenance/repairs'** menu.
- 5 Select the function ⇒ **'Control unit and transmission replacement (together)'** in the ⇒ **'Maintenance/repairs'** menu and confirm your selection by pressing **[>>]** (⇒ *All-wheel control unit - Maintenance/repairs.*)

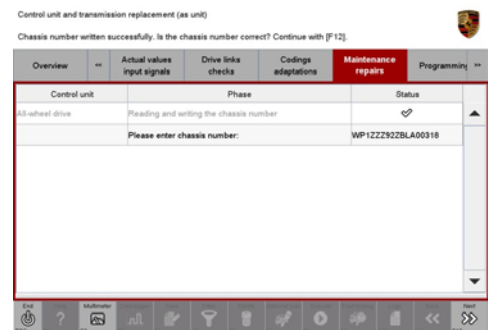
*Checking chassis number*

- 6 Start **reading and writing the chassis number** by pressing the **[>>]** button.
- 7 The message 'Chassis number written successfully' appears. **Check the chassis number** and correct it if necessary ⇒ *Checking chassis number.*  
Then press **[>>]** to continue.

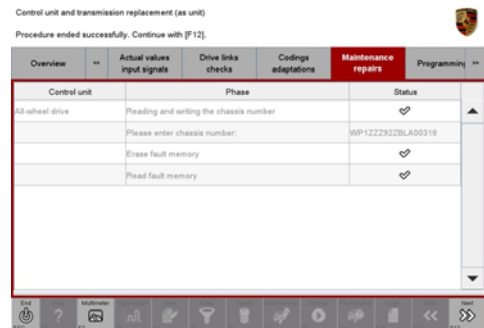
*Procedure ended successfully*

- 8 The message **“Procedure ended successfully”** appears ⇒ *Procedure ended successfully*.

Once coding is completed successfully, press **>>** to continue.

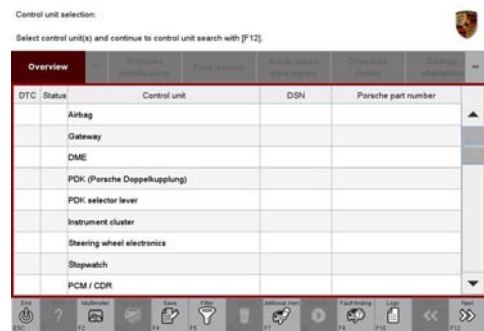
*Control unit selection*

- 9 Select the ⇒ **'Overview'** menu and press **<<** to return to the control unit selection screen ⇒ *Control unit selection*.
