| REFERENCE: | Nova Bus Manuals |
| RS N°: | MQR 7621-533 |

| SUBJECT: | Next Stop wiring harness. |
| JUSTIFICATION: | Protective sheath of the Next Stop wiring harness could become stripped by the sharp edges of the pass-through hole. |

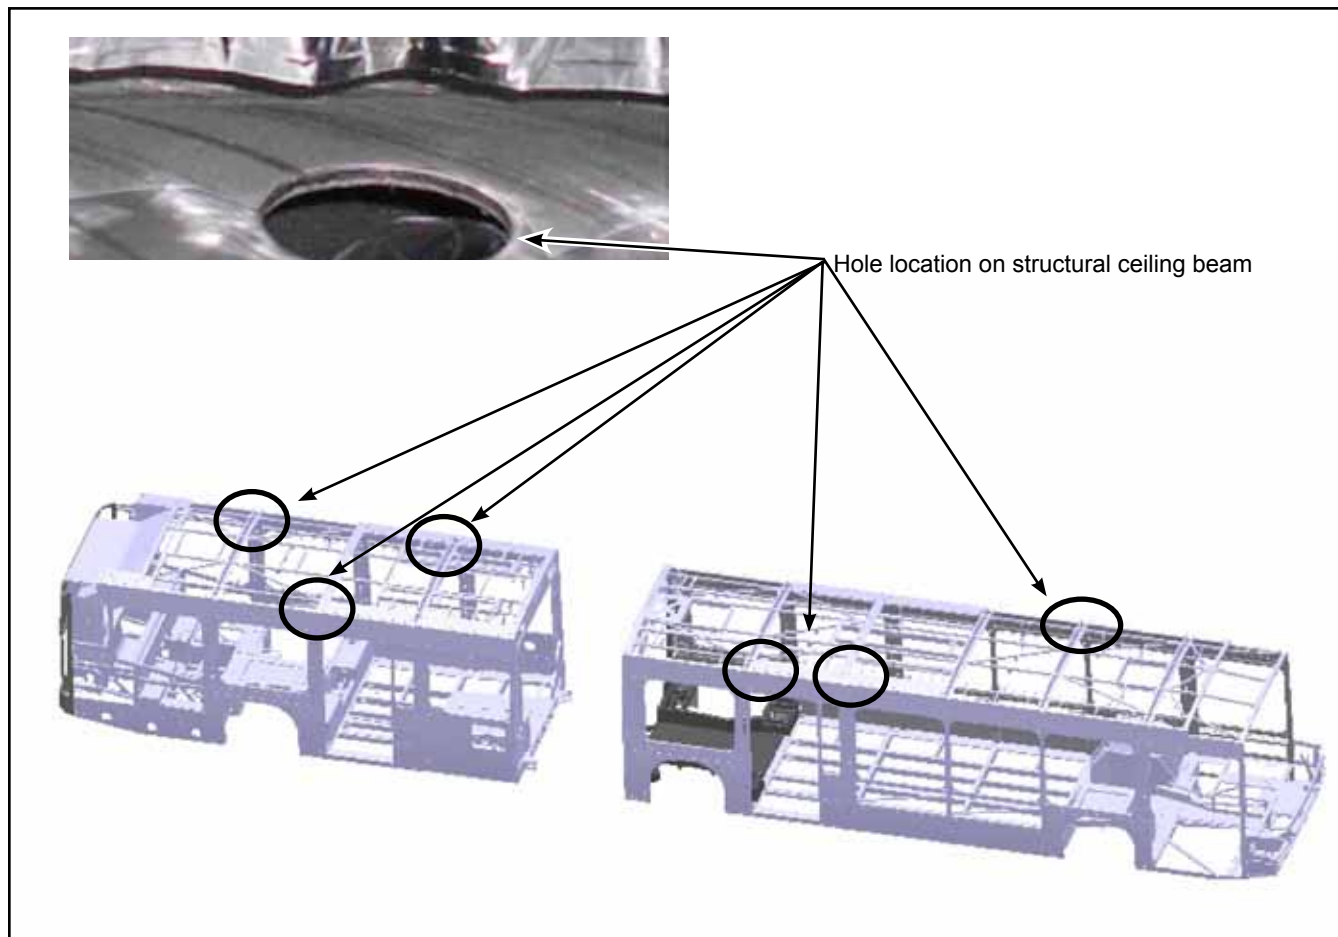
- 1.1. Inside the vehicle, open the corresponding baselights.
- 1.2. Locate the wires passing through the structural ceiling beam hole. See Figure 1.

*Figure 1 - Next Stop Wire Passing Through the Structural Ceiling Beam*

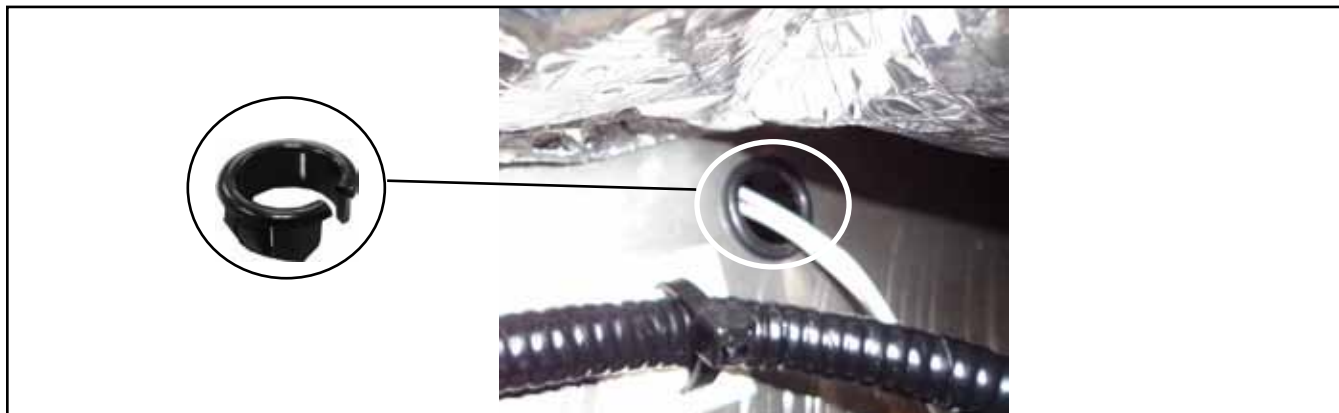
*Figure 2 - Plastic Bushing Installation on the Structural Ceiling Beam*

- 1.3. Install the open/close plastic bushing G5008610 into the hole as shown in Figure 2.

- 1.4. If wires are stripped, wrap electrical insulating tape around the stripped wires.  
1.5. If the wires are not stripped, close the baselights.  
1.6. The vehicle can be returned to service.❖
