| REFERENCE: | Nova Bus Manuals |
| SECTION: | 12 Wheelchair access ramp |
| RS N°: | MQR 7621-277 |

| SUBJECT: | Ramp gear box actuator |

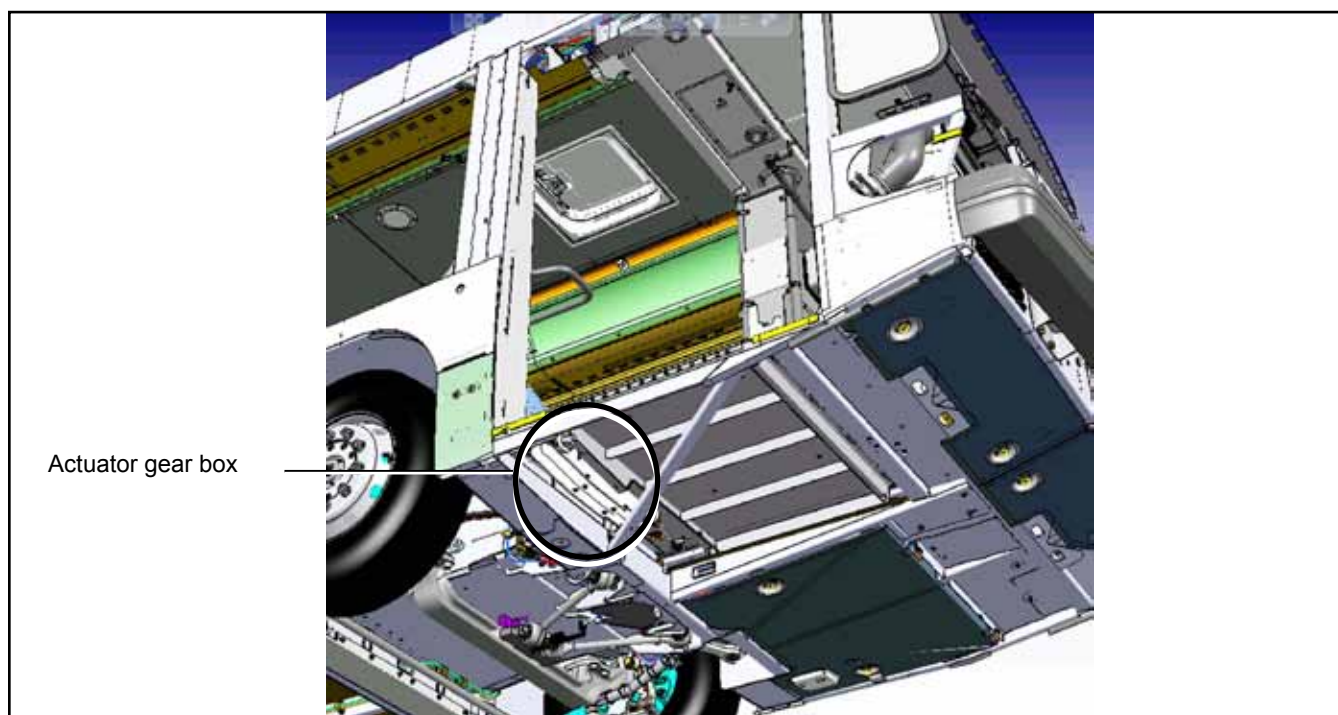
*Figure 1 - Actuator Gear Box Location*

1.1. Locate the access ramp actuator gear box. See Figure 1.

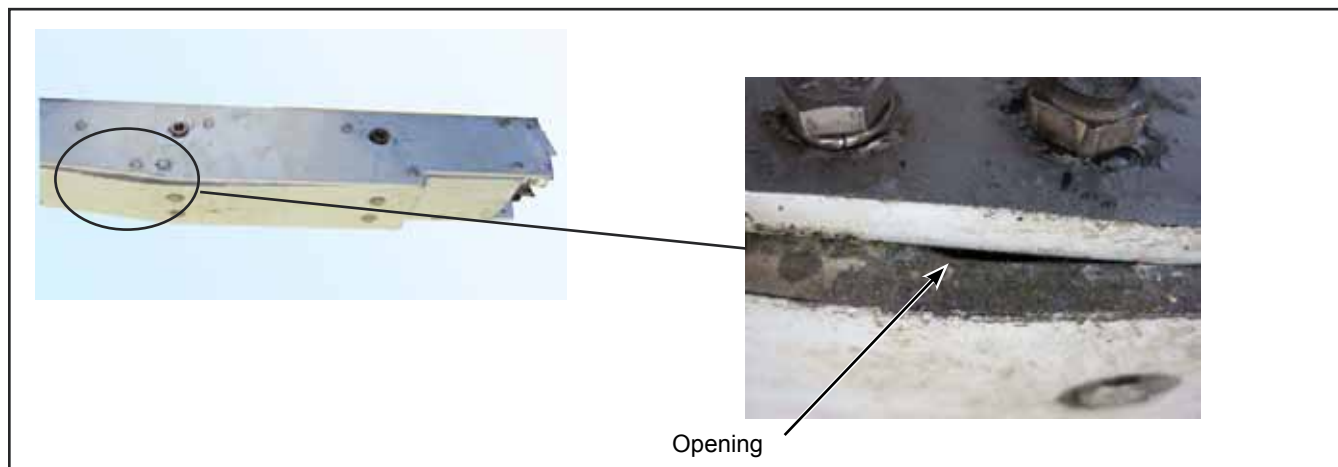
*Figure 2 - Gear Box Actuator Typical Opening*

1.2. Visually verify if there is an opening between the cover and the gear box body. See Figure 2.

- 1.2.1. If the opening is smaller than 0.068 in. (2 mm), use a feeler gauge, the actuator gear box conforms.
- 1.2.3. Clean and apply Sikaflex caulking, or an equivalent into the opening to prevent water infiltration. The vehicle can be returned to service.
- 1.2.4. If the opening is greater than 0.068 in. (2 mm), proceed to **LEVEL 2** of this document.

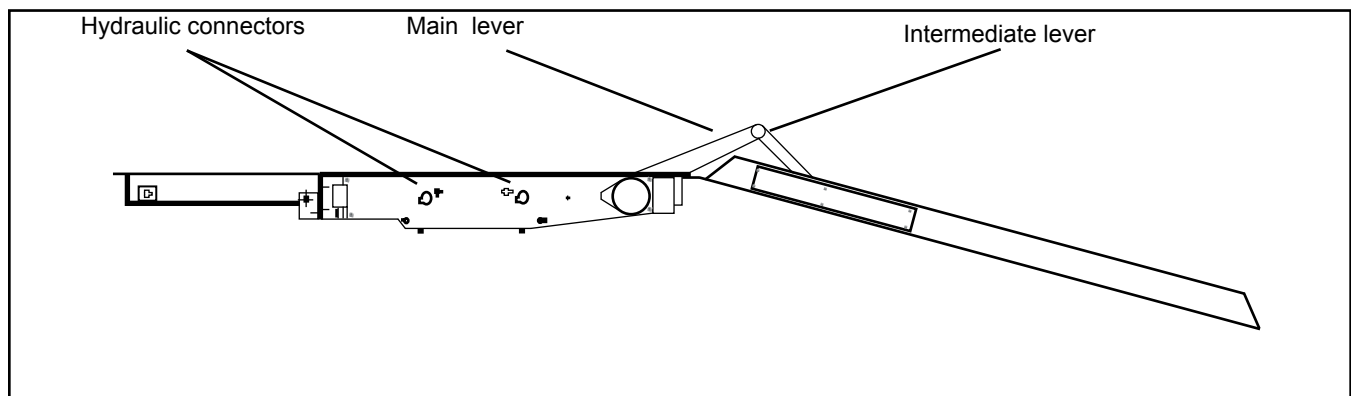
*Figure 3 - Ramp Components*

- 2.1. Raise the vehicle as per section 18: **HOISTING AND TOWING** in the Nova Bus maintenance manual.
- 2.2. Deploy the ramp to the horizontal position. Support the deployed panel.
- 2.3. Dismount the main lever from the intermediate lever. Retain the hardware. See Figure 3.
- 2.4. Disconnect the hydraulic hoses from the actuator gear box. Install plugs onto the hydraulic connectors. A recuperation pan is required for the recovery of the hydraulic oil.

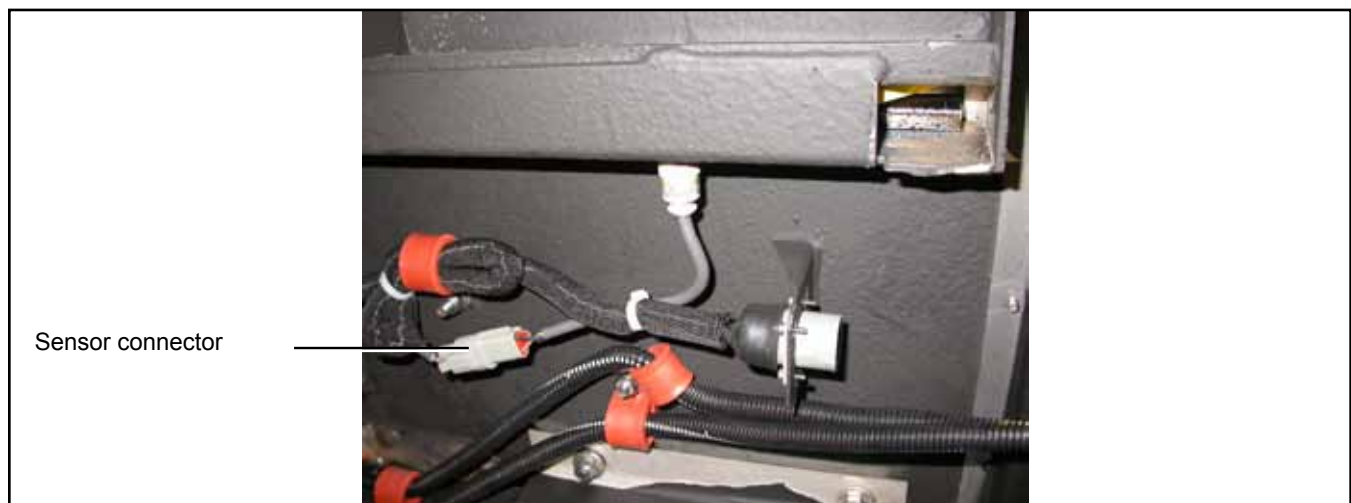
*Figure 4 - Ramp Sensor Connector*

- 2.5. Disconnect the electric sensor harness. See Figure 4.

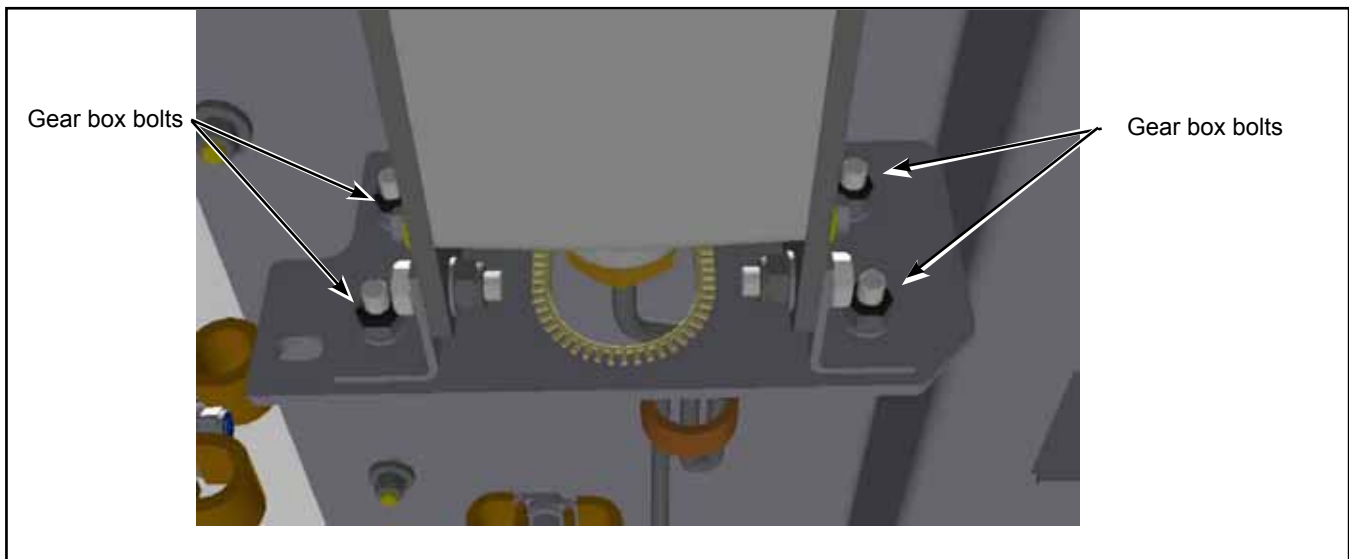
*Figure 5 - Gear Box Attachments*

- 2.6. Place a stand under the actuator gear box to hold it in place.
- 2.7. Loosen the 16 bolts that retain the actuator gear box to the vehicle. See Figures 5 and 6.

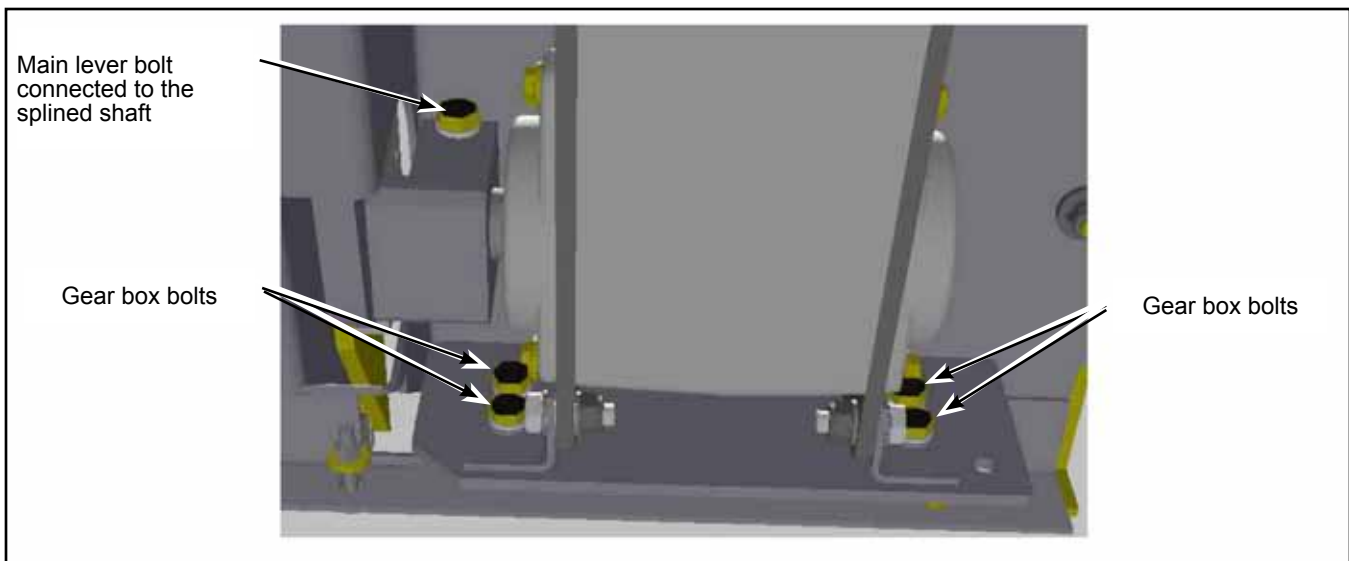
*Figure 6 - Gear Box Attachments*

- 2.8. Loosen and remove the main lever from the ramp splined shaft. See Figure 6. Retain the main lever and hardware
- 2.9. Remove the 16 bolts that hold the gear box. Retain the hardware.

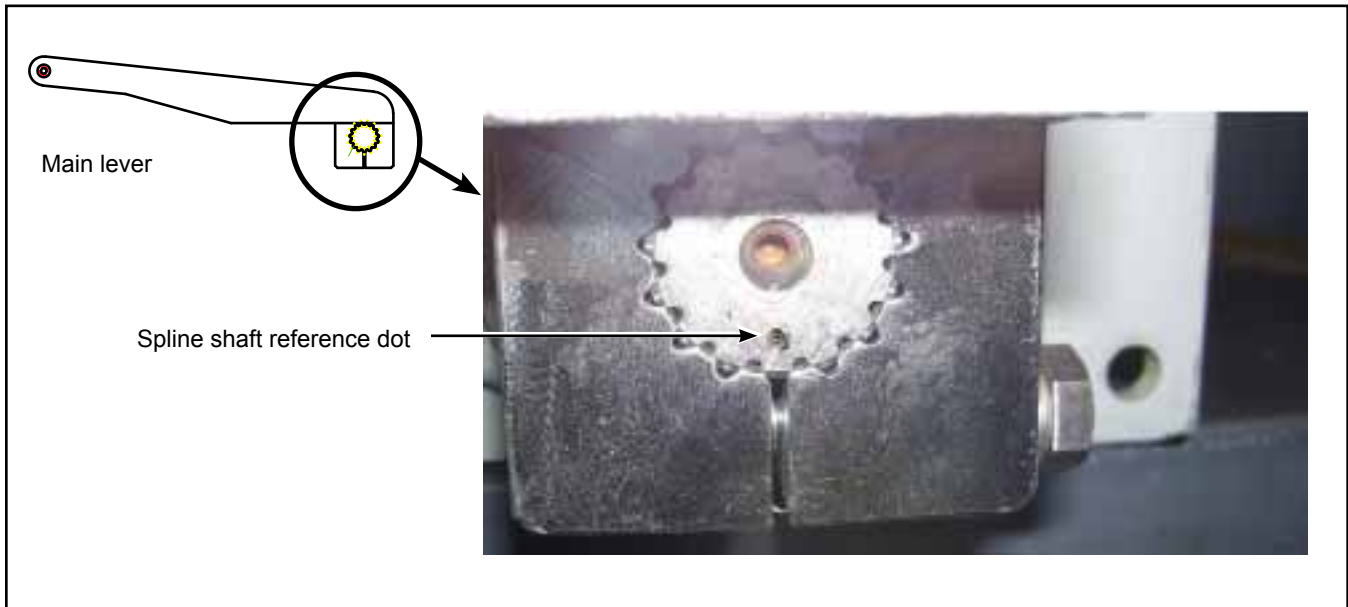
*Figure 7 - Main Lever and Splined Shaft Reference Dot*

- 2.11. Place a new actuator gear box N45950R under the ramp and move it toward the front of the vehicle.
- 2.12. Install the main lever with the retained hardware onto the splined shaft of the access ramp. Ensure that the timing mark on the splined shaft is at the bottom. Align with the main lever slot when installed. See Figure 7. Do not fasten the hardware.

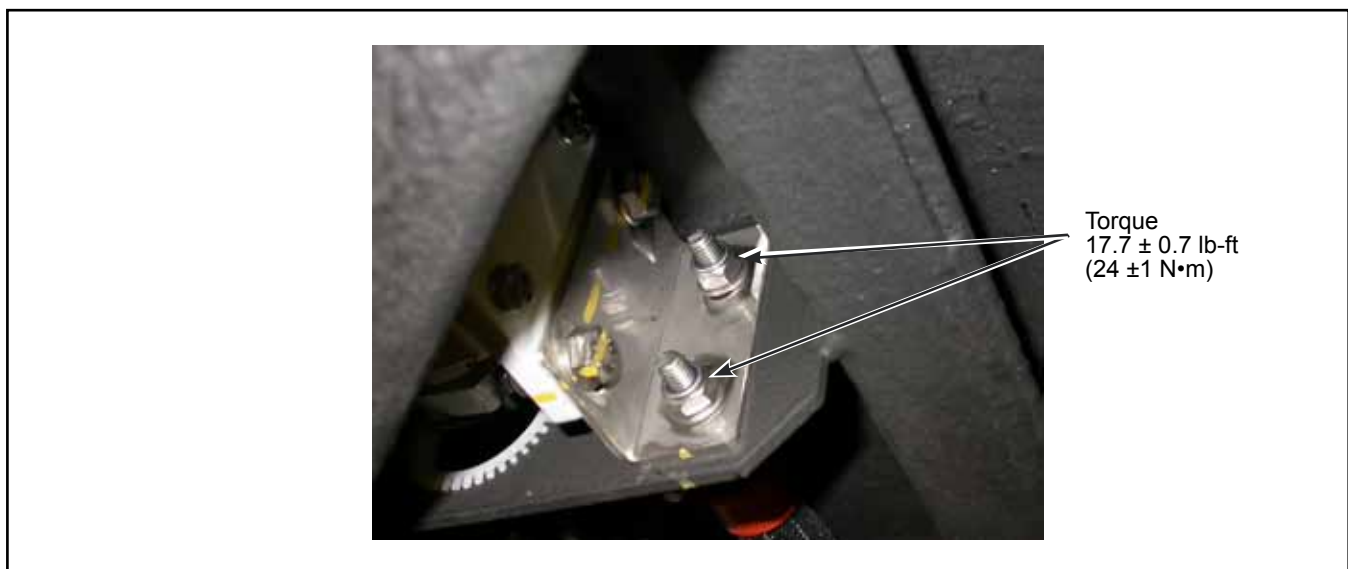
*Figure 8 - Bolt Torque*

- 2.13. Support the actuator gear box to hold it in place.
- 2.14. Install the four supports with the retained hardware. Do not fasten the hardware.
- 2.15. Tighten the main lever bolt and the 16 bolts holding the gearbox to the vehicle at the torque indicated in Figure 8.

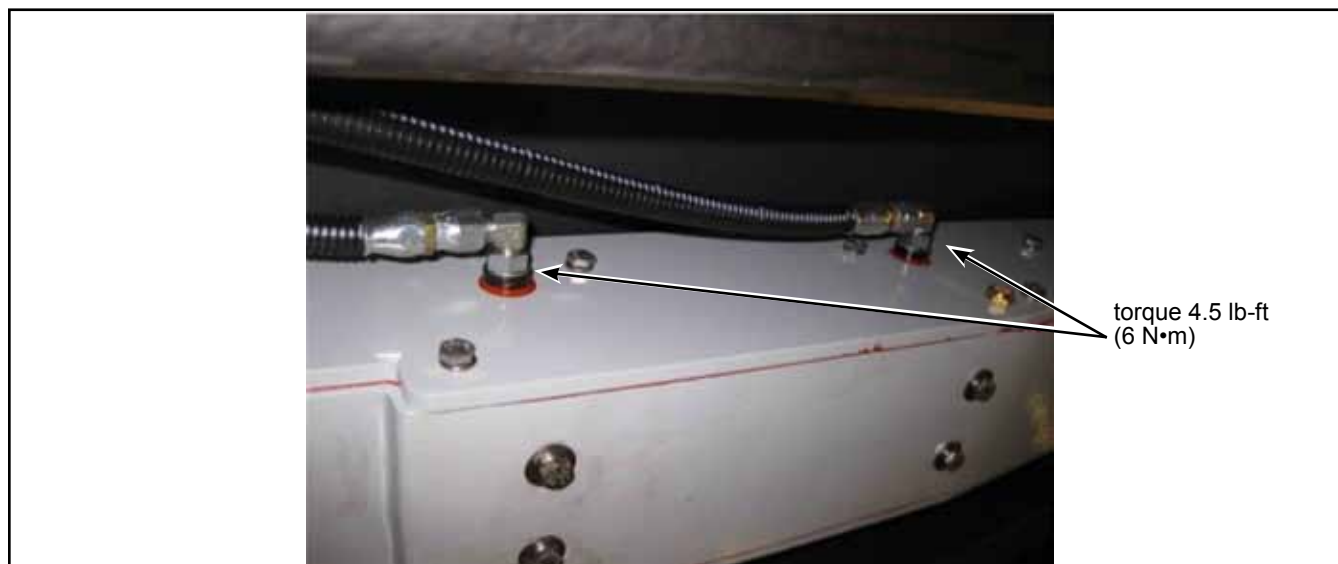
*Figure 9 - Hydraulic Connector Torque*

- 2.16. Install the main lever onto the intermediate lever with the retained hardware.
- 2.17. Connect the sensor wiring harness. Attach the harness to the P clamp. If required use a tiewrap to keep the harness together.
- 2.18. Connect the hydraulic hoses to the actuator and tighten at the torque indicated in Figure 9.
