| REFERENCE: | Nova Bus Manuals |
| RS N°: | MQR 7621-528 |

| SUBJECT: | Articulation platform rubber trim |
| JUSTIFICATION: | Probable lateral displacement of the articulation platform rubber trim. |

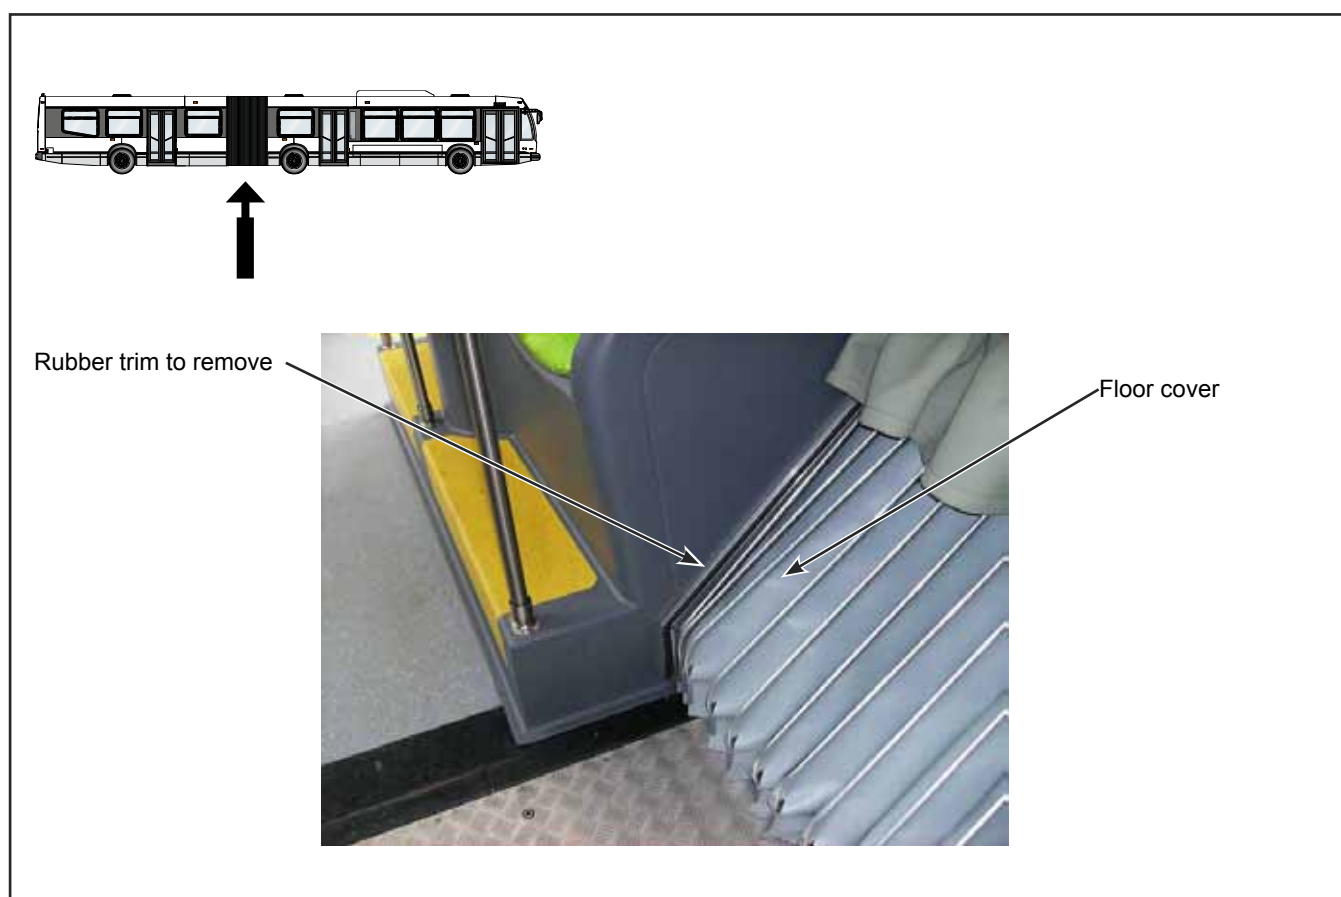
*Figure 1 - Floor Cover to Detach*

1.1. Detach the floor cover attached to the side of the four-seat installation. See Figure 1. Retain the rubber trim.

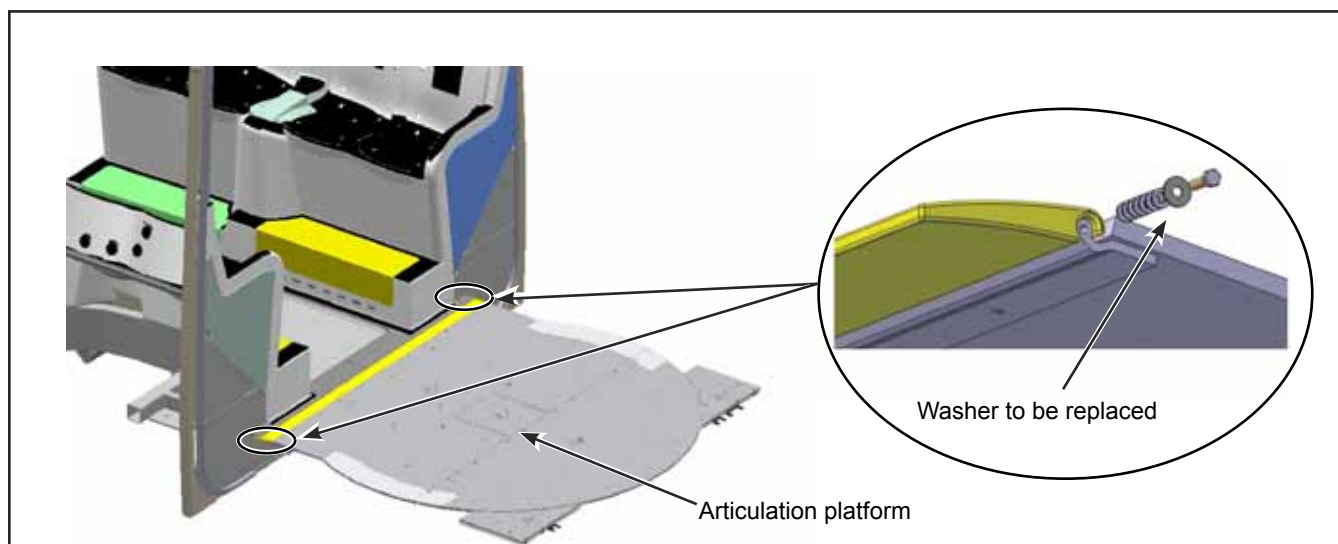
*Figure 2 - Washers to be Replaced*

- 1.2. Remove the bolt with the washers. See Figure 2. Retain the hardware, except the 5/8 in (15 mm) washer, which must be discarded.

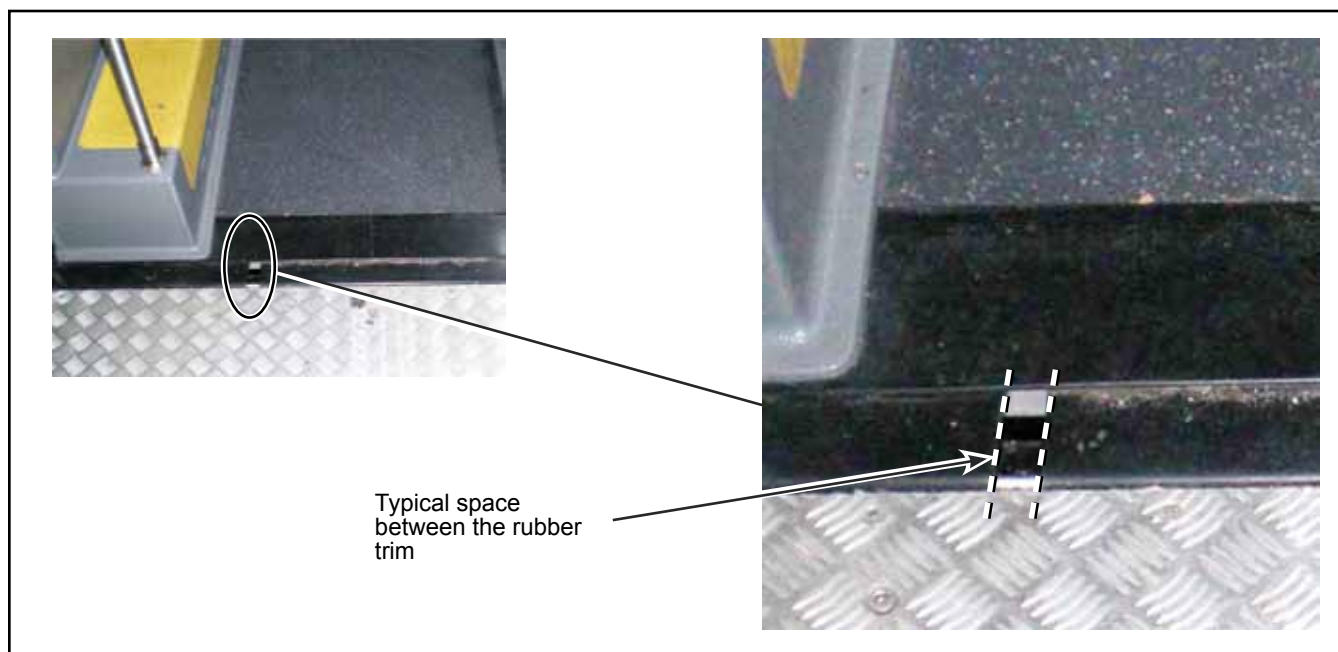
*Figure 3 - Typical Space Between Floor Trim*

- 1.3. If required, replace the floor trim to eliminate any gap in the joints. See Figure 3.

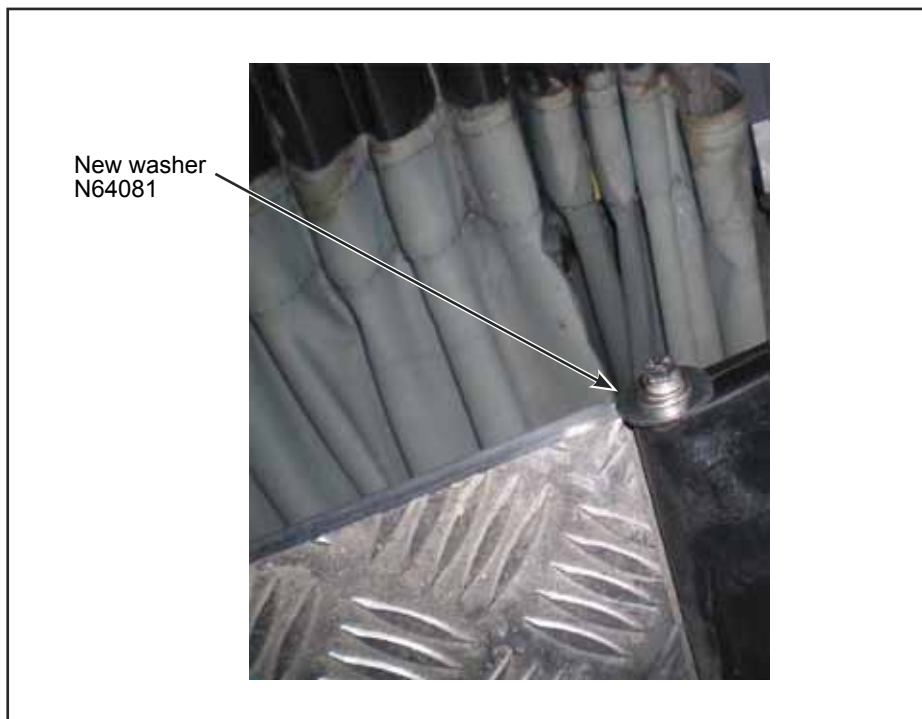
*Figure 4 - New Washer Installation*

- 1.4. Install the retained hardware, replacing the 5/8 in. (15 mm) washer with a 1 in. (25.4 mm) washer N64081. See Figure 4.

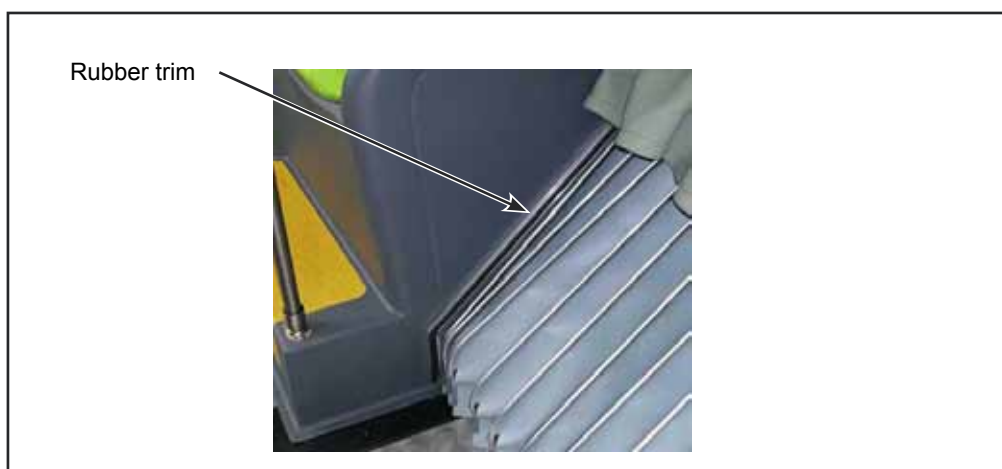
*Figure 5 - Rubber Trim Installation*

- 1.5. Attach the edge of the floor cover to the lateral seat attachment points.
- 1.6. Install the retained rubber trim to affix the floor cover to the lateral seat. See Figure 5❖
