## LACMTA 45CLFW: AC Solenoid Valve Relocation

**Property and Top Bus Number:** LA 45CLFW-05, 315000

**Solution:** Remote mount the HVAC solenoid valve per this work instruction (SOI).

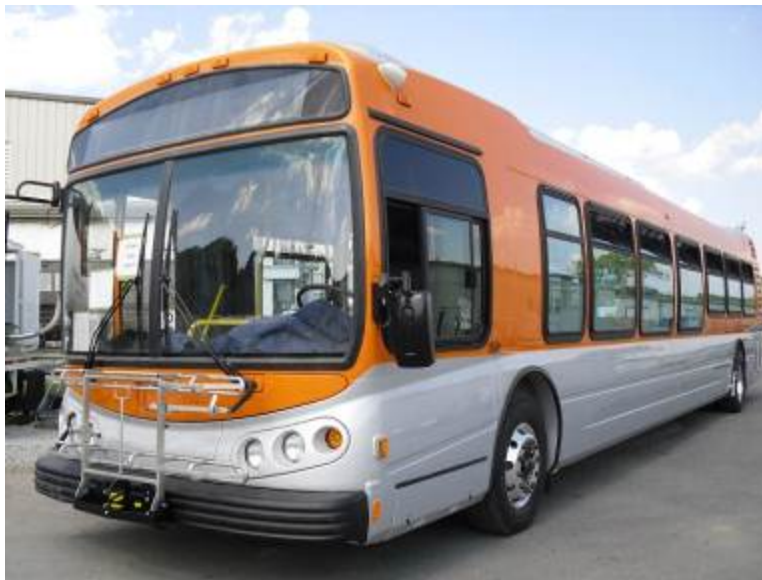
**Issue:** Periodic hammering noise inside the HVAC unit when the solenoid valve closes.

**Reason/ cause:** The coolant solenoid valve inside the HVAC unit was the source of the noise.

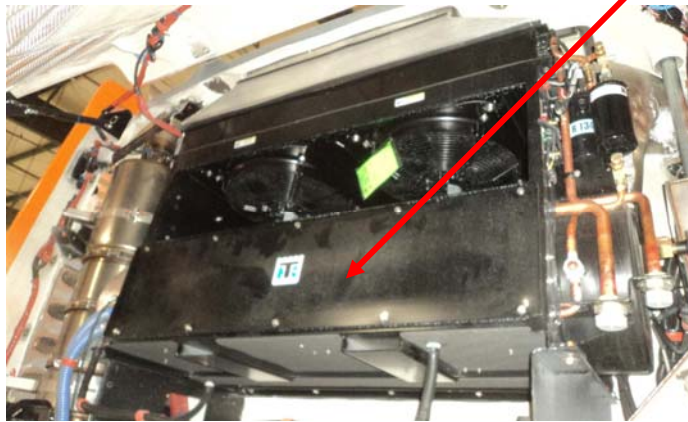
1. Park the bus and apply the parking brake.
2. Turn off main battery disconnect switch.
3. Drain the coolant at the bottom of the radiator. **Follow the safety and technical recommendations of NABI Maintenance Manual.**
4. Contact local TK service center about reworking the solenoid valve inside the TK unit.

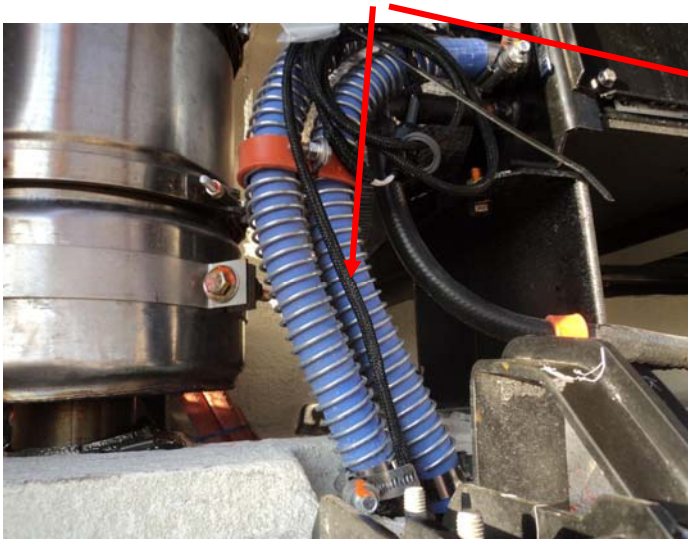
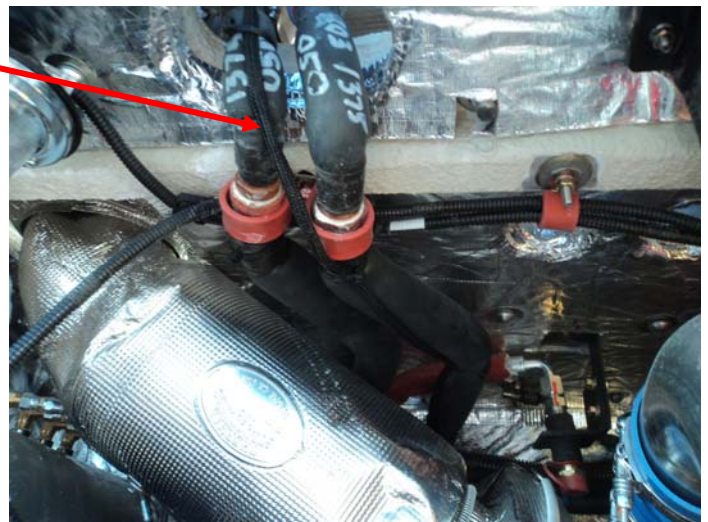
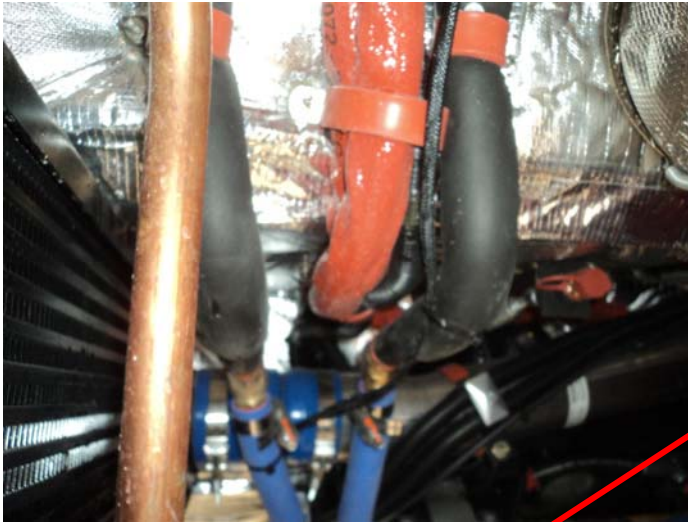
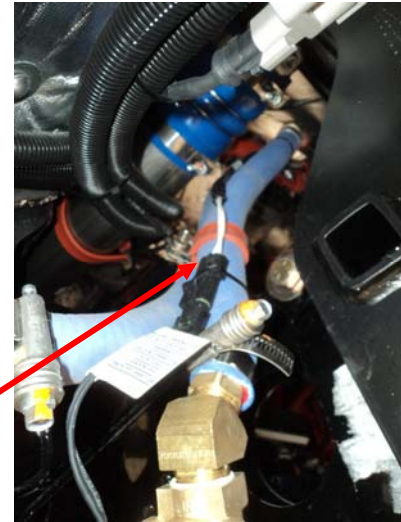
5. The TK representative has to disassemble the valve and remove inner parts (diaphragm, piston, spring, etc.) then reinstall valve housing cap and connect the jumper cable to the bus-side harness.
6. Route the jumper cable from the TK unit to the radiator outlet pipe as pictures show below.

7. Secure jumper cable to hoses with wire ties.
8. Open the street side access door behind the rear axle and locate the check valve assembly.

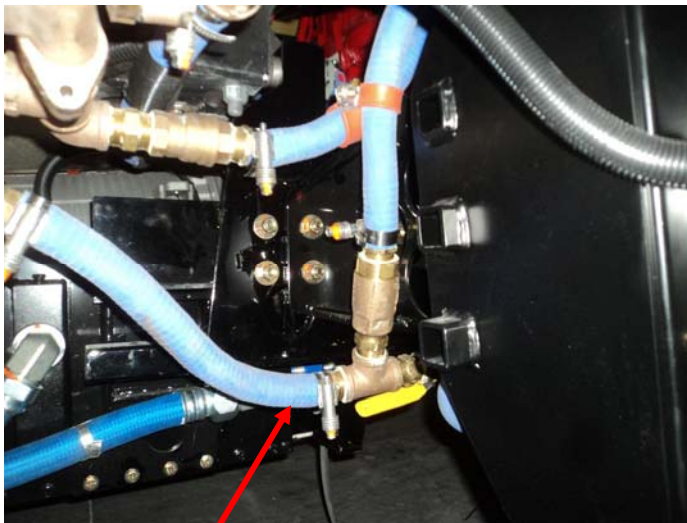
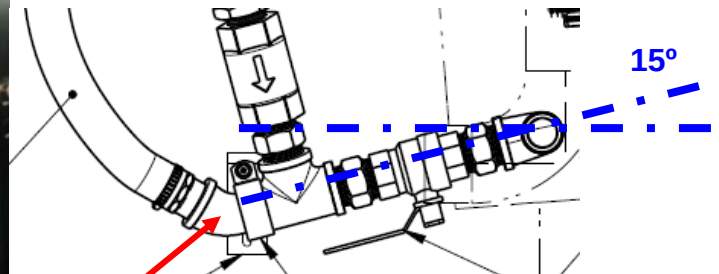
9. Remove hose from the front of the valve assembly.
10. Remove hose barb and install elbow 45, 16MP -16FP then reinstall hose barb into the elbow.
11. Rotate valve assembly down by 15 degree (see above). This is required to provide clearance to install the solenoid valve.
12. Reconnect forward hose to the valve assembly.
13. Remove hose from the top of the valve assembly.

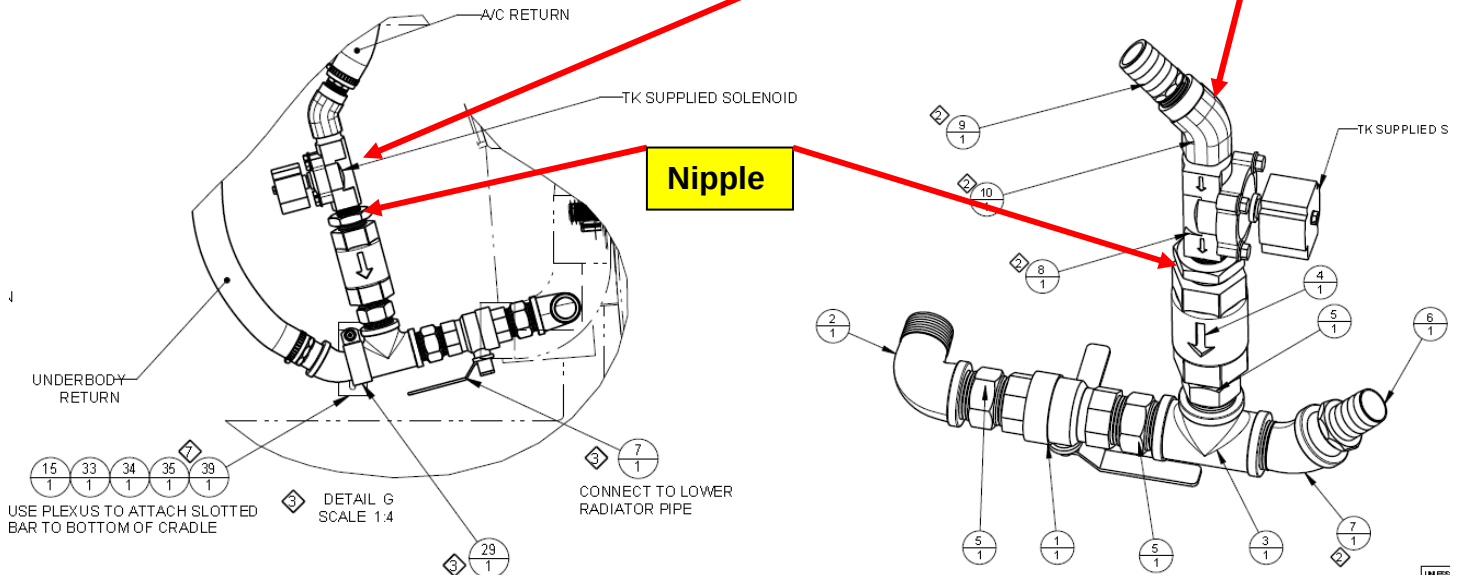
14. Remove hose barb and install a 16MP-12MP nipple, a new solenoid valve, a 12MP-12FP 45 elbow and a 16HO-12MP hose barb to the valve assembly.
15. Reconnect hose to the top of the valve assembly.

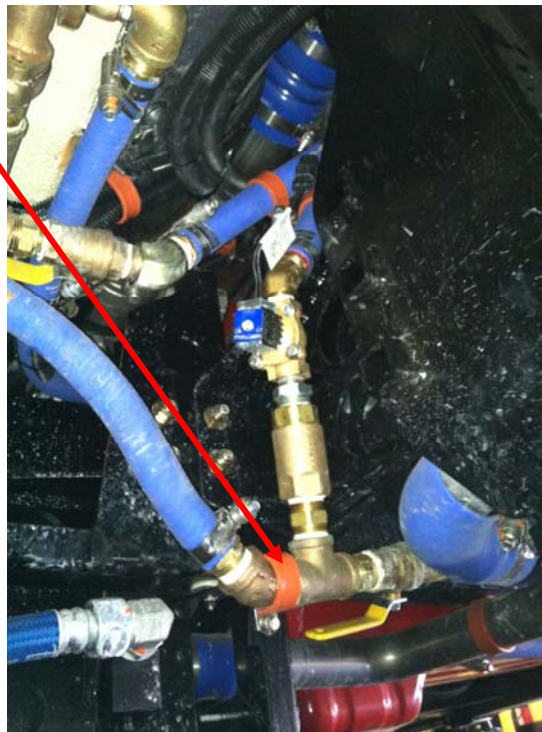
16. Install P-clamp and slotted bar bracket to the valve assemble as picture shows below.

17. Mark the hole location of the slotted bar bracket on the bottom of engine cradle.
18. Install ¼-20 stud to the bottom of the engine cradle according to the followings:
  - Remove paint with 60G abrasive disc.
  - Degrease surface with denatured alcohol.
  - Apply PC-120 primer to the steel surface. Follow instructions on the can.
  - Apply Plexus-AO420 onto the stud and install it to the exact marked location. Ensure that the two components of the plexus adhesive are mixed correctly.
  - Let it dry for 20 minutes.
19. Install bracket to the stud with ¼ flat washer, lock washer and nut.
20. Remove all the tools from work area.
21. Check for completeness of work.
22. Refill and de-aerate cooling system per **NABI L3-FSV-026** work instruction.
23. Record bus number, date of repair and name of technician who completed the work.
