## Westchester Transit: Ceiling Panel

**Property and Top Bus Number:** Westchester 40LFW-44, 255000

**Issue:** Ceiling panel attachments working loose.

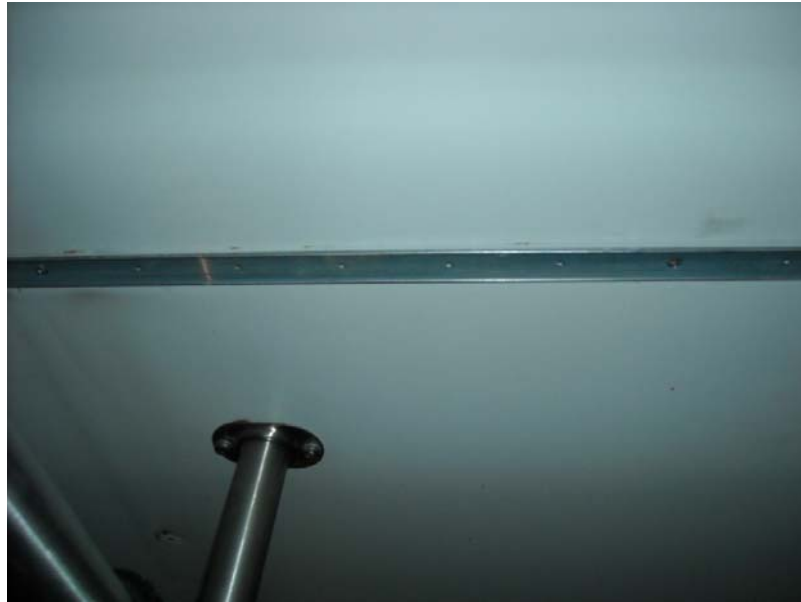
1. Park the bus and apply the parking brake.
2. Turn off main battery disconnect switch(es).
3. Remove cover from ceiling base molding.

4. Install rivet within 2 inches from each ends and add rivets between existing rivets.
5. Re-install cover for ceiling base molding.
6. Clean bus of all debris and metal shavings.
7. Check for completeness of work.
8. Remove all tools from working area.
9. Turn the main battery disconnect switch(es) on.

**Solution:** Install stainless steel rivets per this work instruction, to enhance durability
