**NABI 60BRT: Cooling System Updates (4B)**

**Property name and top bus number:** NABI 60BRT buses equipped with EGR cooler

**Issue:** Air in the cooling system.

Work instruction number L3/FSV-126  
L4/QUA-003

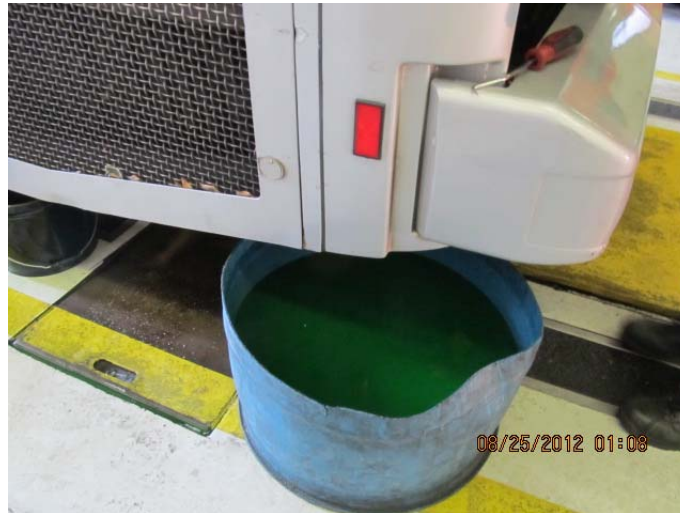
1. Park the bus and apply the parking brake.
2. Turn off the battery disconnect switch.
3. Drain cooling system. Refer to NABI Maintenance Manual about safety and technical details.

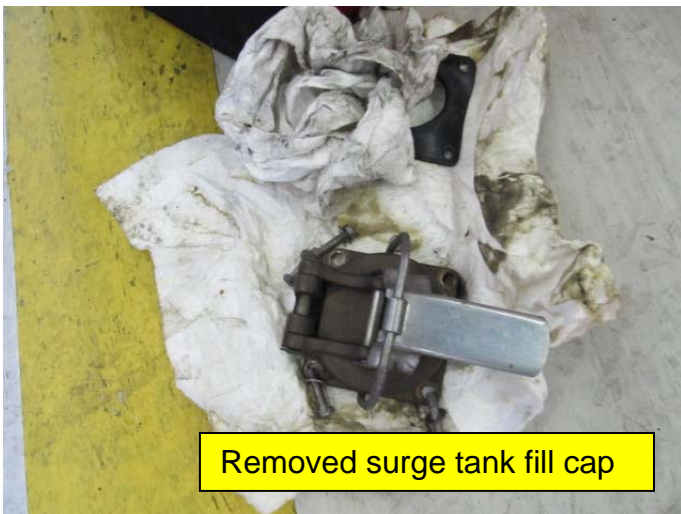
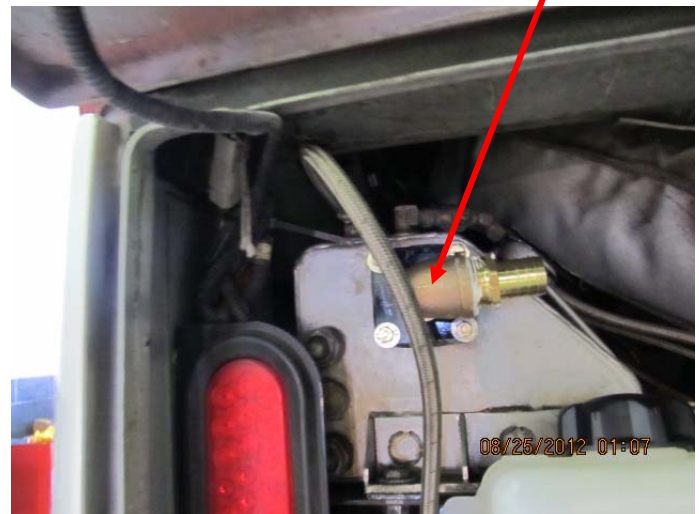
4. Replace existing surge tank fill cap with new adapter plate assembly, which includes 90 elbow and 1" hose barb. Seal treads with thread sealant.

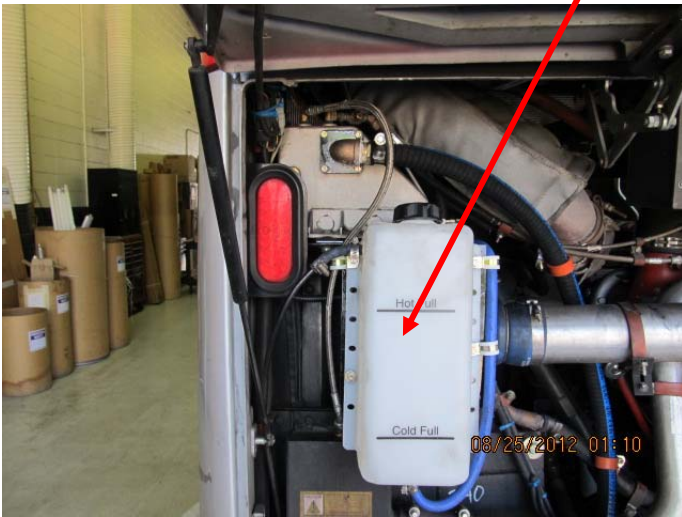
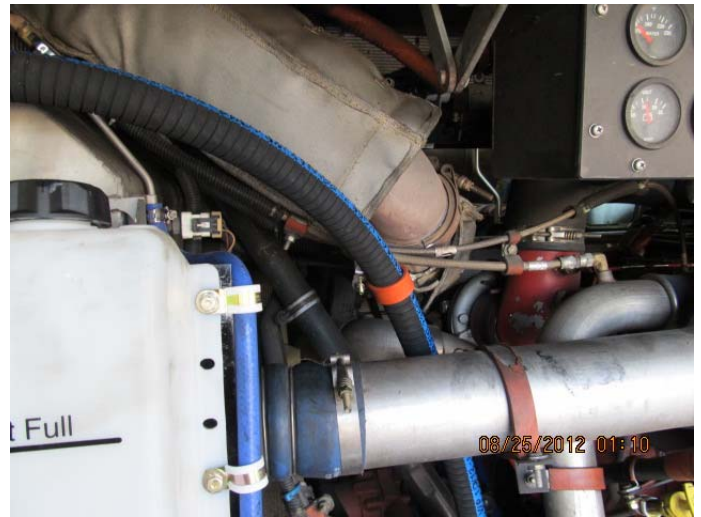
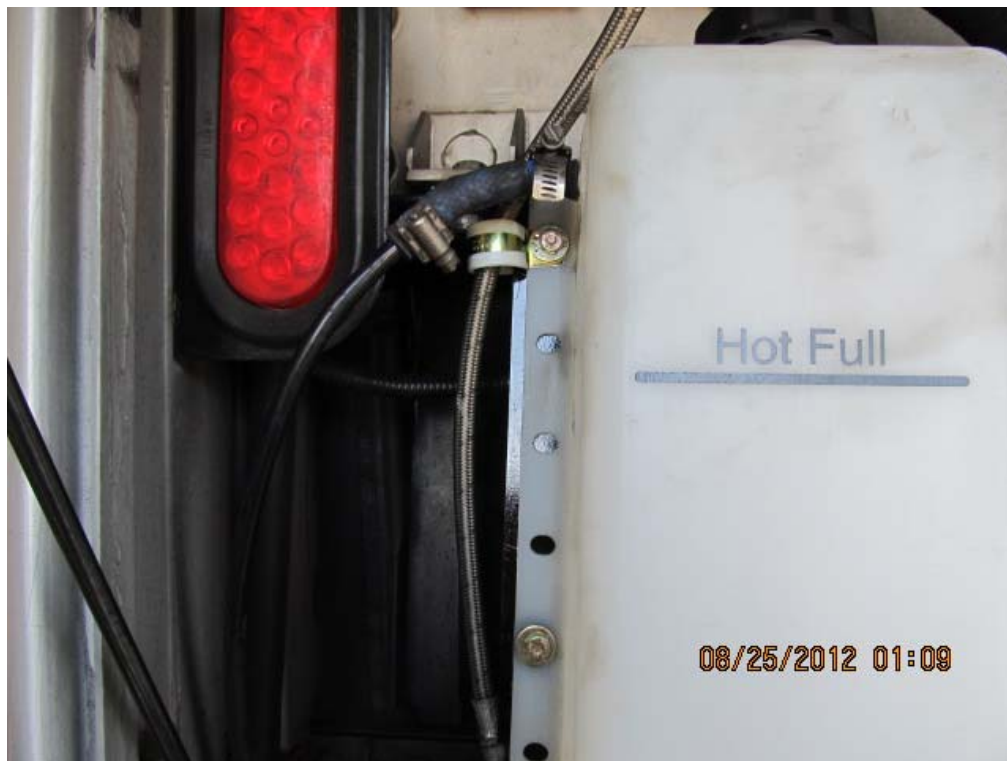
5. Install recovery tank bracket, recovery tank and the required hoses and clamps per the pictures below.

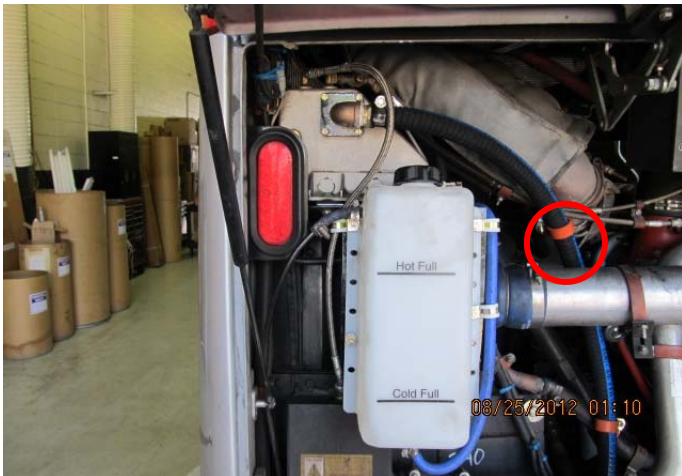
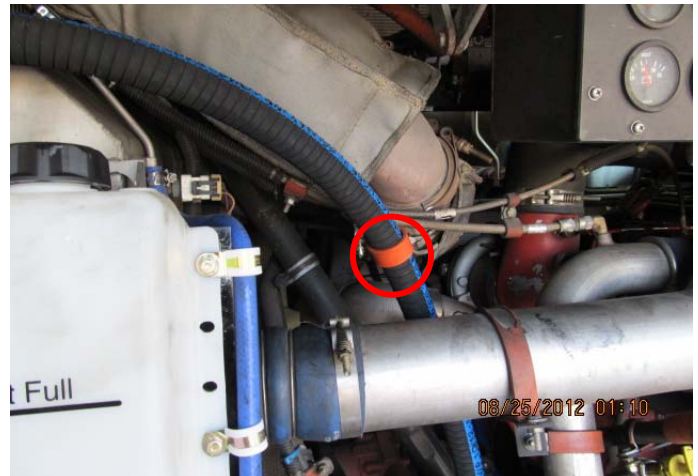
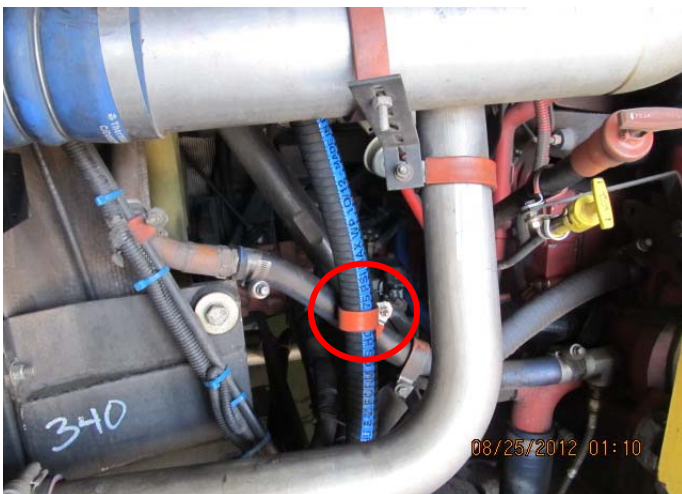
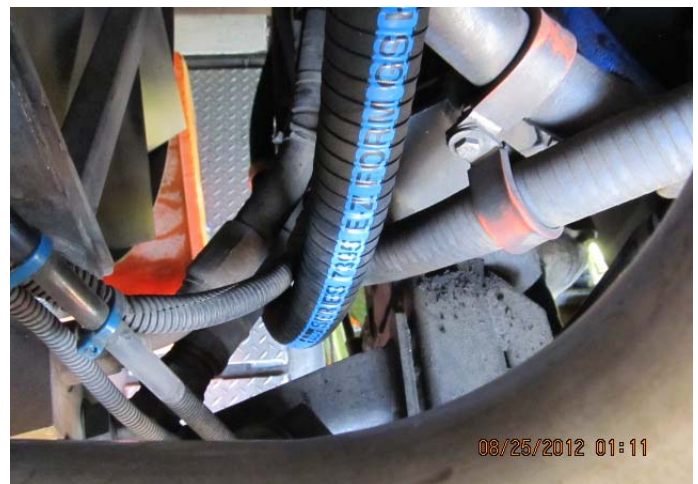
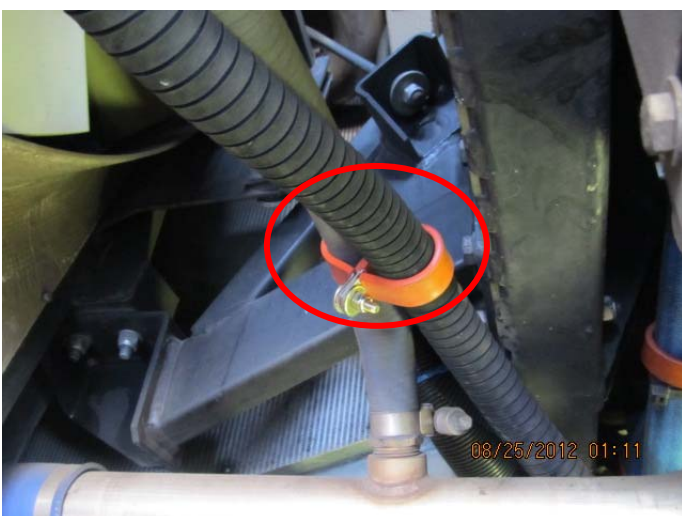
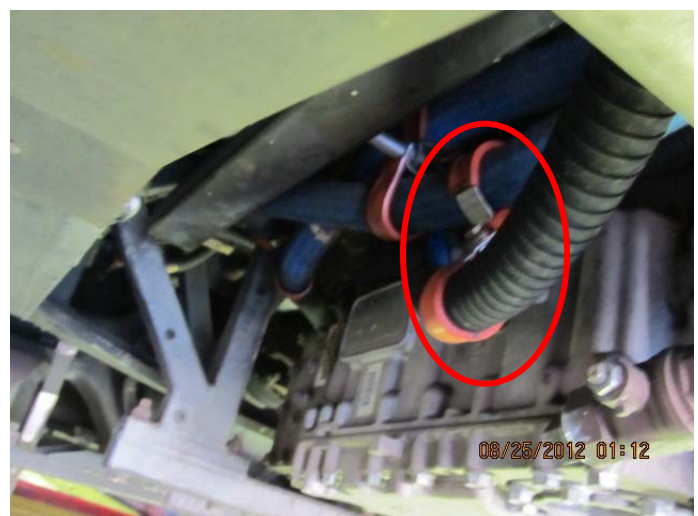
- Route 10' of EZ Form hose from adapter plate on surge tank and secure it with P-clamps as pictures show below.

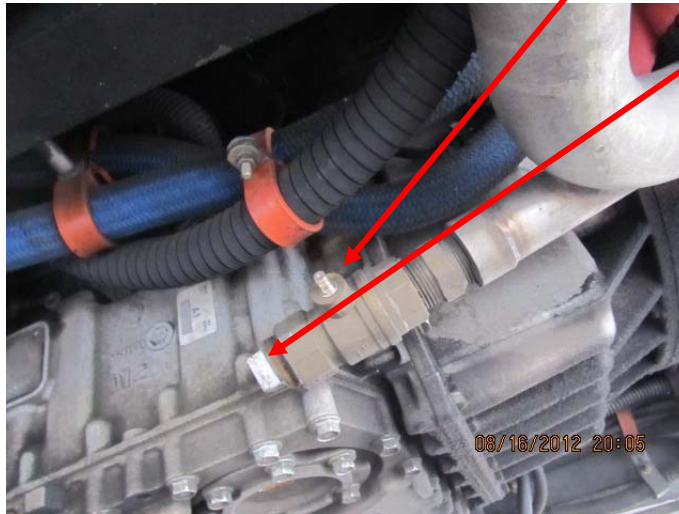
7. Remove heater return hose in between  $\frac{1}{4}$  turn valve at heater return tube and  $\frac{1}{4}$ -turn valve at lower radiator tube.
8. At the lower radiator tube, remove  $\frac{1}{4}$  turn shut off valve handle and install plug in port.

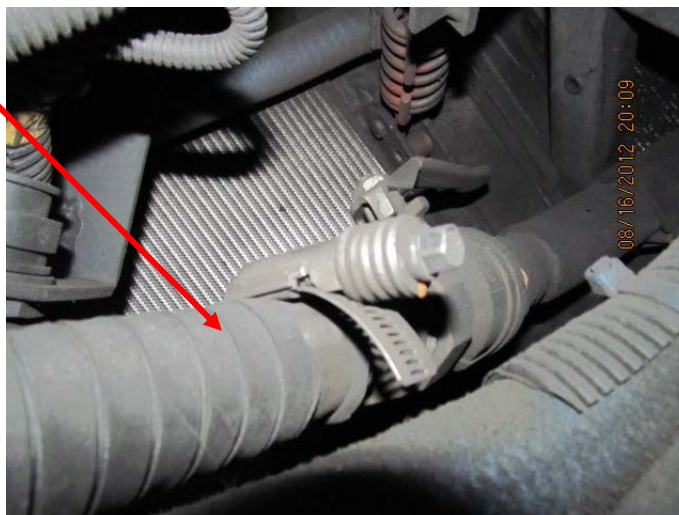
9. Connect EZ- form hose to  $\frac{1}{4}$  turn valve at heater return tube above rear axle.
