New Jersey Transit: Surge Tank Support

Property and Top Bus Number: New Jersey Transit 416.15

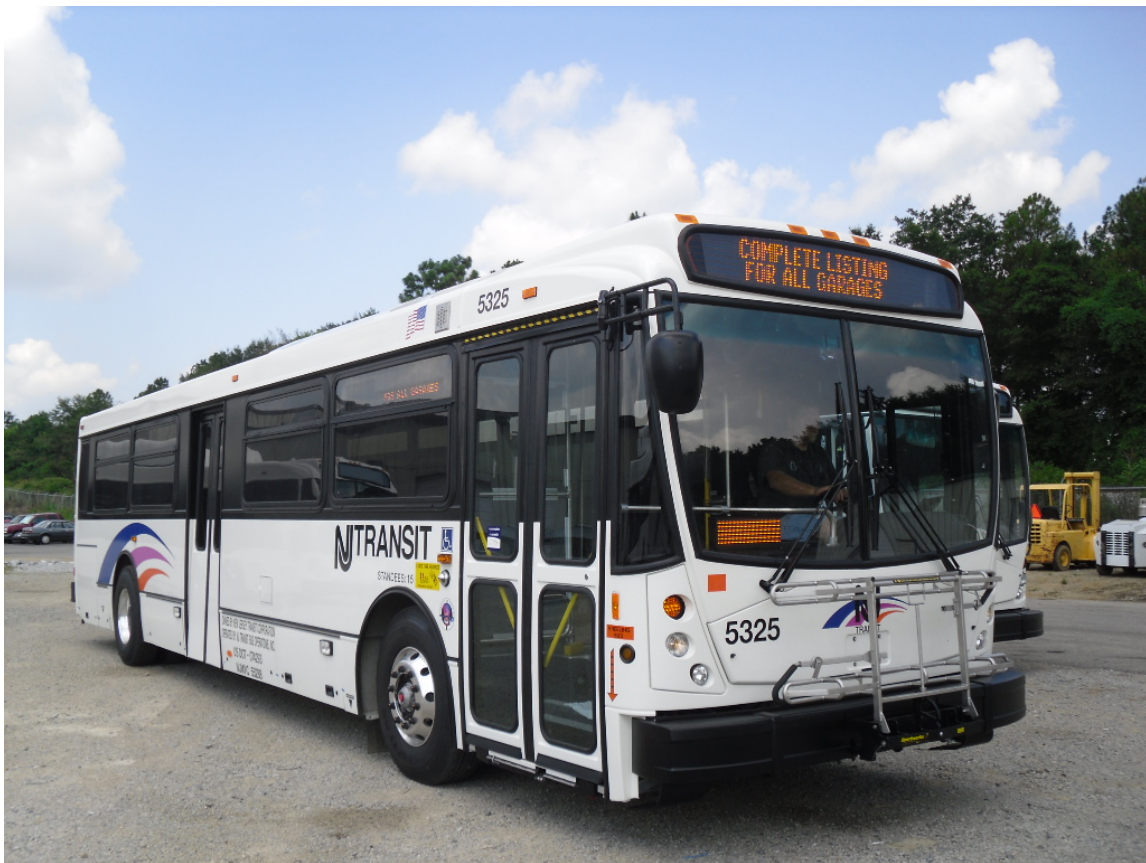
Issue: Surge tank mounting brackets are cracking

Reason/ cause: Design should have included reinforcement of brackets.

Solution: Add support brackets per this work instruction (SOI).

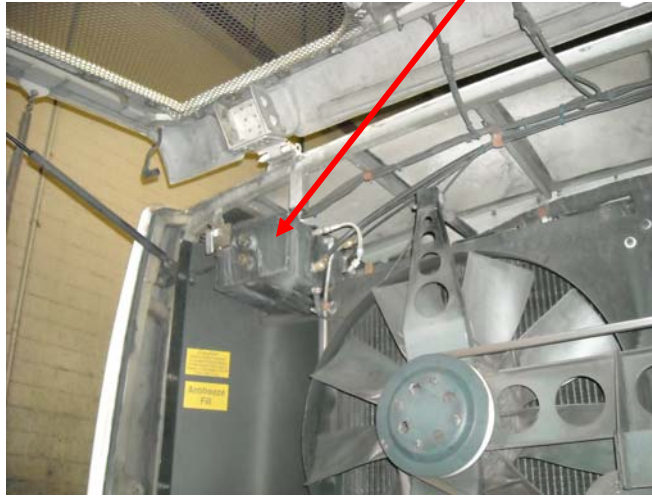
1. Park the bus and apply the parking brake.
2. Turn off main battery disconnect switch(es).
3. Open the rear attic compartment door and locate the surge tank on the street side (SS).
