DART: Optical Flame Sensor and Thermostat

Relocation

Property and Top Bus Number: DART 40FW, 304000

Issue: Optical flame sensor and roof mounted thermostat need to be moved.

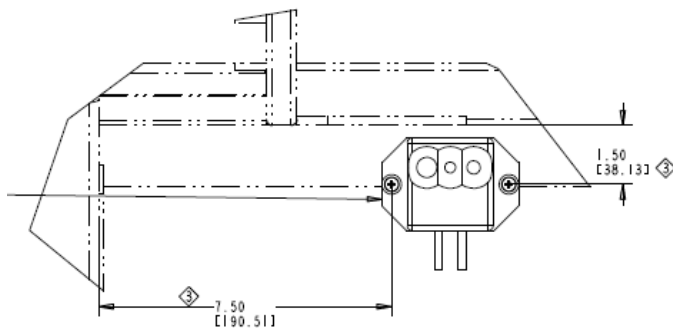
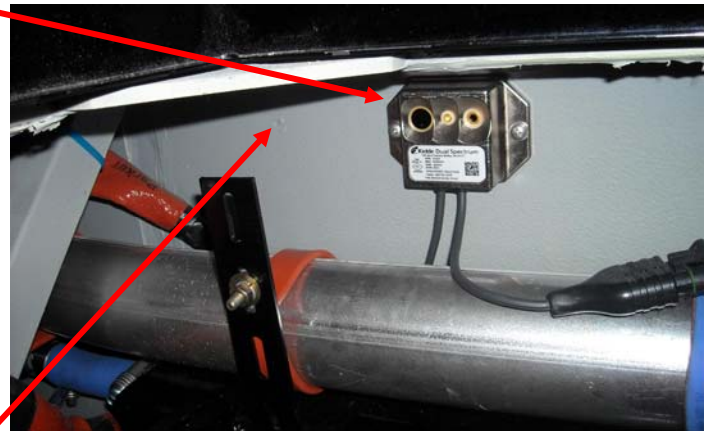
2. Open the settee seats.
3. Open the rear engine hatch.
4. Remove sensor.
5. Drill two 1/8" size holes according to the drawing below.
6. Install sensor to the new location with #10-24x1/2 PH screws, flat and lock washers.

7. Seal the original mounting holes with Fire barrier 3M sealer.

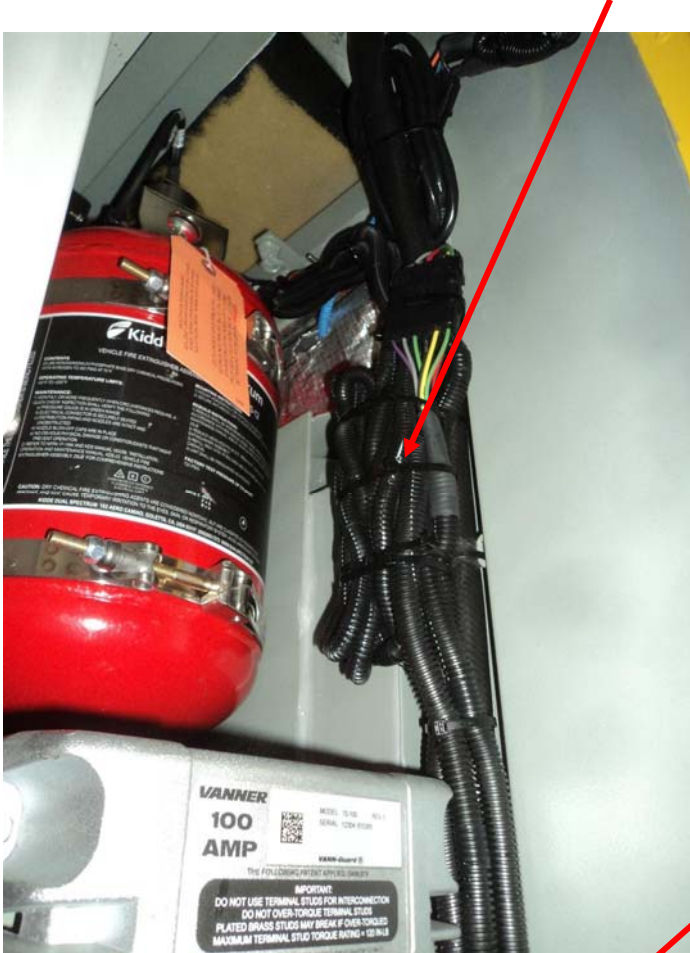
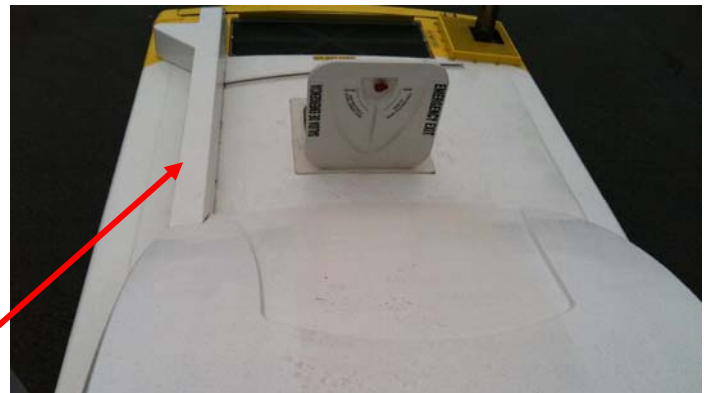
8. There are two harnesses for the upper sensor. The lower harness is 25' long and bailed behind the agent tank. Cut the wire ties and un-bail the harness. Pull slack out upwards.

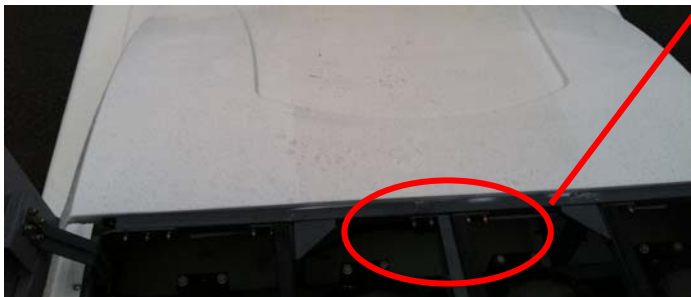
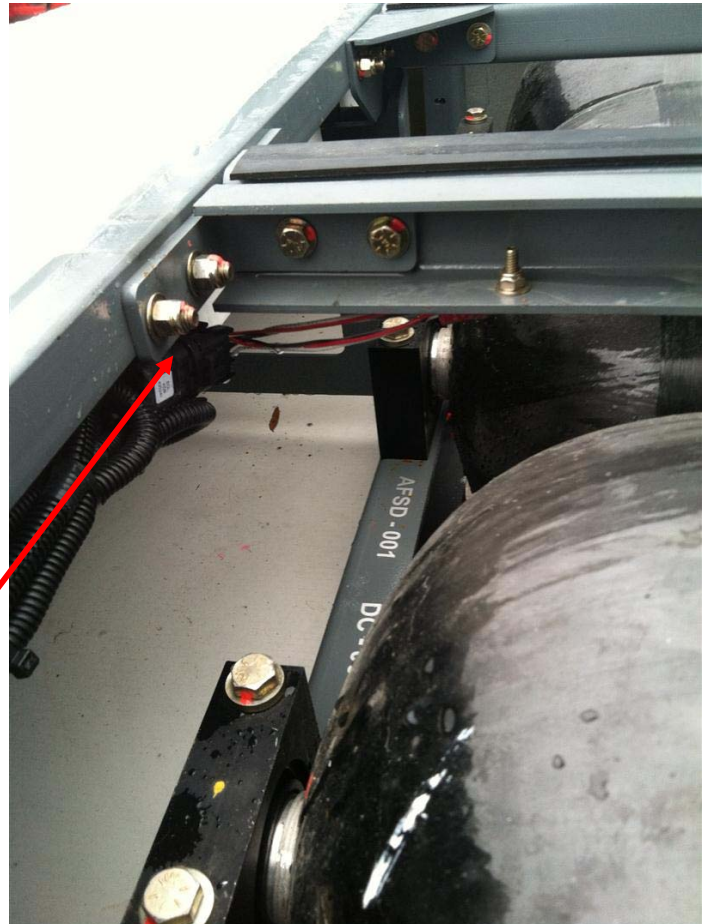
15. Install sensor at the back of the CNG compartment per the pictures below.

16. Connect the lower harness to the sensor.
17. Secure harness as required with wire ties. Ensure that the harness is not rubbing, pinched, bent, etc.
18. Reinstall fuel line cover.
19. Remove unused parts and tools from work area.
20. Check for completeness of work.
21. Close CNG tank compartment doors.
22. Record bus number, mileage and date of completion.
