Service Bulletin

Subject: Water Leak In Trunk

Models: 2008- 2013 Cadillac CTS Models
2005- 2011 Cadillac STS Models

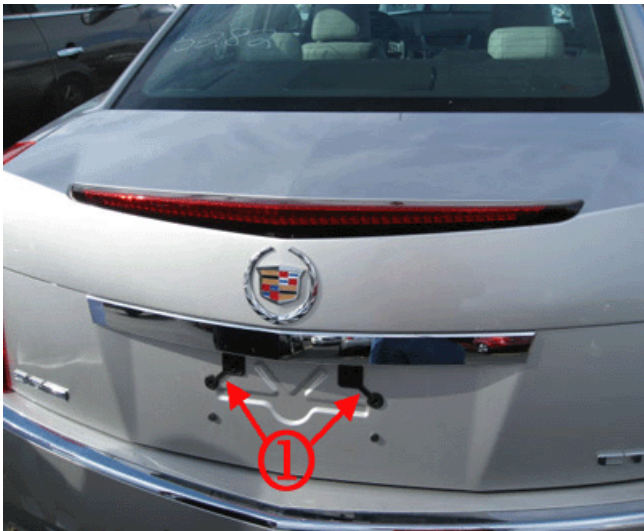
A customer may comment that water drips out of the trunk decklid from behind the trim panel. The cause may be water entering the decklid past one or both of the license plate grommet's foam gaskets (1).

Seal the license plate grommets. A suggested sealer for this repair is Kent Automotive High-Tech P10200 Clear 5 Fl. Oz. Tube Grade.
