Service Bulletin

PRELIMINARY INFORMATION

Subject: Water Leak In Rear Floor Area

Models: 2011 - 2013 Chevrolet Camaro Convertible

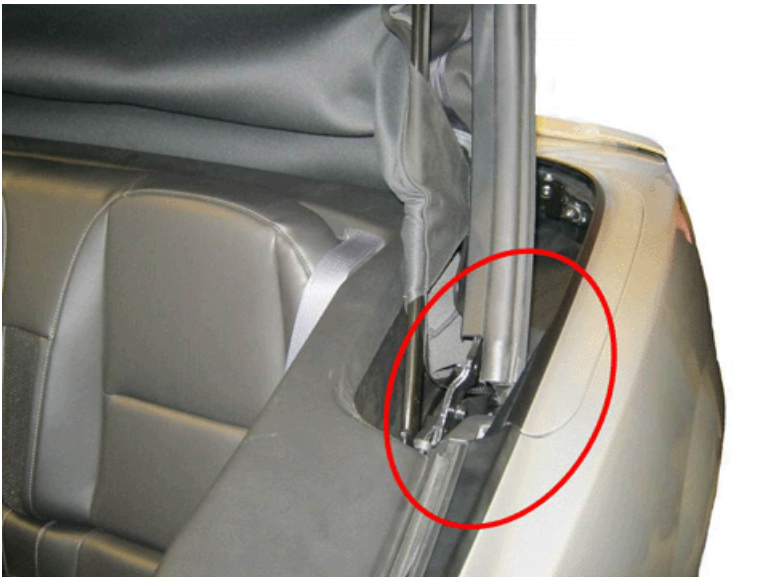
Everything to the inboard side of the rear quarter glass is considered a dry area; water should not be in the "dry area" (1). Everything to the outboard side of the rear quarter glass is considered the "wet area" (2). It is acceptable and by design that water is present on the outboard side of the rear quarter glass and in the area of the quarter glass regulator that the front drain spills into.
