Service Bulletin

Subject: Driver Carpet Footrest Cover Loose or Dislodged from Carpet Base

Models: 2013 Cadillac ATS
Built Prior to October 8, 2012

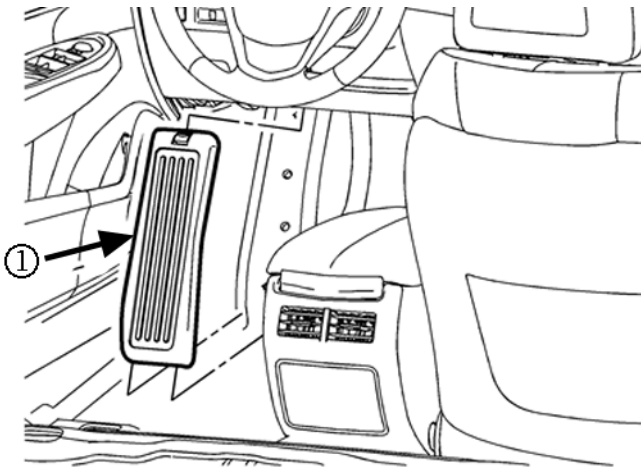
Some customers may comment that the driver footrest cover is loose or is dislodged from the carpet.

The cause of this condition may be that the upper snap feature of the footrest cover won't stay retained to the carpet footrest base.

1. Completely remove the footrest cover (1) from the carpet base. Refer to Driver Footrest Replacement in SI.

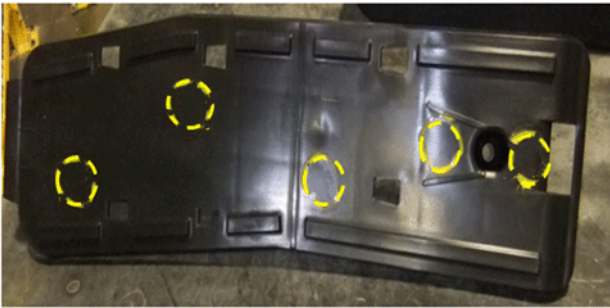
Note: The approximate locations for the hot melt application are shown in the illustration above.
