# Service Bulletin

**Subject:** Transmission Fluid Level Indicator Handle Broken

**Models:** 2007-2013 Cadillac Escalade Models  
2007-2013 Chevrolet Avalanche, Silverado, Suburban, Tahoe  
2007-2013 GMC Sierra, Yukon Models  
Equipped with Automatic Transmission RPOs MYD, MYC

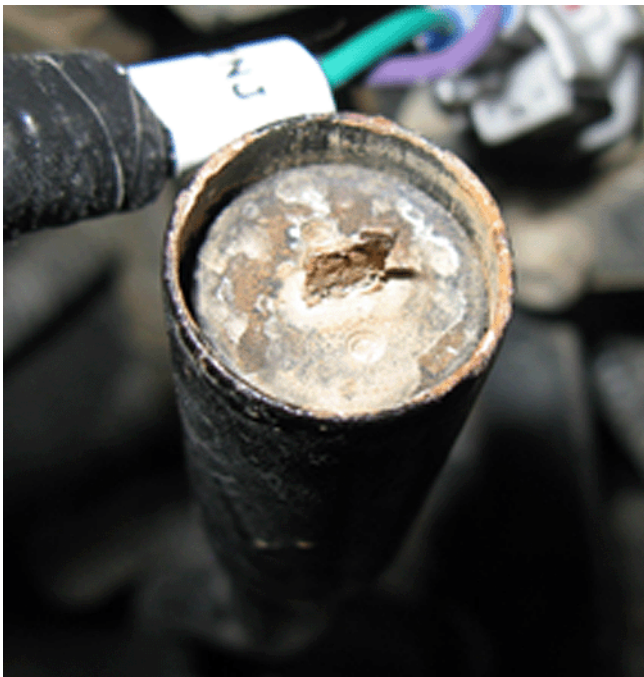
Some customers may comment that while attempting to remove the transmission fluid level indicator to check the fluid, the handle breaks off. Further investigation reveals that the metal indicator material was corroded and broke where the plastic handle is attached.

Technicians should replace the transmission fluid level indicator with the updated part number. The new part is darker in color as shown below.
