Service Bulletin

Subject: Information on Counterfeit Airbag Modules

Models: 2010-2011 Buick LaCrosse

2011-2012 Chevrolet Camaro, Cruze, Volt

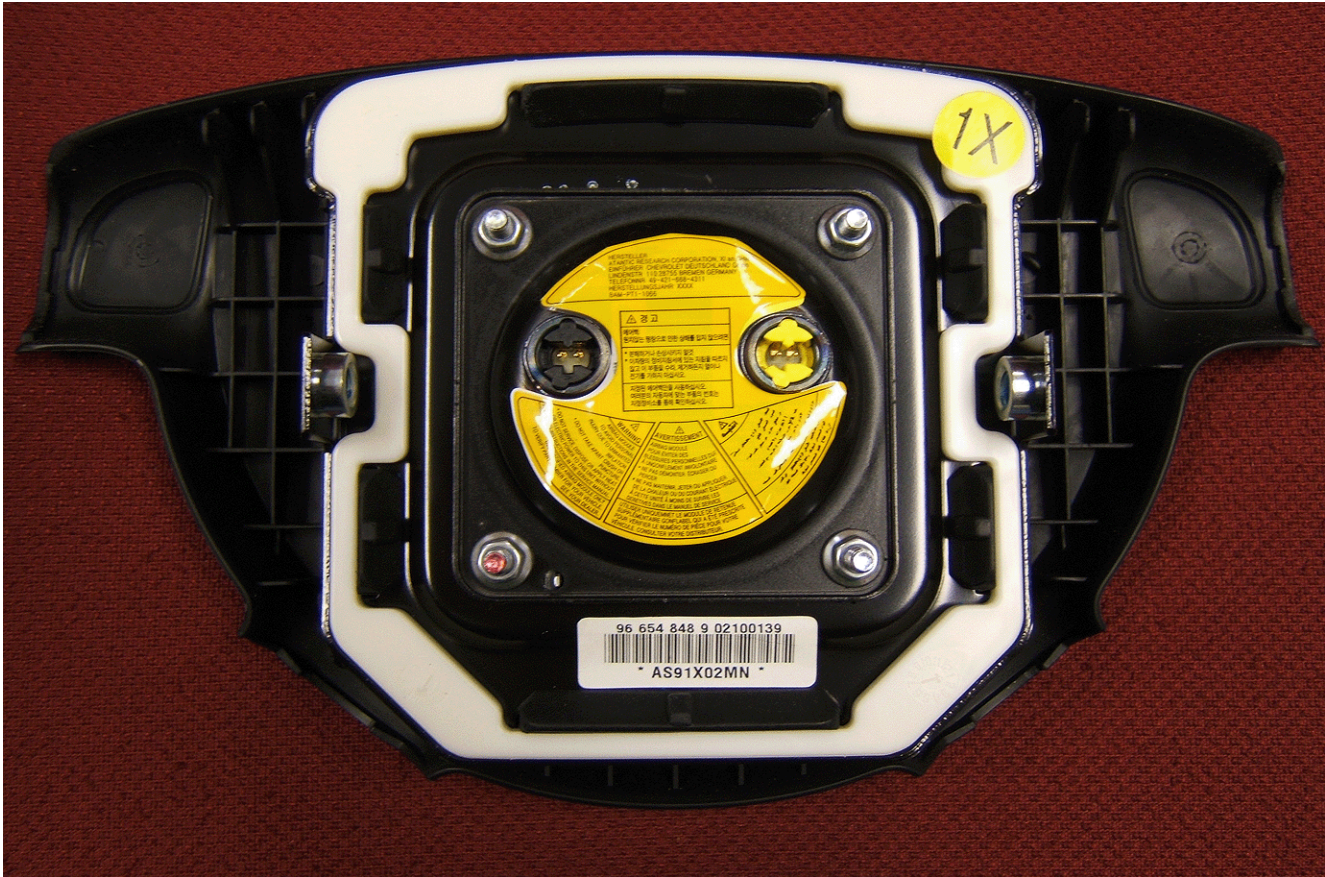
Genuine Aveo Airbag Module

The Chevrolet Aveo uses a metal backed airbag module that is painted black. The physical appearance of the module should exactly match the picture below.

Look for inconsistent materials, stickers, additional holes in the module, or any signs of tampering.

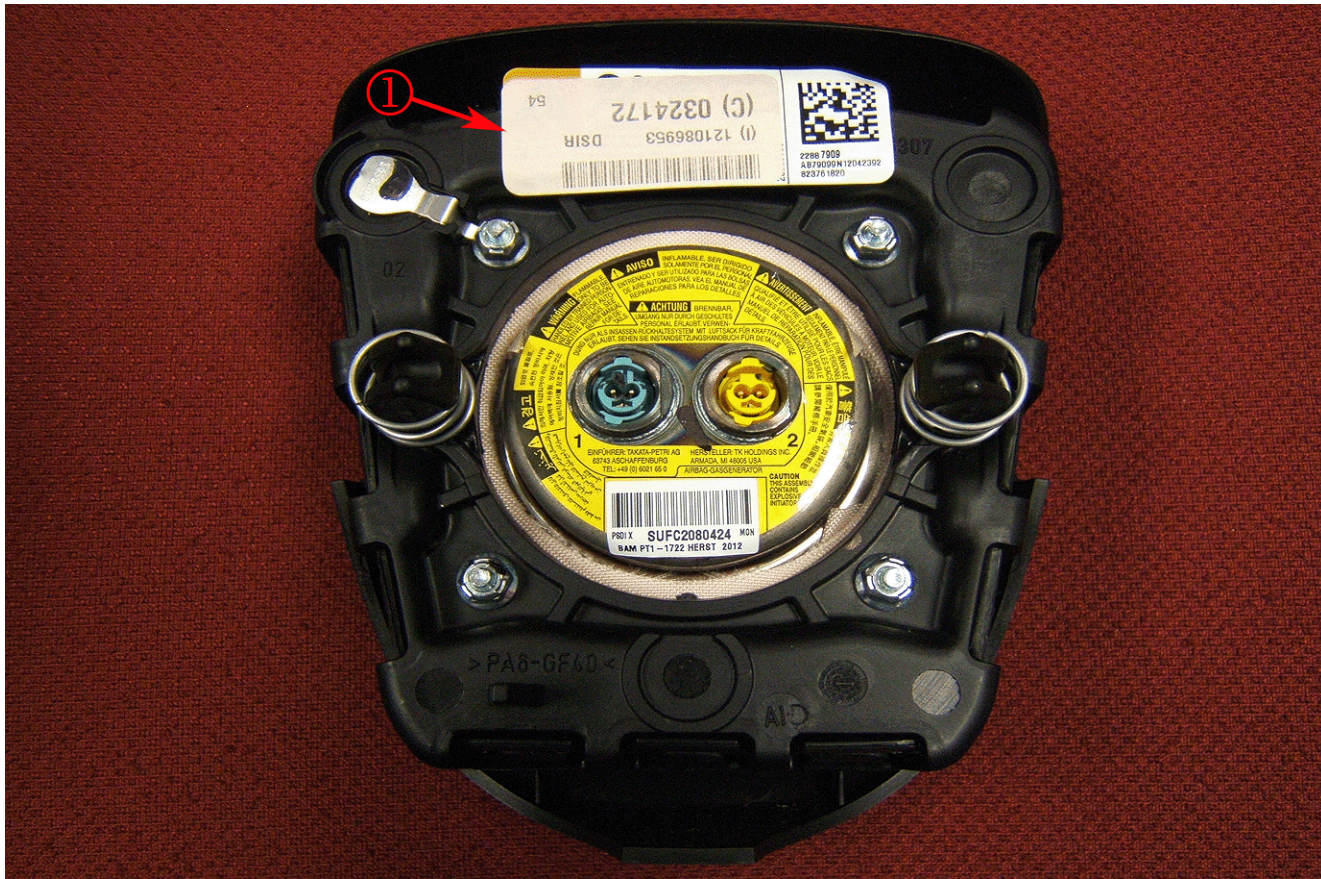
Genuine Camaro Airbag Module

The Chevrolet Camaro uses a plastic backed airbag module black in color. The physical appearance of the module should exactly match the picture below.

Look for inconsistent materials used, variation in the caution sticker, additional holes in the module, or any signs of tampering. The paper label (1) may be present, removed or placed at a different location on the module. This paper label should not be considered critical in validating the authenticity of this module.

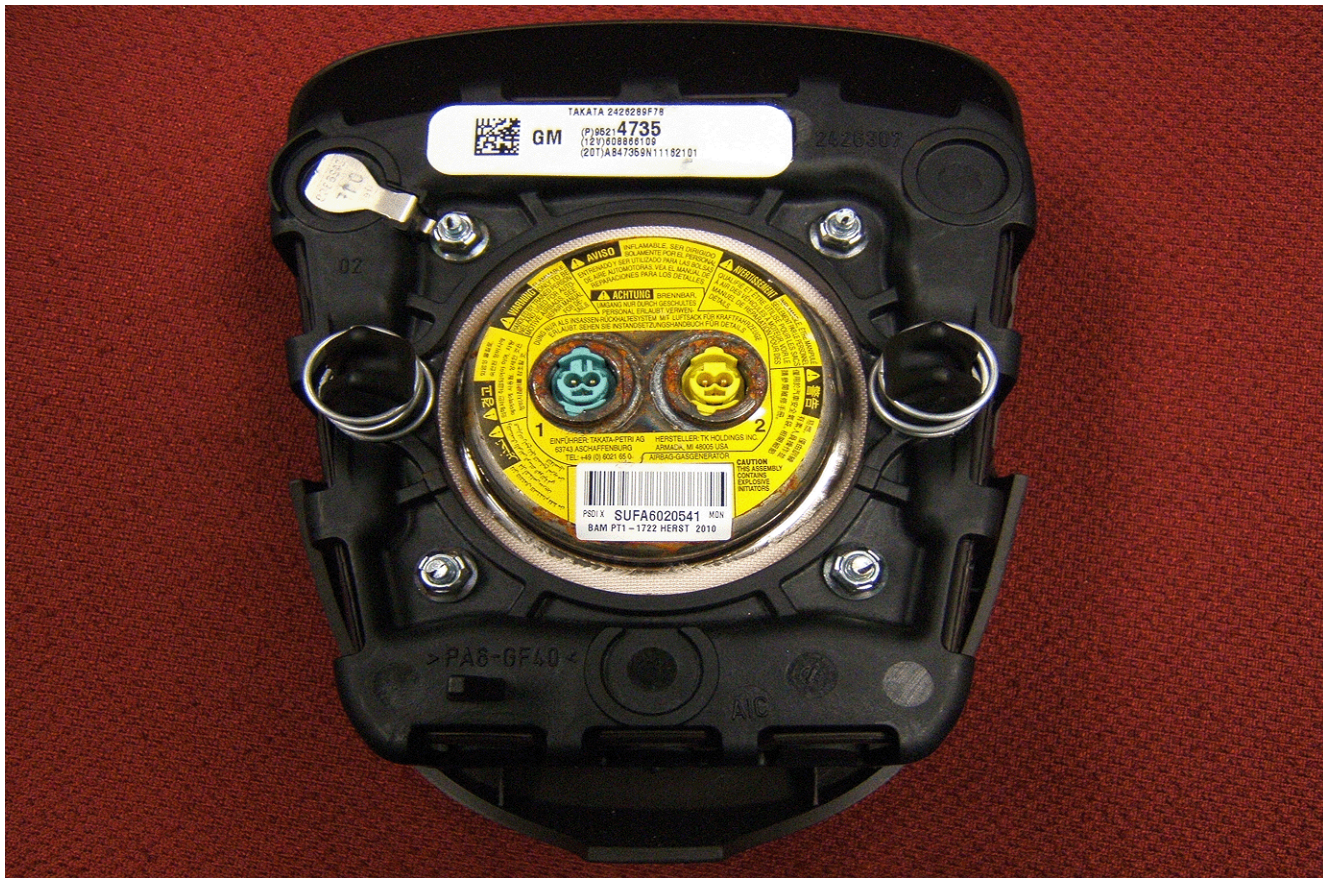
Genuine Cruze / Volt Airbag Module

The Chevrolet Cruze / Volt uses a plastic backed airbag module black in color. The physical appearance of the module should exactly match the picture below. One example is shown for both vehicles. Various part numbers are used for each application but the physical appearance is the same.

Important: This example shows corrosion on the bare metal near the electrical contacts. This is a normal condition you may encounter, and is not an indication of counterfeit, remanufactured or reclaimed parts. The corrosion does not affect operation of the airbag module.

Look for inconsistent materials, stickers, additional holes in the module, or any signs of tampering.

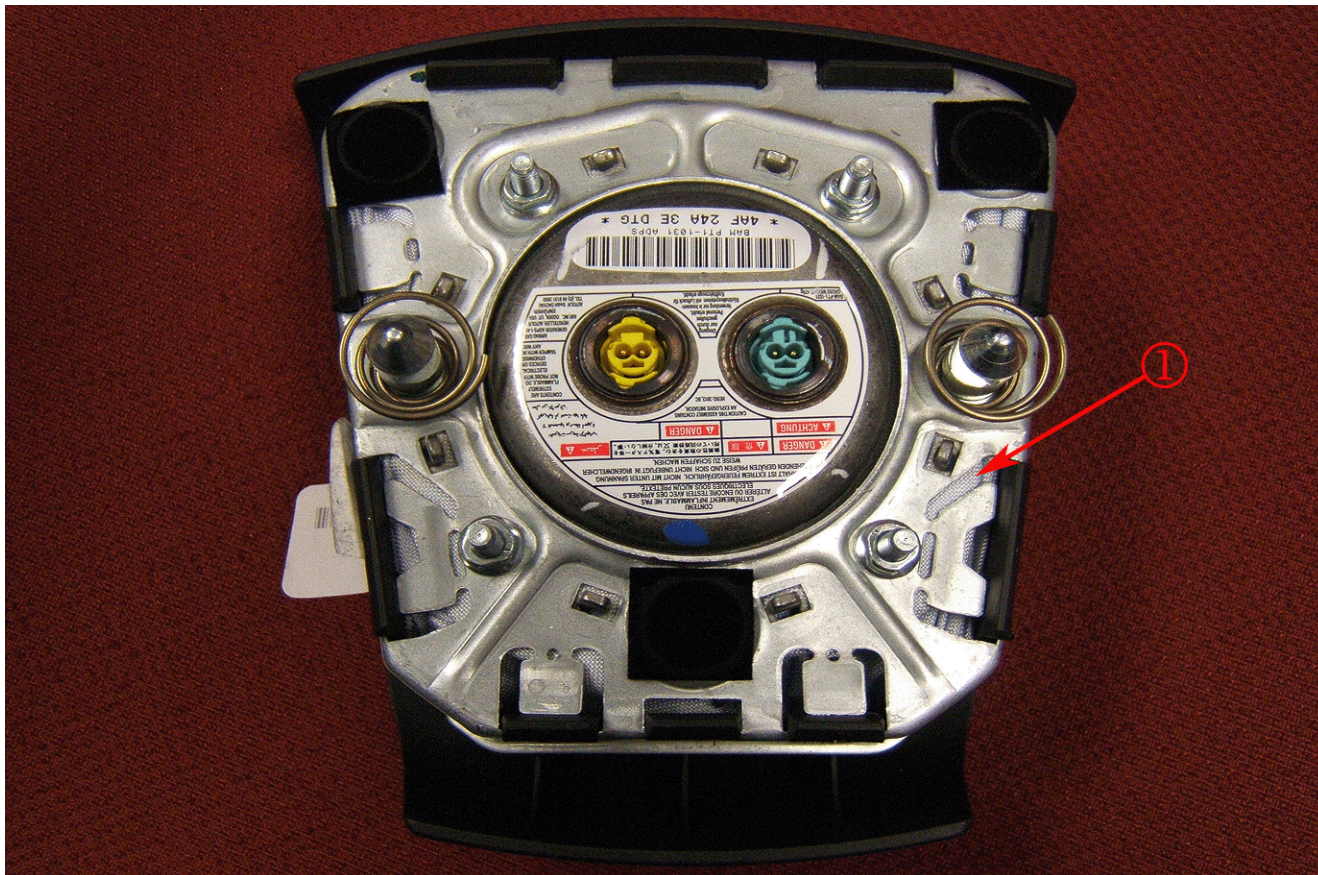
Genuine LaCrosse Airbag Module

The Buick LaCrosse uses an unpainted metal backed airbag module. The physical appearance of the module should exactly match the picture below. Various part numbers are used for each application but the physical appearance is the same.

Important: This type of module allows the airbag (1) to be visible at several points around the edge of the module. Confirm the module has an airbag installed.

Look for inconsistent materials, stickers, additional holes in the module, or any signs of tampering.
