# Technical Service Bulletin

## 66F5 UPDATE - Emblems on rear lid incorrect (NVLW)

Model(s)	Year	VIN Range	Vehicle-Specific Equipment
Audi Q7	2013	000001 – 003182	3.0TDI

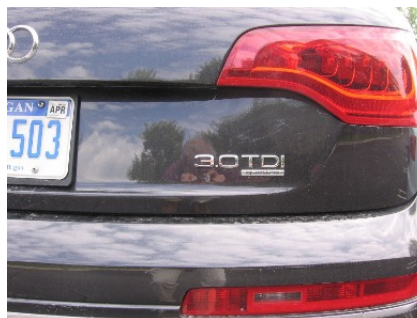
The emblem package on the rear lid of certain model year 2013 Audi Q7 3.0 TDI vehicles is incorrect (Figure 1). The labeling “3.0 TDI Quattro” was installed on the right side of the rear lid. The correct emblem is displayed in Figure 2.

*Figure 1. Wrong labeling.*

Please check any of these vehicles in dealer inventory and remove the “3.0” emblems leaving the “TDI Quattro” emblems installed.

Please ask the customer if they wish to have the “3.0” emblems removed or if they wish to leave the emblems installed before performing any repair. Proceed as the customer desires.

**Tip:** As specified in ElsaWeb the emblems may need to be warmed using a hot air gun to a temperature of 40°C (104°F). If necessary, clean any remaining residue with **D 009 401 04** All Purpose Cleaner. Exercise care when removing the emblems to protect the surrounding painted area.

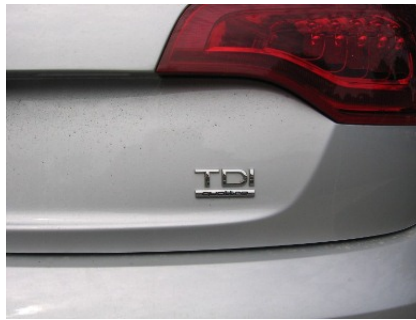
**Figure 2.** Correct labeling should be “TDI Quattro” without “3.0”.

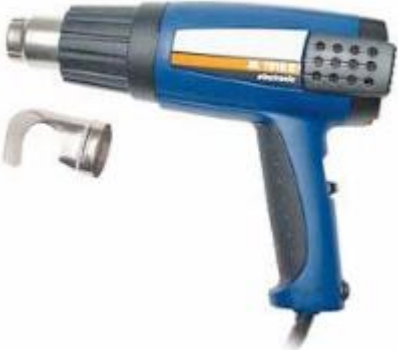
VAS 1978/14A	Hot air blower (or equivalent)
