Technical Service Bulletin

01 MIL on P2015, P2020

01 12 55 2030192/1 October 22, 2012.

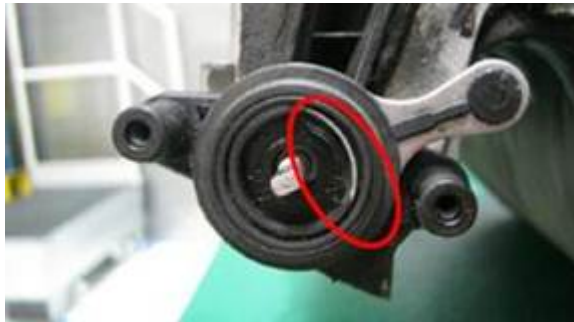
When the potentiometer is removed, the oil seal can be seen, as shown in Figures 2 and 3.

- Figure 2 shows a correct oil seal.
- Figure 3 shows a deformed oil seal which causes the sticking.

Figure 3. Deformed seal.

1. Replace the oil seal with the part number and potentiometer seals according to the following instructions:

To avoid sticking linkage in future, remove the seal spring *before* installation as follows:

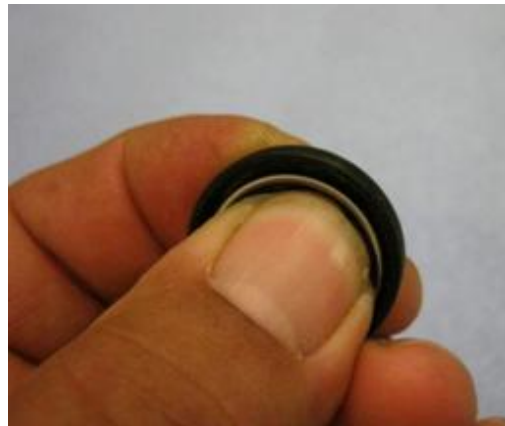
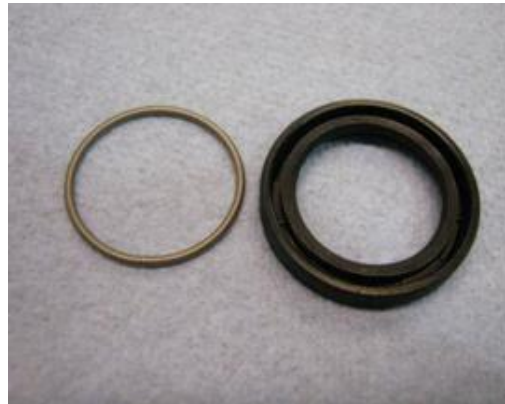
Figure 4. Removing spring.

Tip: Do not use a screwdriver or another tool to remove the spring to avoid damage to the sealing lip.

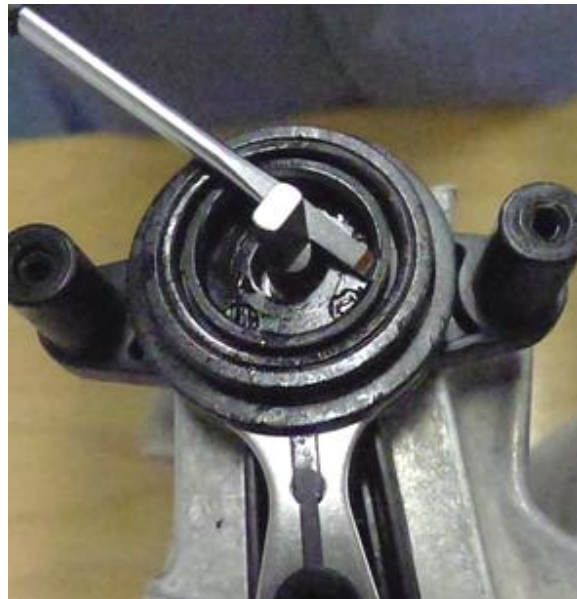
Figure 6. Removing seal ring.

3. Remove the seal ring with a screwdriver. To do this, push the screwdriver under the seal and gently remove seal. (Figure 6).

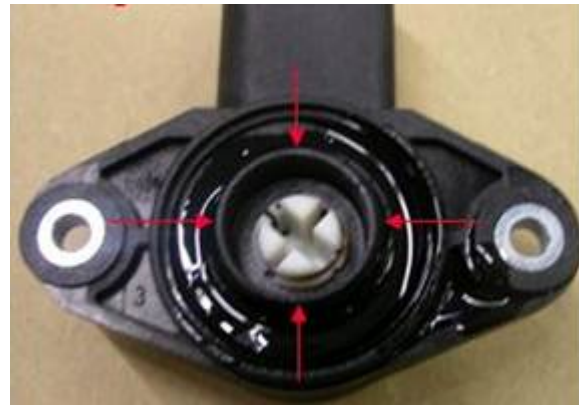
Figure 8. Lightly oiled sensor.

6. Lightly oil the potentiometer before the installation.

Oil the sensor on the contact surfaces, observe Figure 8. Also, apply oil on the contact surface of inner ring of the lip seal ring with engine oil 10W/40.
