Technical Service Bulletin

66 Wind noise from roof carrier bars

66 12 26 2031853/1 November 30, 2012.

Model(s)	Year	VIN Range	Vehicle-Specific Equipment
Audi Q5	2009 - 2012	000001 - 999999	Not Applicable
	2013	000001 - 032698

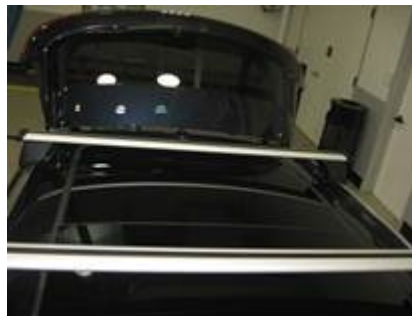
Figure 1. Roof carrier bars installed.

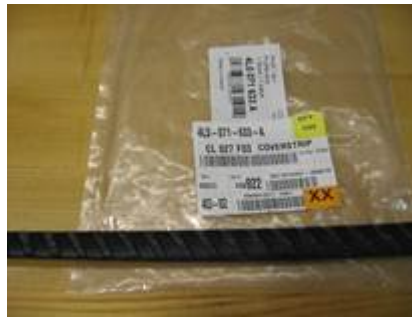
Figure 2. “Fluted” protection strips, part number 4L0 071 633 A.

The wind noise that results from the installation of the carrier bars can be mitigated, although not eliminated, by the installation of “fluted” protection strips, part number 4L0 071 633 A. These are being installed in production and will be included in the carrier bar kit that accompanies the Audi Q5.
