# Service Bulletin

**Subject:** Radio Static on All AM Stations

**Models:** 2008-2012 Cadillac CTS  
Built Prior to May 1, 2012

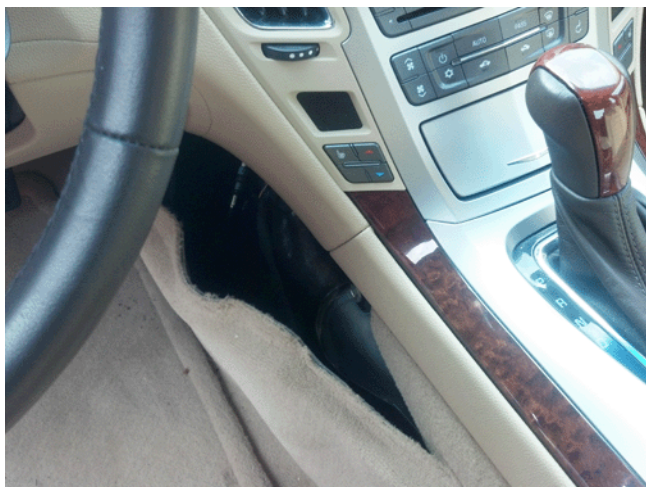
This may be caused by a stiff front coax cable that connects to the radio and goes to the center console connection. This stiff cable can put excessive sideways pressure on the connector at the radio and affect the connection. A newly designed coax cable is now available. Follow the steps below for inspection and replacement of the front coax cable.

1. Inspect the connector on the driver's side of the center console by gently pulling the carpet down out of the trim at the top. The newer cable thinner and much more flexible. If the vehicle has the new cable already installed, this bulletin does not apply. Follow normal diagnostics in

2. Disconnect and reconnect the coax cable connector. If the AM static is less, this is a good indicator of an issue with the front coax or its connection to the radio and the newly designed cable should be installed.

10. Route and install the new front coax cable and secure to the harness with electrical tape.
11. Apply dielectric grease to the radio side of the cable and install the cable into the radio.
12. Install the AM/FM Stereo and Clock and Audio Disc Player Radio Control Assembly.
13. Install the instrument panel trim plate applique – right side.
14. Install the instrument panel trim plate applique – center.
15. Install the front floor console transmission shifter trim plate assembly.
16. Install the right and left front floor console appliques.
17. Apply dielectric grease to the coax cable connection at the center console.
18. Connect the coax cable at the center console connection.
19. Gently tuck the carpet back into the driver side center console.
